DAMAGE TO CONCRETE BUILDINGS WITH PRECAST FLOORS DURING THE 2016 KAIKOURA EARTHQUAKE

Richard S. Henry¹, Dmytro Dizhur², Kenneth J. Elwood³,
John Hare⁴ and Dave Brunson⁵

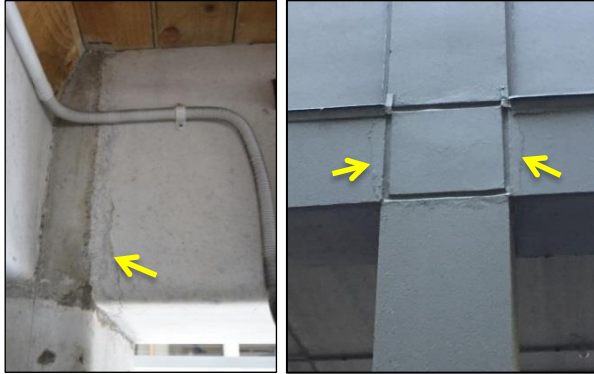
(a) Minor cracking

Figure 2: Examples of beam plastic hinging.

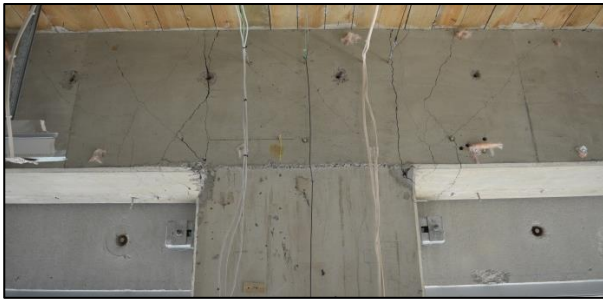
(b) Moderate cracking

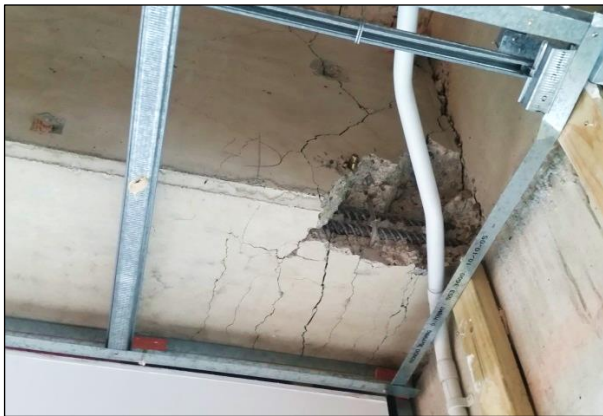
(c) Exceeding CDS C1 criteria

1. Total crack width in plastic hinge $> 0.005d$ (where d is the beam depth).
2. Sliding has occurred on a crack.
3. Wide ($>0.5\text{mm}$) diagonal cracks.
4. Concrete degradation, indicated by significant spalling (concrete cover can be removed by hand).

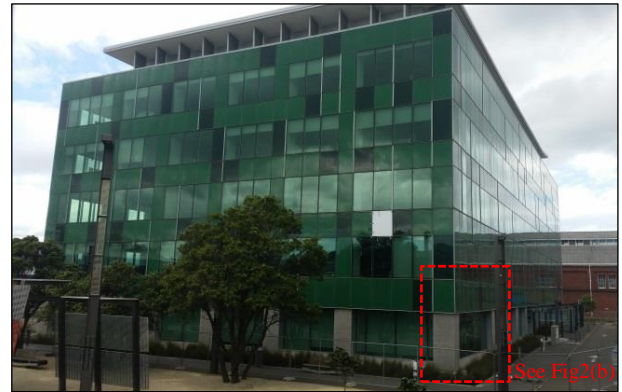
(a) Building overview

Figure 3: Statistics House floor collapse.

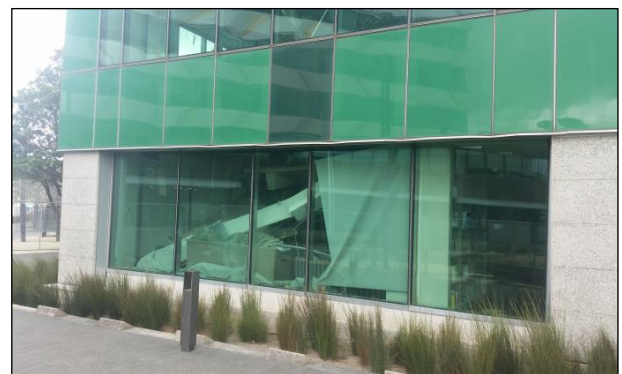
(b) Collapsed floor unit in corner of ground floor

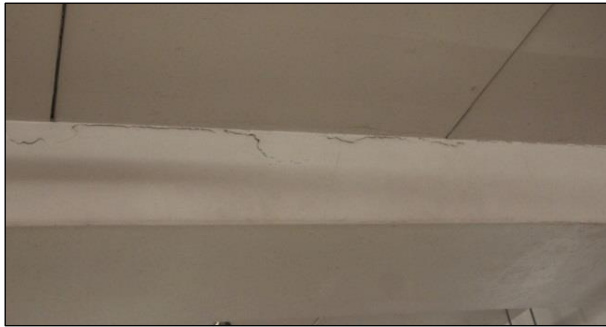
In addition to beam elongation, the building drift and associated rotation of the support beam can lead to damage at the support. Minor spalling of the support ledge was observed in many buildings with hollowcore floor units seated directly on the support beam, as shown by the example in Figure 4a. The use of a bearing strip, as required by NZS 3101:2006 [12] and used since the mid-2000s, can delay the onset of such minor spalling by allowing the unit to slide relative to the support beam. However, spalling of support ledges is still observed (e.g. Figure 3b) when the building is subjected to high drift demands with bearing stresses and prying effects

(a) Minor spalling (without low-friction strip)

Figure 4: Support ledge spalling.

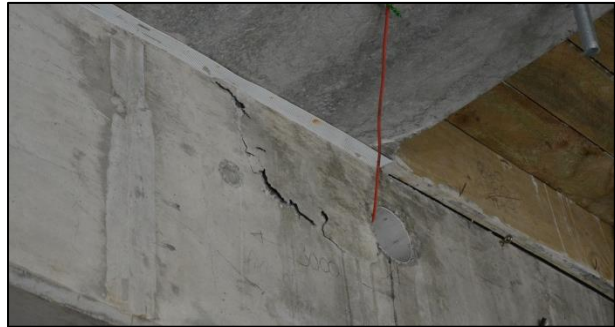
(b) Minor spalling (with low-friction strip)

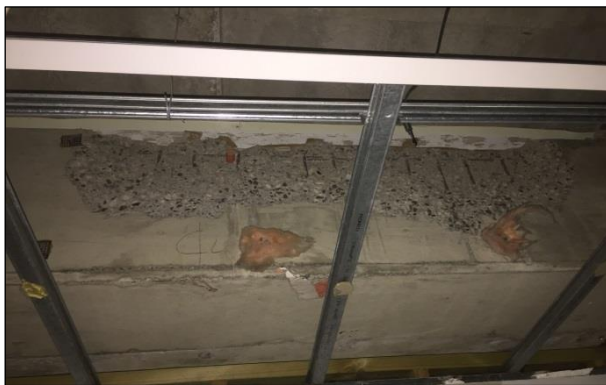
increased. Examples of significant spalling of the support beam are shown in Figure 4c and d where the entire cover concrete has been lost. The seating length in this building was adequate to ensure that a residual bearing area was maintained to prevent complete loss of support and potential collapse of the floor units. Despite the extensive damage observed, Figure 4c highlights the importance of proposed changes to design standard requirements in NZS 3101:2006 [12] (draft amendment 3) where seating lengths must be sufficient to accommodate demands due to both elongation and rotation, as well as the loss of bearing area due to spalling. In addition, the ledge reinforcing is visible in the photos, indicating that adequate ledge reinforcement is essential to maintaining support during large earthquakes.

(c) Spalled ledge exposing reinforcing

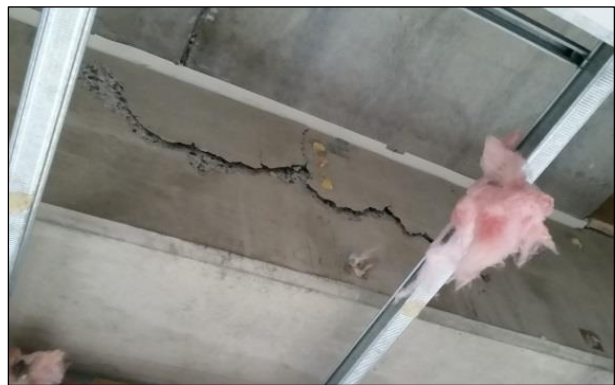
(d) Deep crack at support ledge with concrete still in place

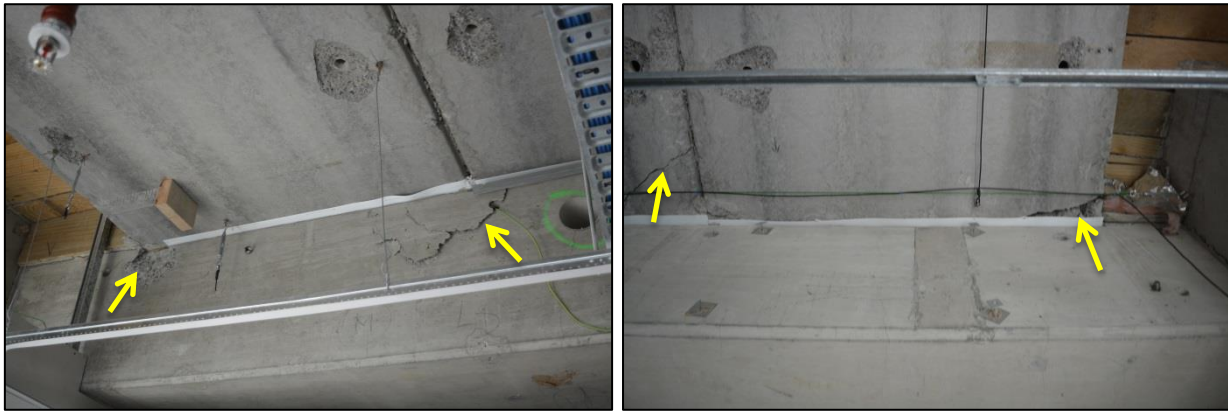
In cases of spaced hollowcore units, examples were observed of spalling of the support beams at the unit corners, or cracking at the corners of the hollowcore unit, as shown in Figure 5. This damage pattern was also observed during the 2010/2011 Canterbury earthquake sequence [9] and is thought to be related to torsional rotation of the hollowcore units due to diaphragm demands or deformation incompatibility. Hollowcore units spaced by timber infills are more susceptible to concentrations of damage at the corners due to the lack of restraint from adjacent units.

(a) Spalled support beam

(b) Cracked corners of hollowcore

Figure 5: Corner cracking or spalling of spaced hollowcore.

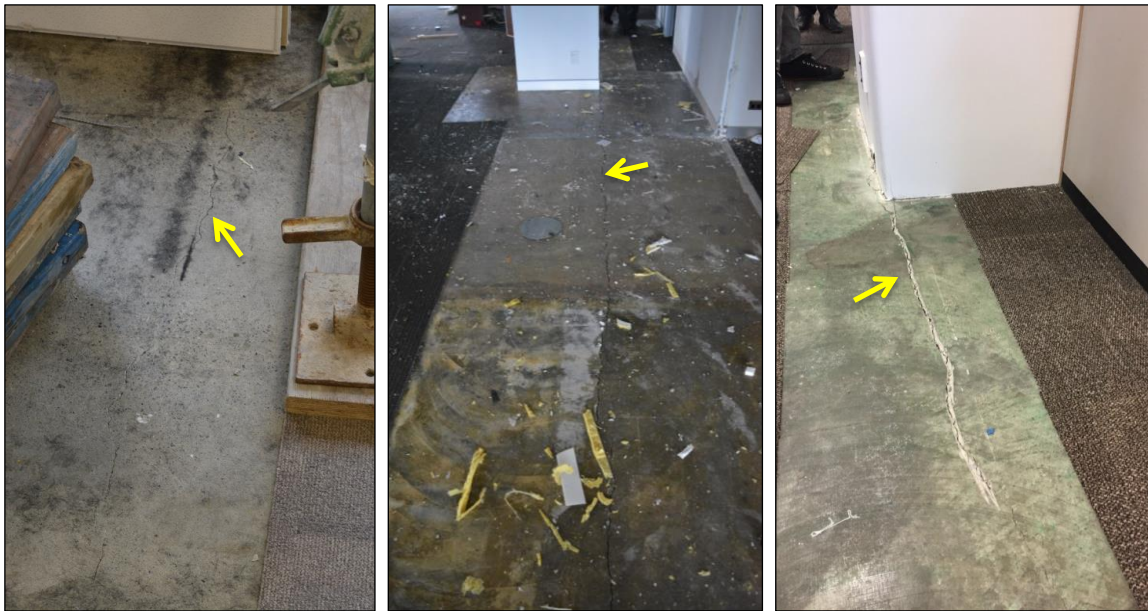
damage. Examples of the cracks observed in floors when the floor coverings were uplifted are shown in Figure 6. Many of these cracks initiate as shrinkage cracks which typically propagate at the joints between precast concrete floor units, or between the floor unit and the support beam. In some cases these shrinkage cracks are widened during the earthquake as additional deformations are imposed on the floor.

Cracks in the concrete topping do not necessarily pose a significant risk in terms of potential collapse, but may result in fracture of mesh reinforcing, a reduction in diaphragm stiffness, and potential loss of diaphragm load paths. As such, the topping cracks alone were not considered a critical damage state, but further investigation was required to identify if cracks propagated through hollowcore units (CDS A, B & C) or if mesh fracture had occurred (CDS C).

**Figure 6: Examples of cracks in floor topping.**

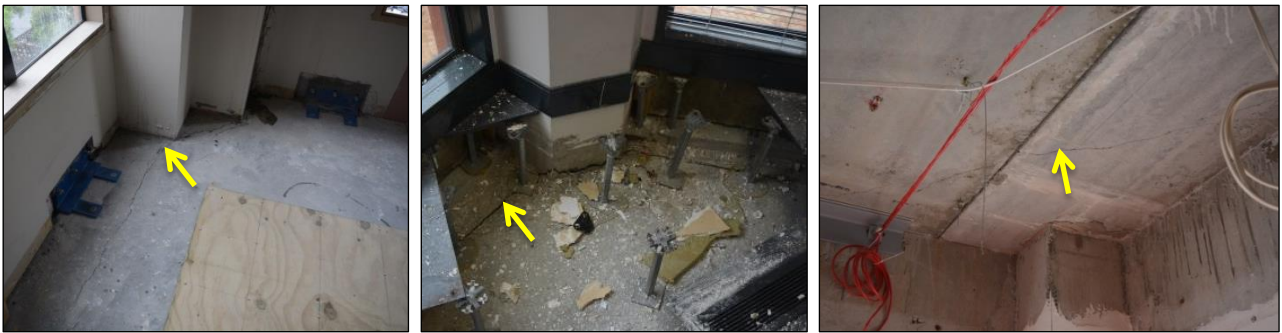
The most commonly observed damage pattern of the floor diaphragms was cracking of floor precast units in the corners of the floor diaphragm. As shown in Figure 7, corner cracking typically takes one of three forms: 1) localised with only one or two, typically fine, cracks near corner column (examples in Figure 8); 2) a complex intersection of many, typically wider, cracks, generally limited to the first unit (examples in Figure 9); or 3) a single diagonal crack set back from the corner, crossing more than one unit, and intersecting the frames roughly halfway along the bay lengths. The first two corner damage patterns result from deformation incompatibility between the beam and the floor unit leading to twisting of the first unit running parallel to the external frame, and can be exacerbated by beam elongation. Hollow core units are weak in torsion and crack at low deformation demands [7, 8]. In 2004, an amendment to NZS 3101:1995 [13] introduced a requirement to include a link slab between the exterior frame and the first precast unit to accommodate the deformation of the beam relative to the floor unit. Due to the small number of post 2004 buildings included in the TDE, the performance of

Figure 8: Damage in corners of floor diaphragm – Single cracks.

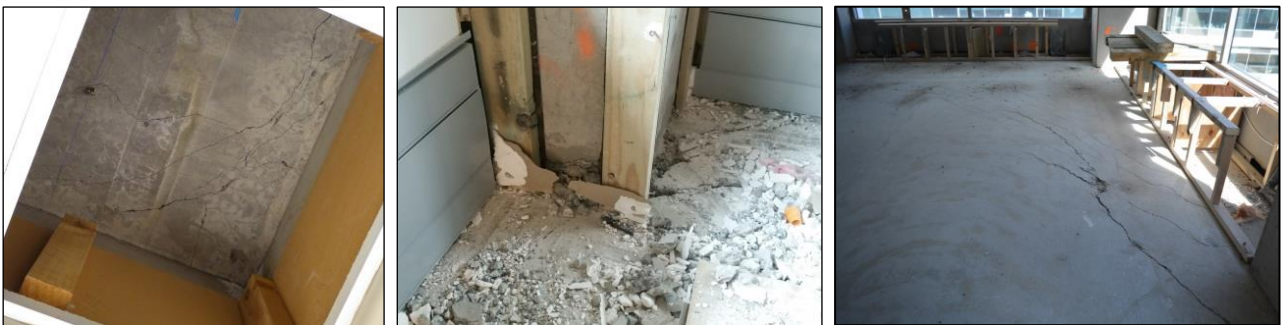
Figure 9: Damage in corners of floor diaphragm – Significant cracking.

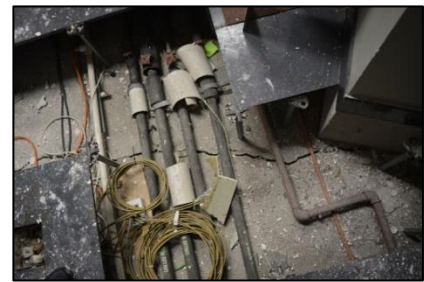
In at least one significantly damaged building, the layout of the structural system led to failure of the diaphragm with wide cracks extending through the topping and hollowcore units (10-15mm wide in some locations with topping steel mesh fracture). The principal crack ran longitudinally along the unit and stepped across cells at discrete locations, with damage to internal webs of the unit being likely. As illustrated generically in Figure 10, connection between the diaphragm and the short seismic frames at perimeter was interrupted by the presence of stairwells, leading to high shear demands on a short length of diaphragm. Floor unit demands were further exacerbated by limited beam elongation in the corner of the building and reasonably high building drifts (estimated at 1.0 - 1.5%).

(b) Wide floor cracks

Figure 10: Generic illustration of rectangular moment frame building with diaphragm failure at openings for stairwells.

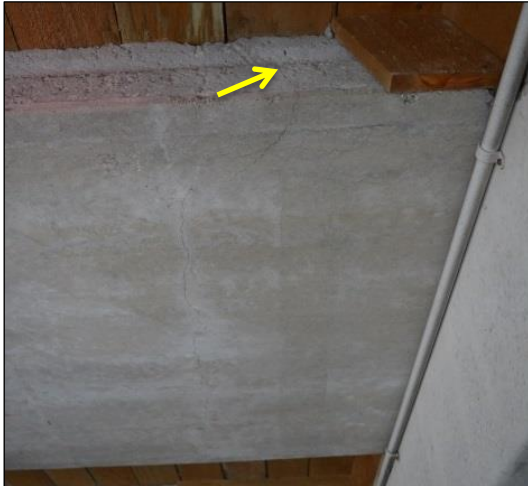
(a) Narrow crack (<math><0.5\text{ mm}</math>)

Figure 14: Diagonal cracking in webs of hollowcore floor unit.

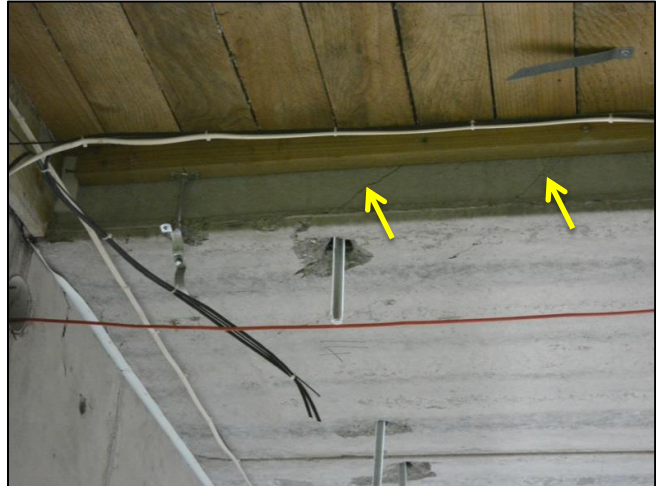
(b) Wider cracks

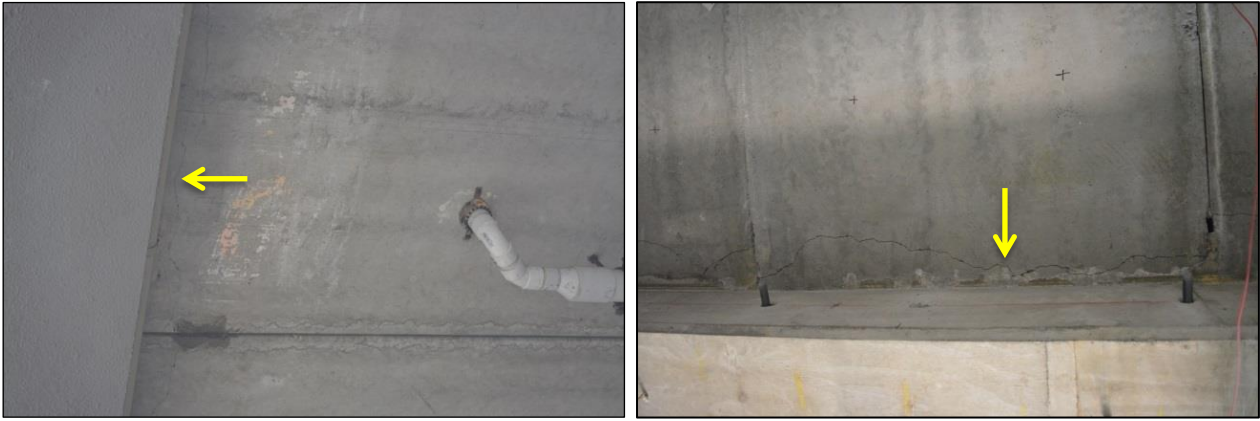
Figure 15 shows examples of transverse cracking within 100 mm of beam support. This unit was located adjacent to a column offset in the supporting frame. Column offset resulted in localised deformation concentration in beam and thus higher stresses on the floor units.

Figure 15: Transverse cracking of hollowcore floor units close to support.

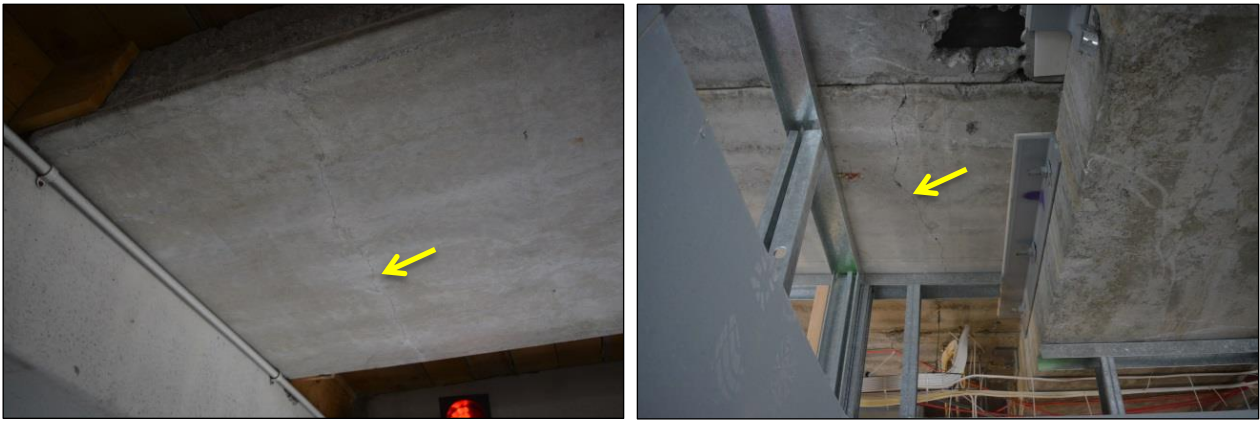
Several buildings were also found where single transverse cracks in the hollowcore units occurred at approximately 300 mm from the support (gravity or seismic frames) as shown in Figure 16. The location of crack on top surface typically corresponded to the end of the starter bars and in many cases the crack was found to extend vertically for the full depth of the unit. While past research has shown that

negative moments at supports may lead to cracking at the end of the starter bars, this cracking was previously found to extend into a diagonal crack in the unit web with significant concern for remaining gravity load support [15], in contrast to the vertical crack observed here. The exact cause of the observed vertical cracking pattern through the depth of the unit is unknown. Initially there was some suspicion this cracking could be due to temperature or shrinkage effects on the restrained unit. However, a review of 11 parking garages in Auckland (i.e., where no earthquake damage is present) did not lead to the identification of any similar cracking patterns, suggesting that this transverse cracking of units in Wellington is most likely earthquake-induced. Given the distance of the transverse crack from the support (typically 300 mm), the bond for bottom flange prestress strand is likely sufficient to sustain gravity loads, but further widening of the crack in aftershocks was still a concern. It is noted that typical retrofits of hollowcore floor systems in New Zealand [3] only provide support for units within approximately 100 mm of the supporting beam and would not prevent collapse of units failing at such cracks at approximately 300 mm from the support. Further research is needed to understand the cause of this cracking pattern, the capacity in future aftershocks, and potential retrofit techniques to address this failure mode.

Figure 16: Transverse cracking of hollowcore floor units away from support.

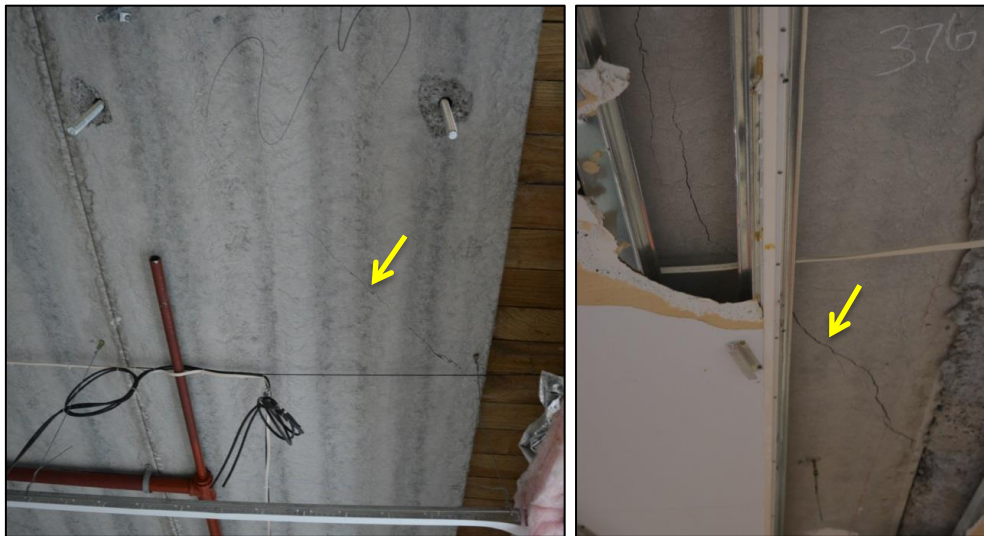
In some buildings more complex damage patterns were discovered including diagonal cracking across hollowcore units, as shown by the examples in Figure 17. These cracks either occurred near the corners of the buildings where diagonal cracking in the topping propagated through the hollowcore unit, or at irregularities in the floor plan or structural system layout.

Figure 17: Diagonal cracks in hollowcore floor units.

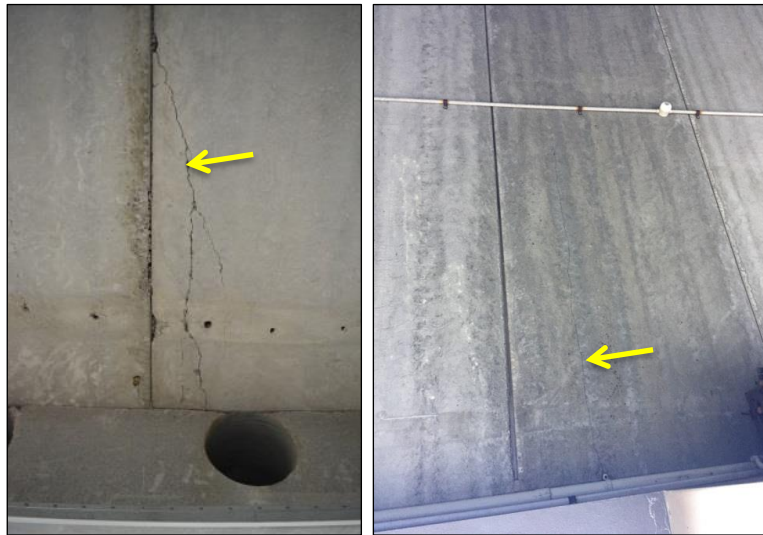
(a) Cracks only at ends

Figure 18: Longitudinal cracks in hollowcore floor units.

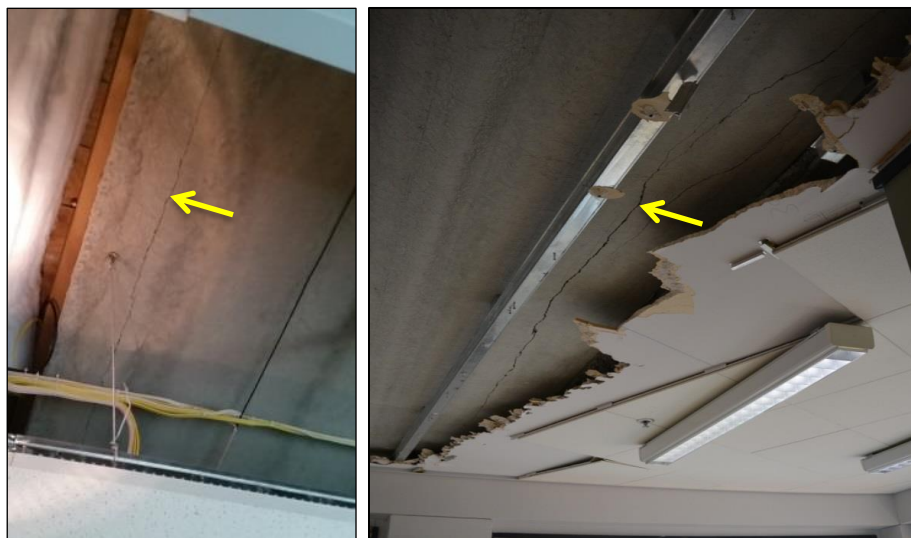
propagating diagonally across units (through multiple cells) were observed. In general, longitudinal splitting cracks can be commonly found in buildings with hollowcore floor units. A survey of parking buildings in Auckland with hollowcore floor units identified several cases of longitudinal cracking, highlighting that longitudinal cracks can form due to loading other than earthquakes. Longitudinal cracks were not classified as a significant collapse risk as they do not significantly compromise the vertical load capacity of the hollowcore unit.

(b) Wide cracks along entire length

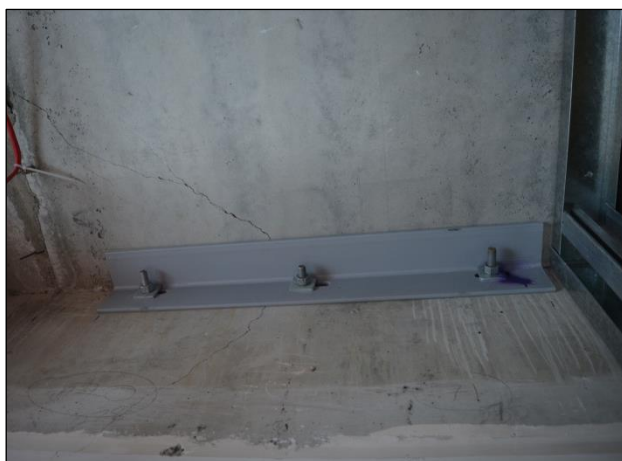
The use of an angle or RHS to extend the seating length may help to prevent loss of support due to elongation and/or support beam spalling, but does not address the potential for failure of the precast unit. As observed in buildings in Wellington, transverse cracking in hollowcore unit can occur a significant distance away from the support (>100 mm) and beyond the extended seating. Additionally, if the steel angle

or RHS is placed hard against the precast unit, the increased restraint and prying forces might actually increase the risk of transverse cracks developing in the unit.

(a) Steel angle at hollowcore floor unit support

Figure 19: Precast floor seismic retrofits.
