FACADE DAMAGE ASSESSMENT OF MULTI-STOREY BUILDINGS IN THE 2011 CHRISTCHURCH EARTHQUAKE

Andrew Baird¹, Alessandro Palermo² and Stefano Pampanin³

SUMMARY

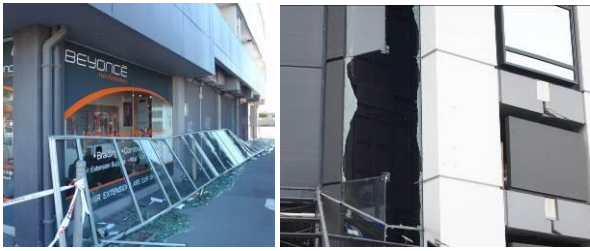
Not only can damage to the facade cause a building to be unusable, but there is also the risk of injury or death from things such as falling panels, masonry or glass, as shown in Figure 2. It is also clear that facade systems are particularly vulnerable to earthquakes since new and continuing damage to facade systems has been observed throughout Christchurch in recent aftershock events.

Figure 2: Examples of heavy damage to facade systems caused by the February 22 earthquake.

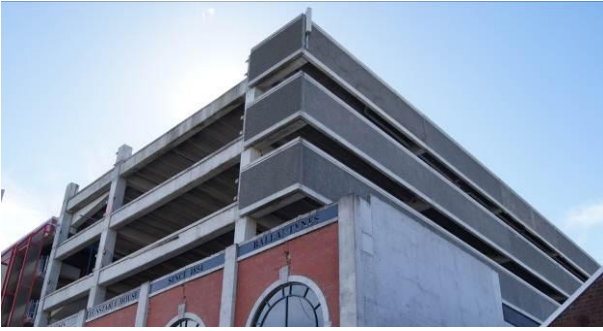
The majority of heavy claddings surveyed were precast concrete panels. Precast panels can be either storey-height panels that provide multiple architectural functions or panels that are purely aesthetic. The function of spandrel panels, like those in Figure 8 for example, is typically only to hide reinforced concrete members from view. There were approximately an equal proportion of storey-height panels and aesthetic panels surveyed.

Figure 8: Structure with disconnected spandrel panels.

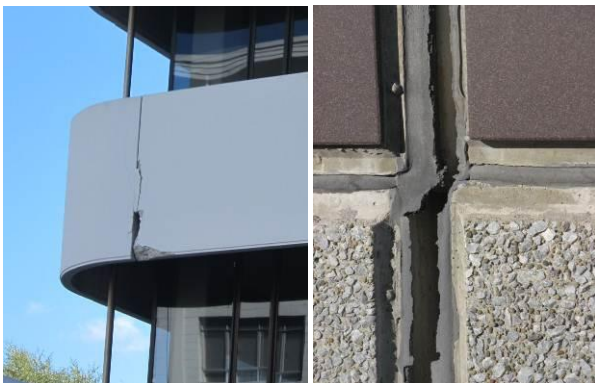
The majority of heavy claddings exhibited little to no damage. Where damage was present, it likely consisted of cracking or corner crushing. Corner crushing was most likely due to pounding with adjacent panels, as seen in Figure 9 (left). Within the CBD only one case of panel disconnection was observed. It was the result of several spandrel panels shearing off their bolted connections and falling to the sidewalk below, as shown in Figure 8. Fortunately no one was killed by these falling panels; however there was the risk of multiple fatalities as the heavy panels fell on approximately five tonnes of concrete fell to the sidewalk.

The panels were attached to the structure by an angle which was fixed to the panel by a cast-in anchor. Horizontal slots were present in all metal angles to allow sliding of the bolt, however, upon inspection, many of these bolts had sheared off close to the bolt head.

The slotted connections should theoretically have prevented large in-plane forces being carried in the panels. This is because slotted connections allow relative movement between the structure and the panels. However, it was observed that the bolt heads had not been able to move along the slots because their washers had been welded to the metal angle. This would have resulted in significant forces being transferred through the panels under in-plane deformation of the structure, likely leading to the shear failure.

Minor damage was also observed in the form of panels having residual displacements and/or rotations. The ejection or rupture of sealing joints due to movement between panels was also common, as shown in Figure 9 (right).

Figure 9: Corner crushing of spandrel panels (left), torn polysulphide seal (right).

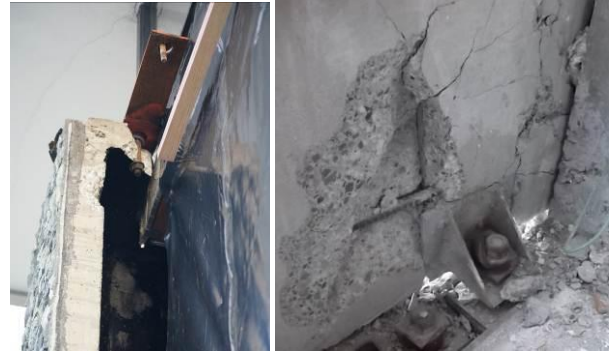
Complete disconnections of large concrete panels were also observed in the magnitude 6.3 aftershock on June 13th 2011. The remaining connection is shown in Figure 10 (left). However these panels were attached to a two-storey building and outside of the four avenues so are not included in the survey.

Frame elongation caused significant damage to the connections and panels in a multi-storey reinforced concrete perimeter frame building within the Christchurch CBD. Shown in Figure 10 (right) is a close up of the connection between the panel and the beam.

Figure 10: Connection of coffered precast panels that failed in June 13 aftershocks (left), precast panel and connection damage due to beam elongation (right).

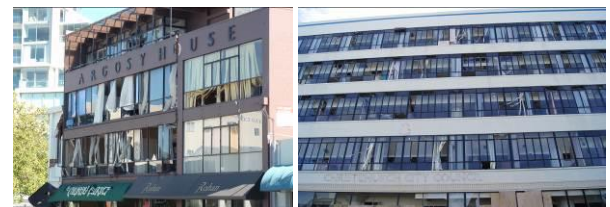
Lightweight claddings of all ages showed various levels of damage. Cracked or broken glass is usually the most obvious indicator of damage to light-medium weight cladding systems. Older systems normally provide less movement allowance for the glass and consequently were more likely to exhibit glazing damage, like that shown in Figure 11. Several buildings with older, non-seismic glazing frames were re-glazed between September and February, only to be damaged again in the February earthquake.

Figure 11: Damage to light-medium weight cladding.

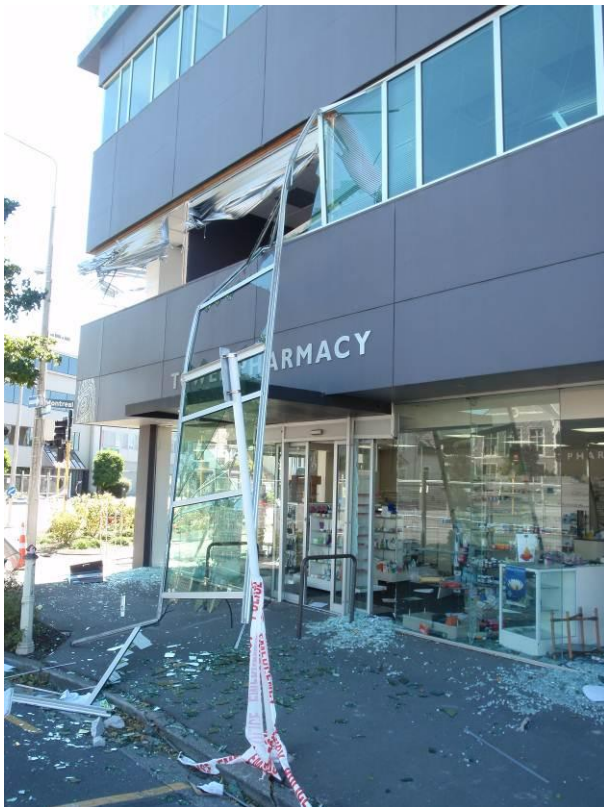
Damage to the frame of light-medium weight claddings was difficult to distinguish from street level, so it is likely this type of damage was overlooked. However there were observed cases of frames being bent and warped, as well as one case where the glass has punctured through the frame itself. Failure of the frame was rare, with only one curtain wall system having a large-scale failure. This involved multiple sections of a curtain wall system completely detaching from the building, as shown in Figure 12. The entire aluminium frame and glazing along one side of the building at the second floor fell to the ground. Closer inspection showed that the aluminium frame was screwed into a wooden sub-frame and the failure was a result of the screws both shearing off and tearing out of the wood.

Figure 12: *Disconnection of a light-medium weight cladding.*

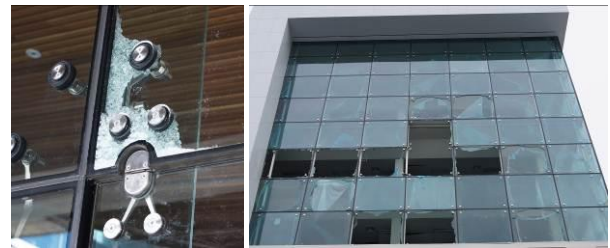
A lot of heavy damage was observed in spider glazing, as can be seen in Figure 13. Spider glazing is a reasonably modern system so it would be expected that it should have performed better than other systems, however this was not the case. It appeared that damage originated around the ‘spider’ that holds each glass pane, likely a result of the ‘spider’ creating stress concentrations in these regions due to the restraint of the connection to the structure.

One of the recently installed spider glazing systems was designed to allow ULS seismic inter-storey displacement of +/-50 mm. The actual measured inter-storey displacement during the February 22 earthquake was 220 mm, over four times the structure’s design level displacement. The amount of movement a spider glazing system can accommodate is not large (50 mm is near the limit of a spider aesthetic system) and this was apparent by the amount of damage observed.

Figure 13: *Examples of damage to spider glazing systems.*

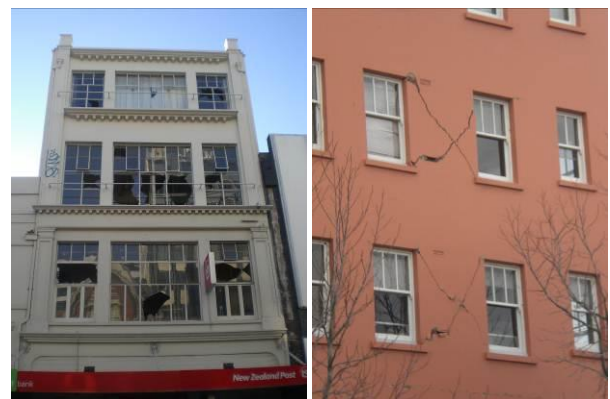
Infill systems include masonry and glazing infill systems that are located within the frame of the structure. Infill facades performed very poorly in comparison with other facade systems, as can be seen in Figure 14.

Older glazing infill systems were particularly susceptible to damage. These systems typically consist of highly modulated glazing frames that do not contain any in-plane movement allowance apart from the small gaps which surrounds each glass pane. These gaps are typically only a few millimetres and consequently only allow a minimal amount of in-plane drift before the glass begins to carry force. Once this occurs, the stiff, brittle glass is at high risk of cracking and dislodging from the frame.

Figure 14: *Examples of damage to infill systems.*

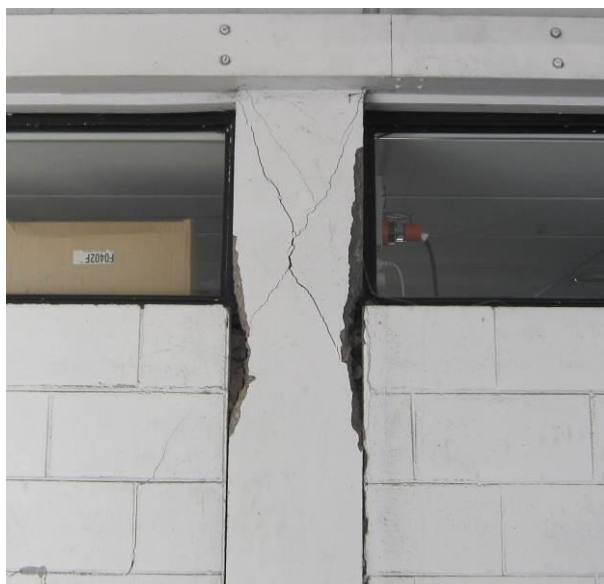
Reinforced masonry infill did not typically show much damage other than small cracks, however, it was evident the infill had an effect on the seismic performance of the primary structure [12], as can be seen in Figure 15, where the infill had a short column effect causing shear cracking in the column.

Figure 15: Short column effect due to infill.
