THE DECEMBER 28, 1989 NEWCASTLE, AUSTRALIA EARTHQUAKE D.R. Brunston*

ABSTRACT

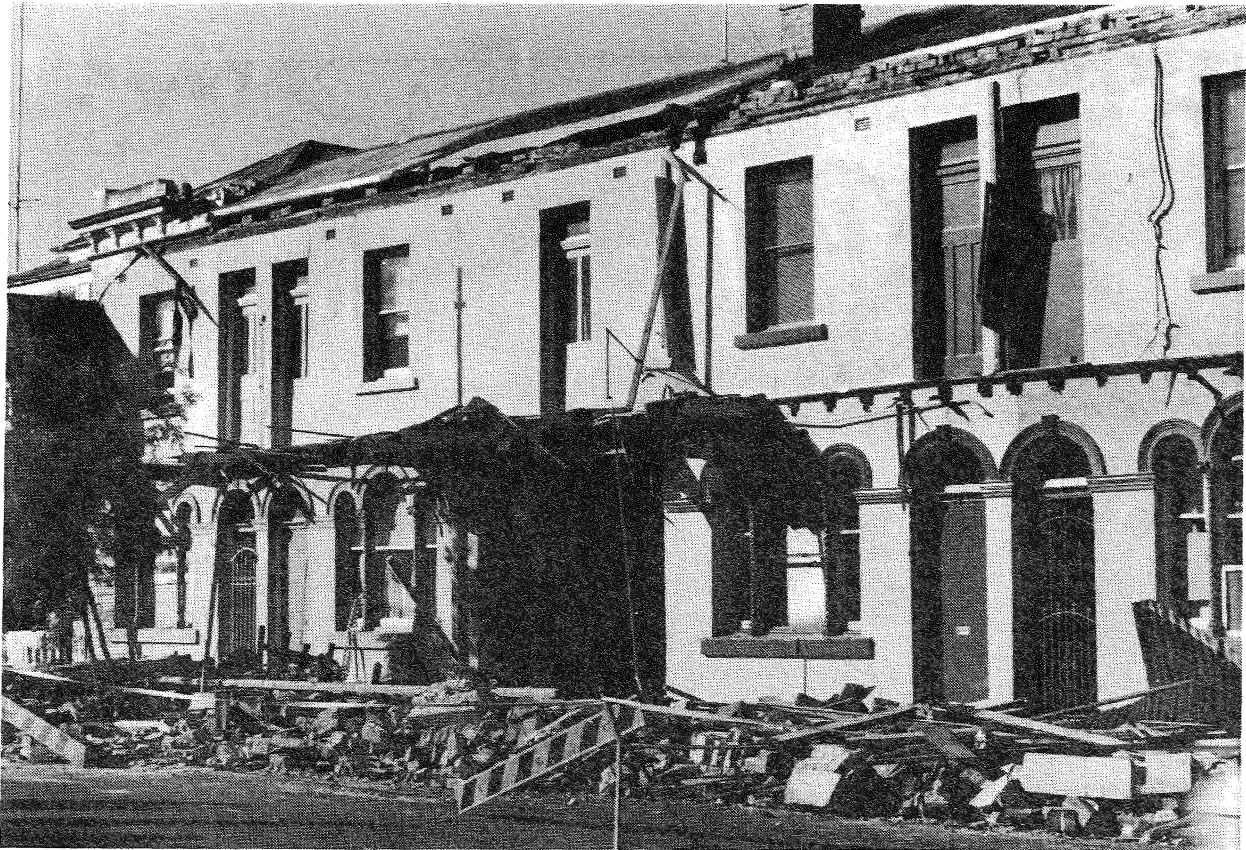
FIGURE 6 PARAPET AND AWNING FAILURE - RESIDENTIAL BLOCK

Parapet failure was the most common form of masonry damage, and posed the greatest hazard to members of the public. Figure 6 shows a residential building block which illustrates the outcome of a common facade failure mode. The high - level parapet had fallen outwards onto the tied awning below, which in turn pulled out of the brick walling above first floor level, with all of the debris ending up on the footpath. Deaths resulted from this mechanism in Beaumont Street, Hamilton with other casualties recorded elsewhere. Ironically, many of the tied awnings were originally supported by posts at the kerbline, but cases of collapse caused by motor vehicles led to state legislation requiring the removal of such posts being passed in the 1950's.

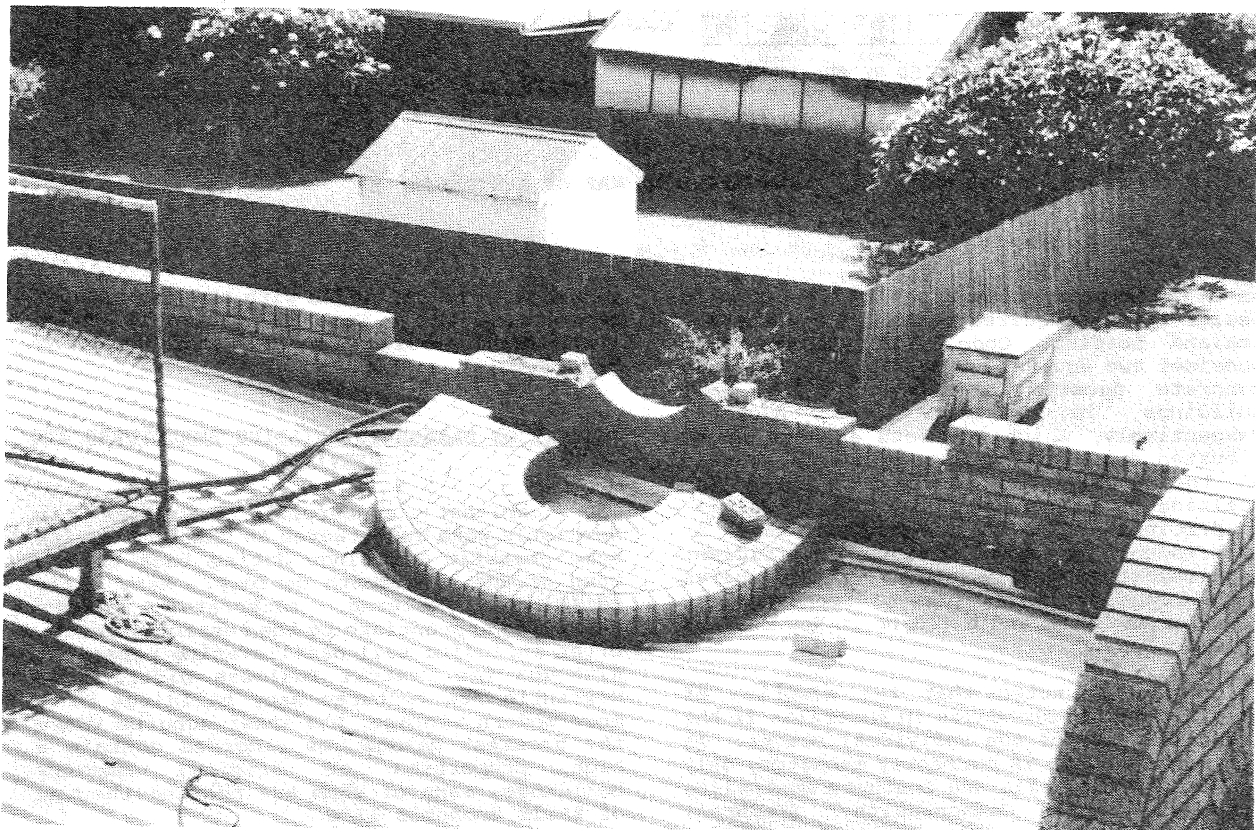
FIGURE 7 PARAPET FAILURE - MODERN RETAIL BUILDING

Inadequately detailed modern masonry parapet elements also failed, with an example taken from a two-year-old retail building in Hamilton shown in figure 7.

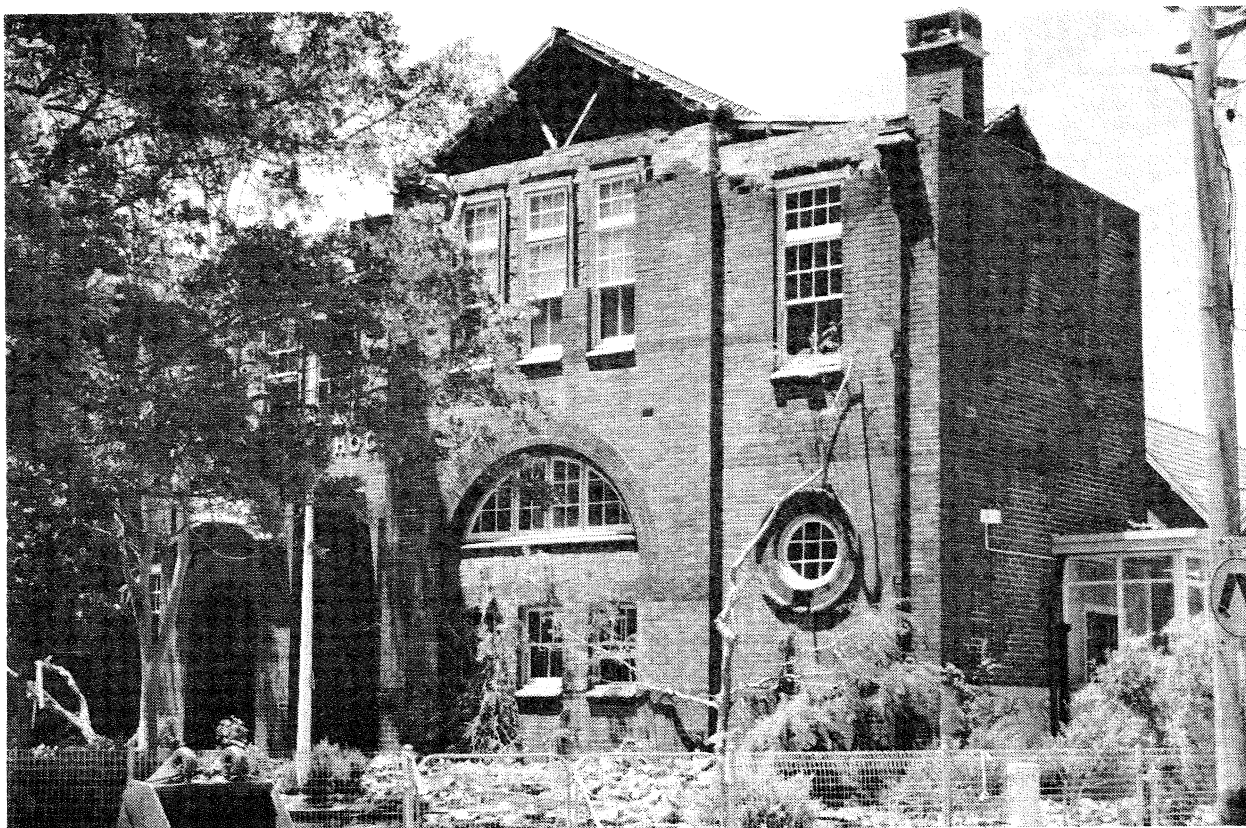
FIGURE 8 GABLE END FAILURE - THE JUNCTION SCHOOL

The collapse of inadequately tied gable ends also occurred in a wide range of buildings, notably in early schools with steeply pitching roofs and hence large gable areas (refer figure 8). However this type of damage was also observed in more modern domestic and industrial buildings, illustrating that the basic principles of lateral restraint in construction were not always being followed. Typically the gable brickwork was only butted up against the roof timber framing, with nominal tooting-in of the ridge beam and rafters. For the prevalent case of outward falling gables, this detail appeared to offer insufficient restraint to resist design wind suction forces.

Fortunately in many cases the roof framing comprised trusses parallel to the gable ends, so that progressive collapse was avoided. However this gave rise to several cases in the CBD where the buildings that had lost gables suffered little additional damage, but neighbouring premises were extensively damaged by the falling brickwork.

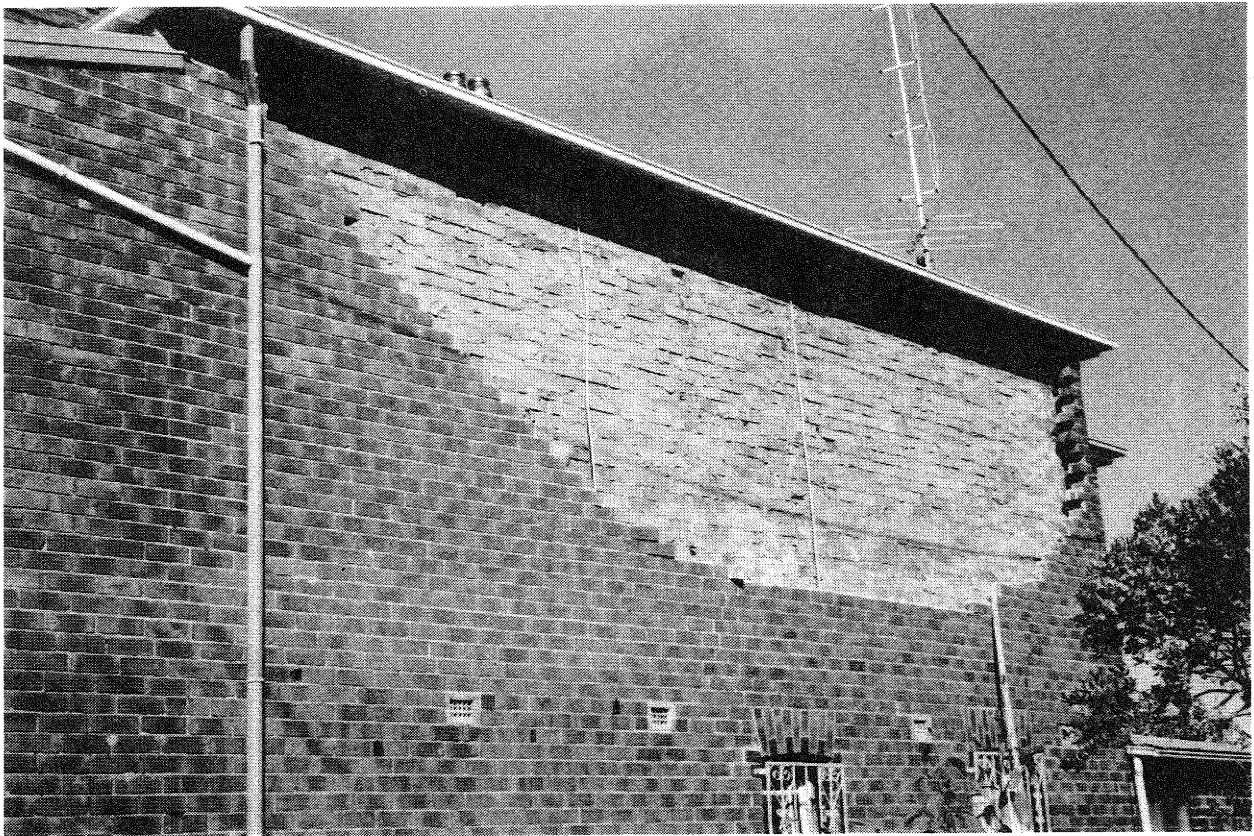
FIGURE 9 FAILURE OF OUTER SKIN OF CAVITY BRICK WALL

The failure of sections of outer skins of cavity brick walls was due principally to severely corroded cavity ties (refer figure 9). The harsh coastal and industrial atmospheric conditions appear responsible for this corrosion which often rendered the ties totally ineffective (refer figure 10), despite many ties being galvanised originally.

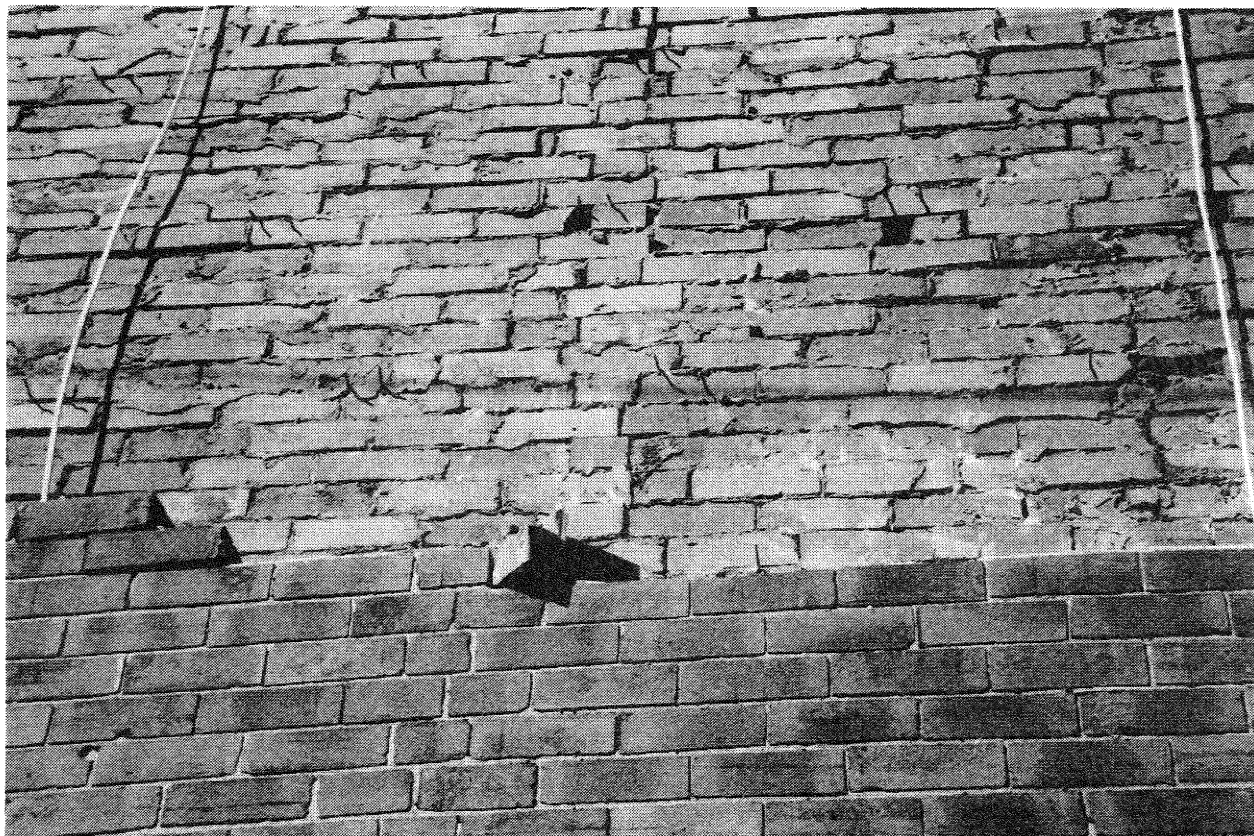
FIGURE 10 CORROSION OF BRICK CAVITY TIES

A related problem for all early masonry was the extensive use of lime mortar. The inclusion of lime caused the degeneration of the mortar to a friable state, clearly with negligible bond strength and unable to offer any protection to the embedded cavity ties.

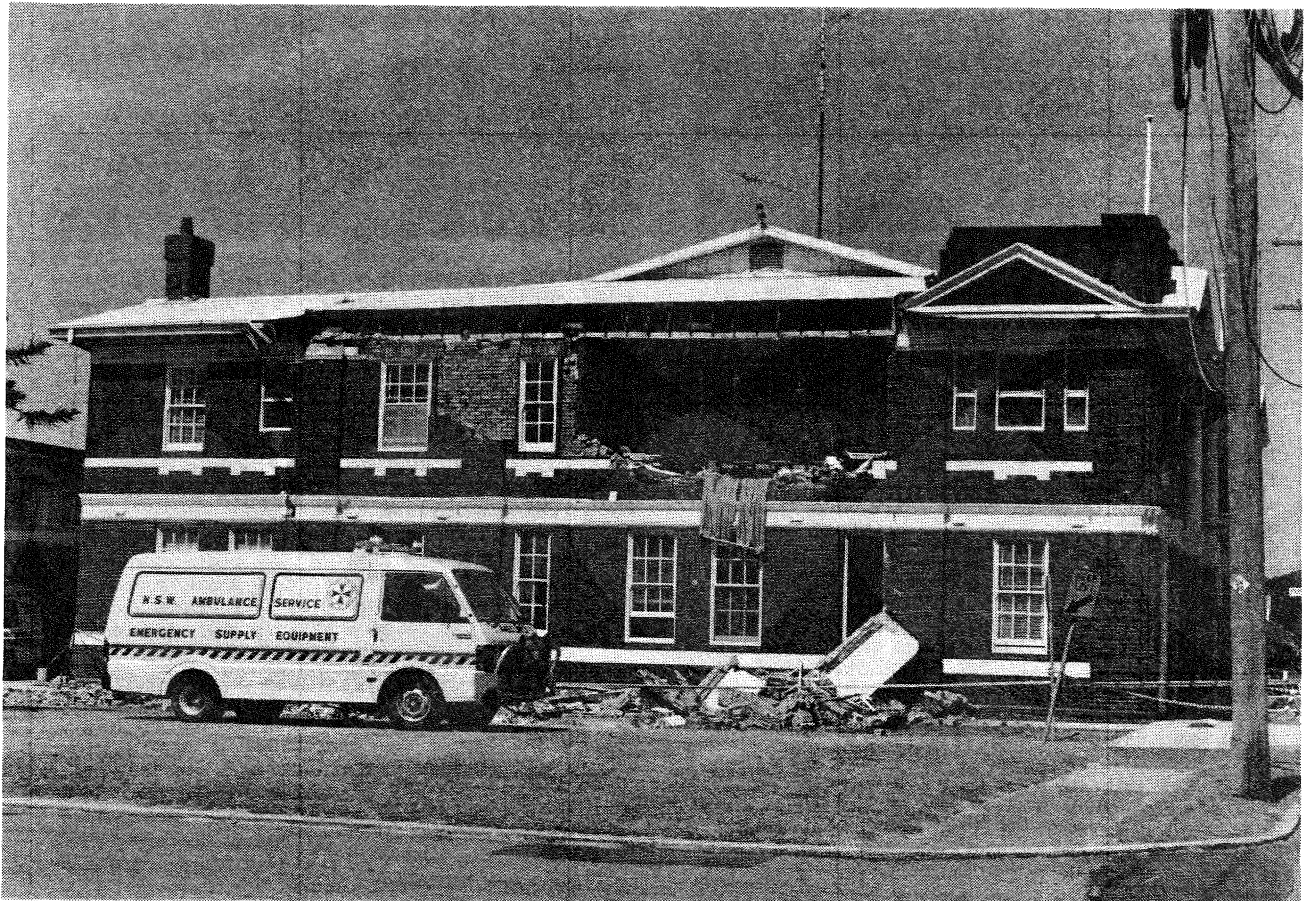
The older masonry regional headquarters of both the fire and ambulance services received moderate structural damage (refer figure 12), although other district stations suffered only non-structural disturbance. It is understood that emergency operations were not significantly affected, but once again illustrates the risks associated with housing key equipment and operations centres in aged buildings of non - ductile construction.

FIGURE 12 DAMAGE TO REGIONAL AMBULANCE HEADQUARTERS, HAMILTON.
