SURFACE RUPTURE OF THE GREENDALE FAULT DURING THE DARFIELD (CANTERBURY) EARTHQUAKE, NEW ZEALAND: INITIAL FINDINGS

M. Quigley¹, R. Van Dissen², P. Villamor², N. Litchfield², D. Barrell², K. Furlong³, T. Stahl¹, B. Duffy¹, E. Bilderback¹, D. Noble¹, D. Townsend², J. Begg², R. Jongens², W. Ries², J. Claridge¹, A. Klahn¹, H. Mackenzie¹, A. Smith¹, S. Hornblow¹, R. Nicol¹, S. Cox², R. Langridge², K. Pedley¹

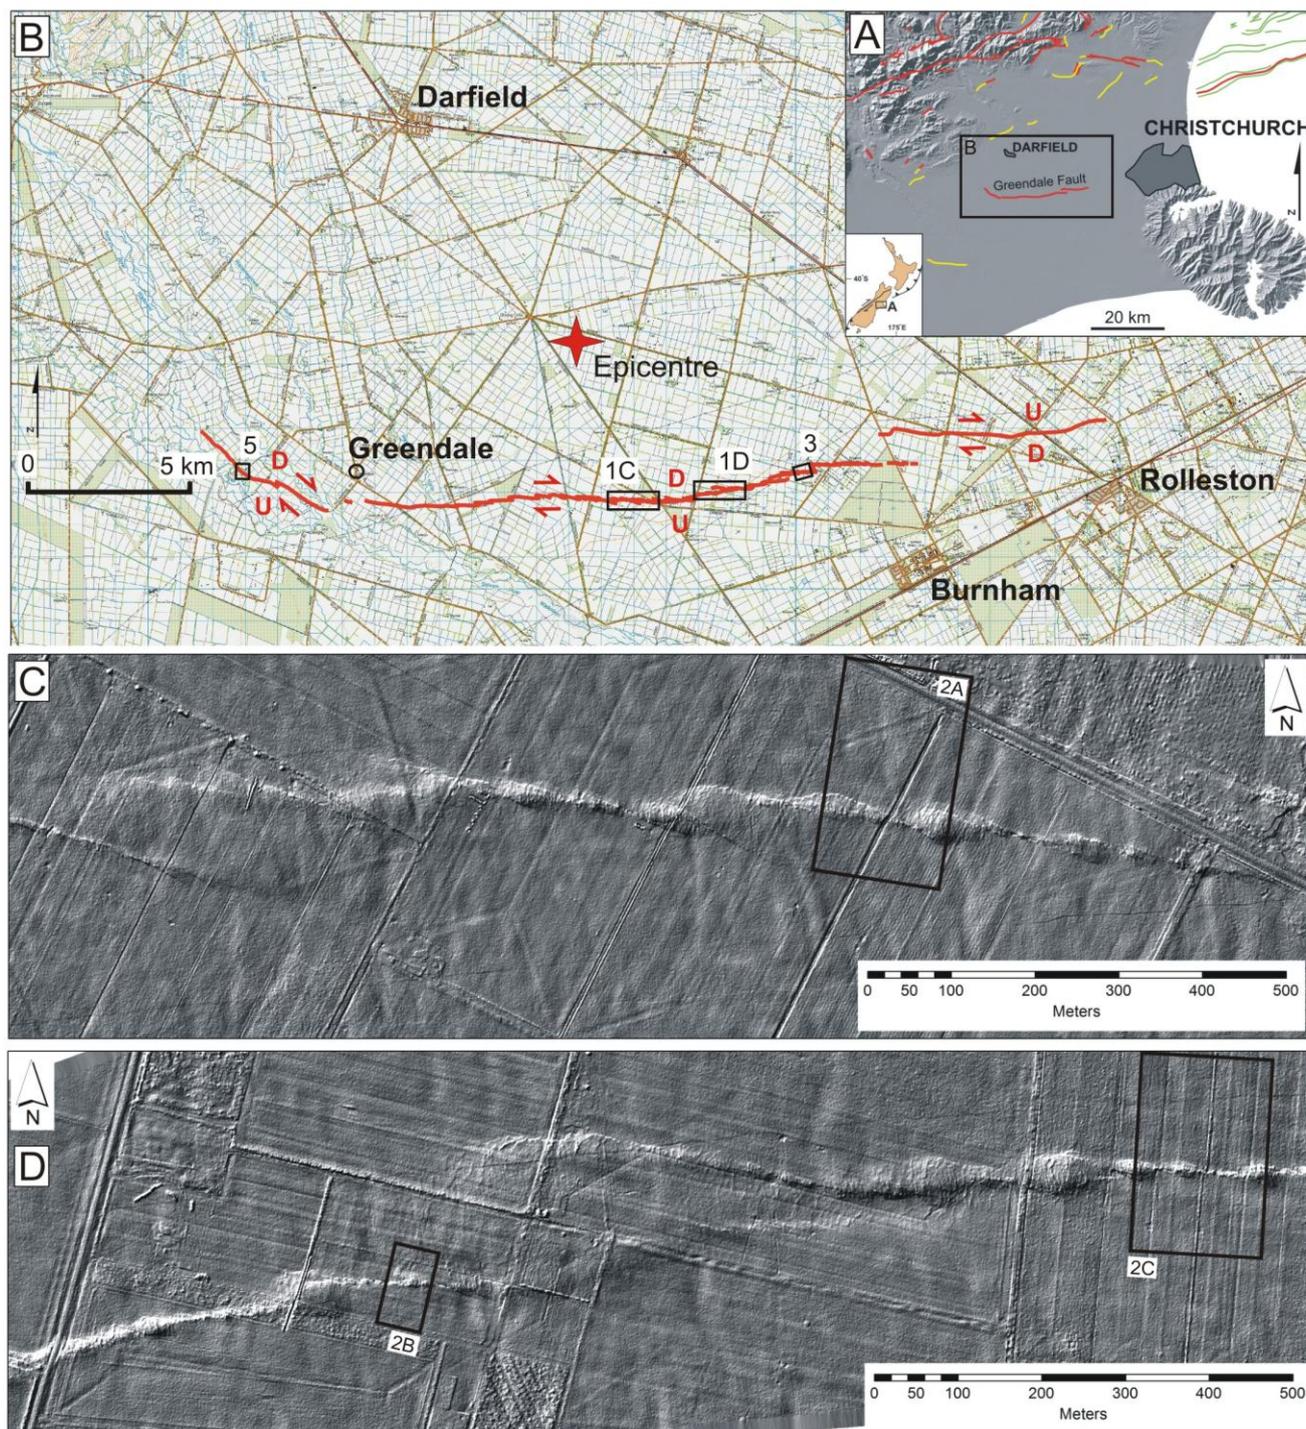
Figure 1: A) DEM of the Christchurch area of the Canterbury region showing location of the Greendale Fault and other tectonically active structures. Red lines are active faults, and yellow and green lines are, respectively, on-land and off-shore active folds (combined data from Forsyth *et al.* (2008) and GNS Active Faults Database). B) Mapped surface trace of the Greendale Fault. Red arrows indicate relative sense of lateral displacement, while vertical displacement is denoted by red U = up and D = down. Also shown are locations of Figures 1C, 1D, 3 & 5, and Darfield earthquake epicentre (red four-pointed star). C & D) LiDAR hillshade DEMs (illuminated from the NW) of two ~1.5 km long sections of the Greendale Fault, showing characteristic left-stepping en echelon rupture pattern, and dextral offset of roads, fences, hedges and crop rows. Also shown are locations of Figures 2A, 2B & 2C.

The zone of identified surface rupture extends from ~4 km west of the hamlet of Greendale for about 29.5 km to an eastern tip ~2 km north of the town of Rolleston (Figure 1). The fault was named the Greendale Fault by the fault rupture reconnaissance and response team. The gross morphology of the surface rupture is that of an en echelon series of east-west striking, left-stepping surface traces (Figure 1). The largest step-over is ~1 km wide, located ~7 km from the eastern end of surface rupture, with another ~20 step-overs between 300 and 75 m wide, and a multitude of smaller ones. Push-up structures have formed at most of these restraining left-steps, with amplitudes up to ~1 m, but typically < 0.5 m (Figures 1C & 1D).

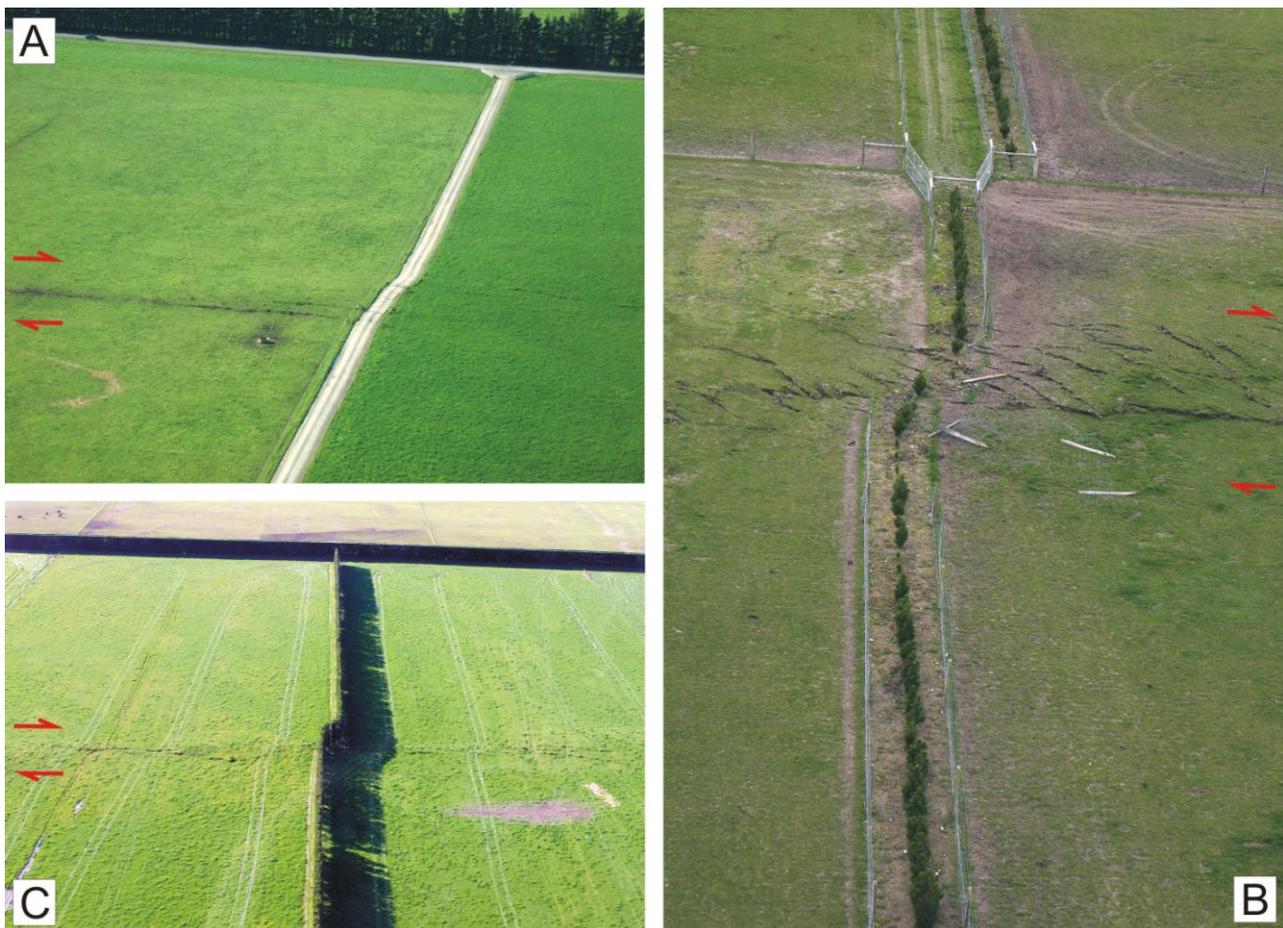
Many well-defined straight features were offset by the fault (Figure 2), allowing the amounts and styles of displacement to be measured with high precision at more than 100 localities along the entire length of surface rupture. Average displacement over the full length of surface rupture is ~2.5 m (predominantly dextral), and is distributed across a ~30 to 300 m wide deformation zone, largely as horizontal flexure. On average, 50% of the dextral displacement occurs over 40% of the total width of the deformation zone. Offset on discrete shears, where present, typically accounts for only a minor percentage of the total displacement. Across the paddocks

Figure 2: Oblique aerial photographs of Greendale Fault surface rupture (see Figures 1C & 1D for locations). Lateral displacement is distributed across a deformation zone of several tens of metres width; red arrows indicate relative sense of lateral displacement. A) 4.5 to 5 m of dextral displacement of a single-lane gravel road. Photo taken by Simon Cox about 11 hours after the earthquake looking north. B) ~3.5 m of dextral displacement of two wire fences and a row of small pine trees. Photo taken by Richard Cosgrove several days after the earthquake looking north. C) 4.5 to 5 m of dextral displacement of a hedge-row (wind break) of pine trees and tractor tyre tracks. Photo taken by David Barrell about 11 hours after the earthquake looking north.

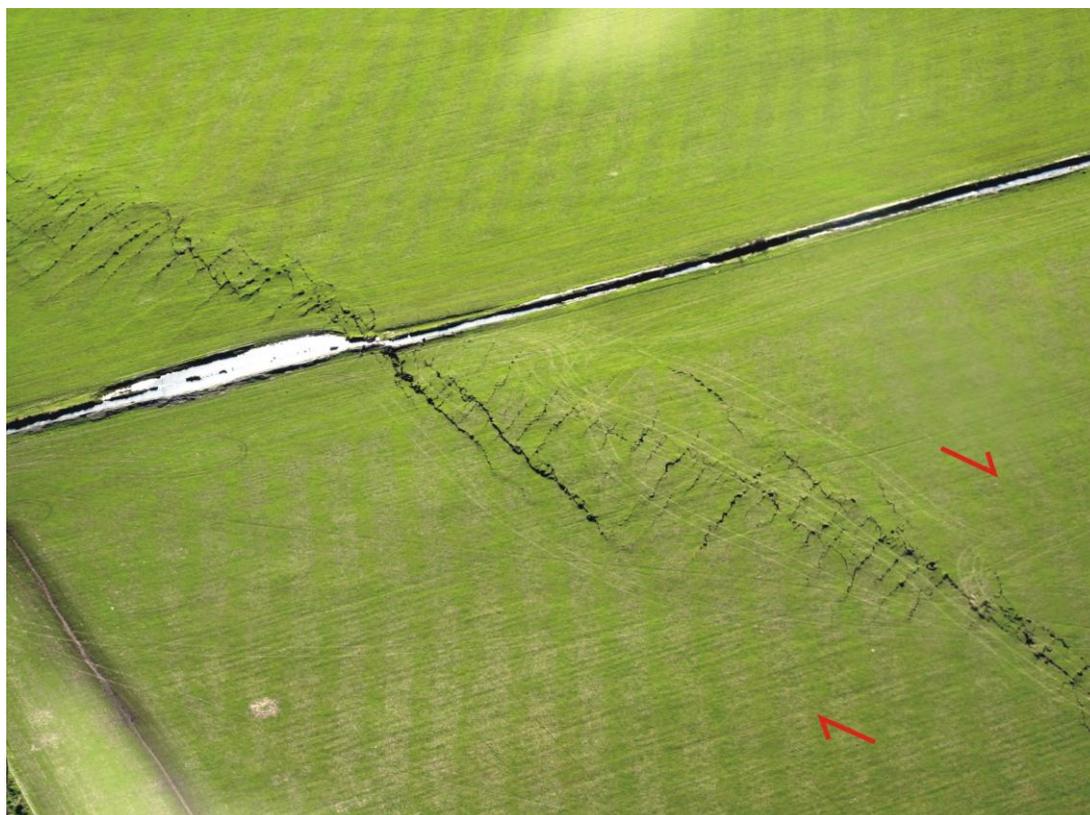
The distribution of surface rupture displacement is approximately symmetrical along the fault, with ~6 km at either end of the fault where overall displacement is less than ~1.5 m, and an ~8 km long central section where net displacement is > 4 m, with maxima of ~5 m (Table 1). Over the reach of the fault where displacement exceeds the average, the deformation zone comprises east-southeast striking Riedel fractures with right-lateral displacements, southeast striking extensional fractures, south-southeast to south striking Riedel fractures with left-lateral displacements, northeast striking thrusts, horizontal dextral flexure, and decimetre-amplitude vertical flexure and bulging (Figure 3).

Figure 3: *Oblique aerial photograph of Greendale Fault surface rupture (see Figure 1B for location). Red arrows indicate relative sense and width of lateral displacement. Here, ~3.5 m of dextral displacement is distributed across a deformation zone up to 40 m wide comprising Riedel shears, conjugate Riedel shears, horizontal dextral flexure, and decimetre-amplitude vertical flexure and bulging. Photo taken by Richard Jongens about 11 hours after the earthquake looking northwest.*

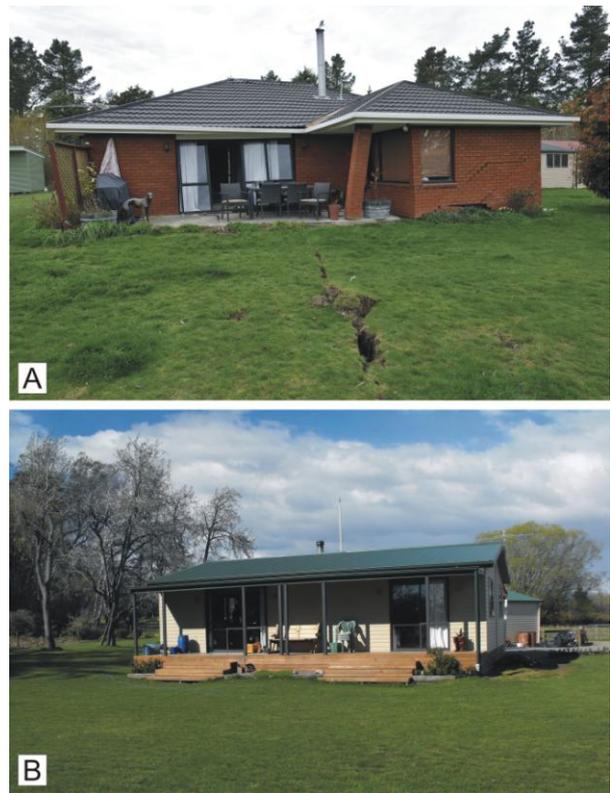
Over a dozen buildings, typically timber-framed houses and farm sheds with light-weight roofs, lay either wholly, or partially, within the Greendale Fault surface rupture deformation zone. None of these buildings collapsed, even the two with 0.5 to 1 m of discrete shear extending through/under them (Figure 4A), but all were more damaged than comparable structures immediately outside the zone of surface rupture deformation. Some of the properties worst damaged by fault rupture have been condemned. From a life safety standpoint, all these buildings performed satisfactorily, but with regard to post-event functionality, there are notable differences. The houses with concrete slab foundations (typically brick-clad) suffered moderate to severe structural and non-structural damage, while a light industrial building with a more robust concrete slab, and the two piled structures (Figure 4B) were less damaged and will be more straightforward to reinstate.

Figure 4. *Examples of houses affected by Greendale Fault surface rupture. A) Timber-framed, brick-clad house with concrete slab foundation and light-weight roof that is located within a ~150 m wide deformation zone accommodating 4 to 5 m of dextral displacement. House is badly damaged by ~0.5 m of discrete strike-slip rupture that passes through the foundation of the house as well as distributed shear within the broad deformation zone. Photo by Dougal Townsend. B) Light-gauge steel framed, plywood- and weatherboard-clad house with steel pile foundation and steel I-beam bearers that is tilted, and rotated, but only slightly damaged, by ~1 m of distributed vertical and dextral fault rupture spread over several tens of metres width. Photo by Russ Van Dissen.*

deformation were subjected to only a portion of the fault's total surface rupture displacement, and no structure within this zone collapsed. This provides a clear example of the appropriateness of the MfE's *Distributed* Fault Complexity parameter, at least for Building Importance Category 2a structures (i.e. residential structures).

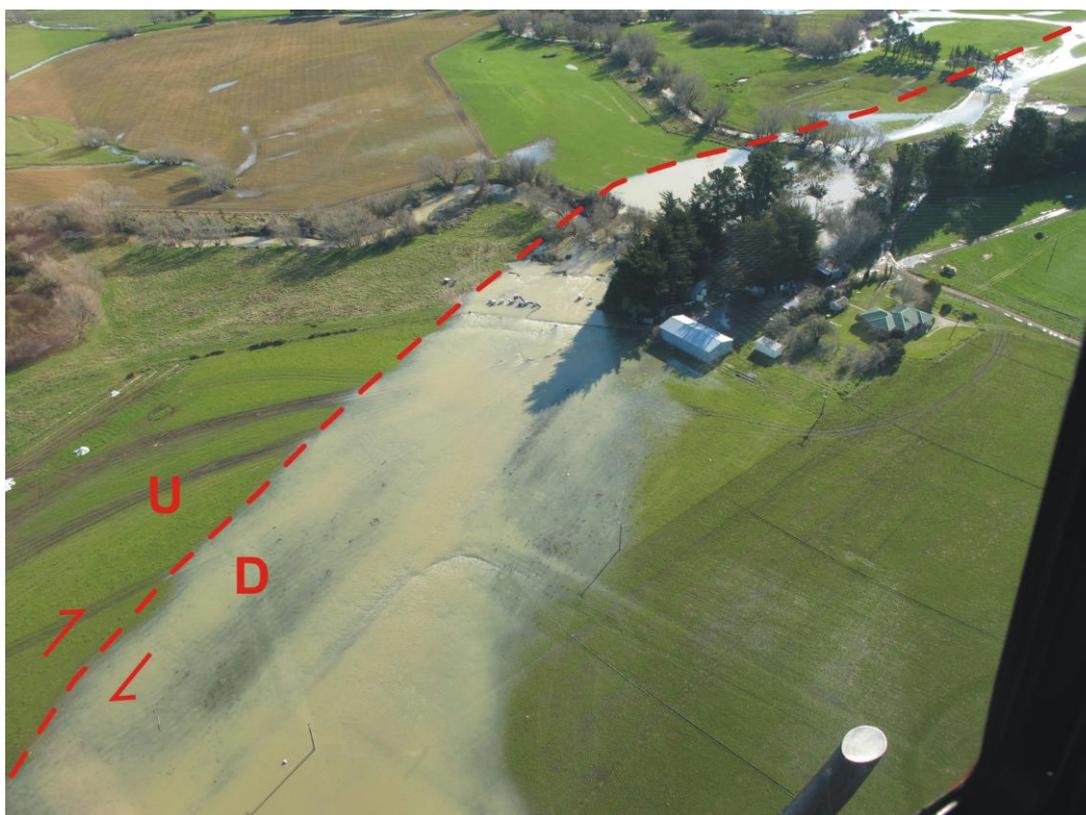
Some irrigation channels flooded due to the fault displacements, other ground disturbance and/or changes in groundwater tables. The most spectacular and extensive flooding caused by fault rupture occurred at the Hororata River, near the western end of the fault (Figures 1B & 5), where ~1 to 1.5 m of both dextral and vertical (southwest-side up) rupture extended across the river, partially blocking its channel, and resulting in partial avulsion. Deepening of the channel downstream of the fault rupture, via two backhoes, was required in order to return the full river flow to its original channel position.

Figure 5: *Oblique aerial photograph of Greendale Fault surface rupture and partial avulsion of the Hororata River (see Figure 1B for location). Hororata River flows right to left (i.e. southeast), location of Greendale Fault is denoted by dashed red line with relative sense of lateral displacement shown by red arrows, and relative vertical displacement indicated by red U = up and D = down. Here, ~1.5 m of oblique dextral southwest-side up rupture of the Greendale Fault extended across the Hororata River, partially blocking the river's channel, and leading to partial avulsion and significant flooding of dairy farmland. Photo taken by David Barrell about 11 hours after the earthquake looking west.*
