Deterioration of Cement-Rendered Brick Masonry Buildings: Case Study of a World War II Airfield in East Lothian, Scotland

Isobel Griffin¹, Andrea Hamilton¹ and James Tate²

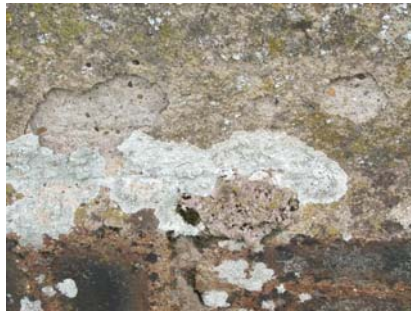
Fig. 2 The blistering render on Building 47 (Spare Parts Store)

The visual survey demonstrated that for the 3 affected buildings, the blistering occurred more frequently on south-facing walls, but also on north-facing walls. It was found in patches all over, but seemed to be concentrated on the piers and on the flat areas of wall just adjacent to the piers. On Buildings 46 and 47 it was found immediately to the right of the piers, on the south east side.

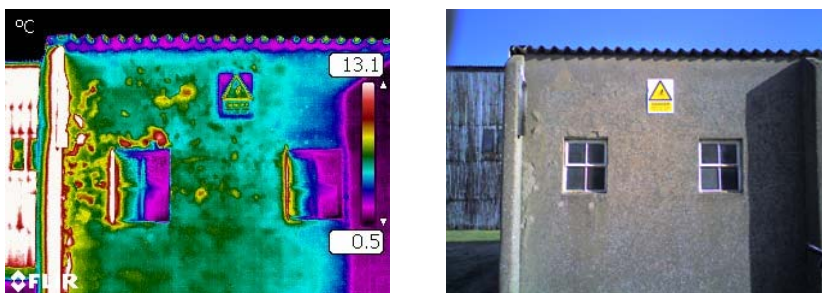
The infrared thermography survey was undertaken on a day when the walls of Building 46 were heated up by the sun, and the blistering areas appeared warmer. This was because there are air pockets within the blistered render, creating a thermal break and resulting in the render heating up more readily than elsewhere. Furthermore, the infrared thermography showed large areas adjacent to the visible blistering which looked sound to the naked eye, but where hollow patches had begun to form below the surface. This was confirmed by tapping. For example, the area between the 2 windows on the NW side of the SW wall on Building 46 looked fine, but the infrared thermogram showed that it was beginning to blister.

Figs. 3, 4 Infrared thermogram of the SW wall of Building 46, with a digital image for comparison (Images: Maureen Young)

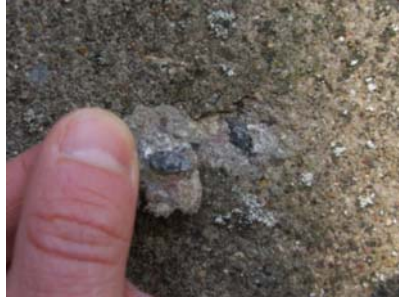
It was found that blisters often seem to form above certain types of aggregate, including a greyish flaky material, a soft orange-yellow material, and little pods of fibrous material, which may be of plant origin. Examination with the SEM showed that the small pods are composed of long tangled fibres. The greyish material has a fairly smooth appearance, and the soft yellow material is rough and granular. Preliminary X-ray diffraction results have identified lots of carbon in the greyish material, suggesting it may be charcoal, and quartz in the yellow material, suggesting it may be sandstone. These aggregates are all very soft, and are probably quite porous.

Fig. 5 A blistering piece of render on Building 47, with a large grey particle underneath
