# Acute Posttraumatic Catastrophic Failure of a Second-generation, Highly Cross-linked Ultra-high-molecular-weight Polyethylene Patellar Component

MATTHEW J. GOLDSTEIN, MD; MICHAEL P. AST, MD; FRANK R. DIMAIO, MD

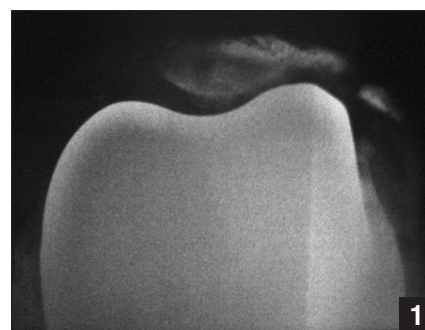
**Figure 1:** Preoperative Merchant radiograph showing a fracture of the patellar component.

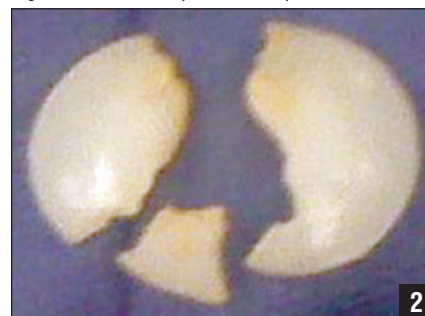
**Figure 2:** Photograph of the retrieved gross surgical specimen of the fractured second-generation, highly cross-linked ultra-high-molecular-weight polyethylene patellar component.

On entry into the joint, fragments of polyethylene were encountered (Figure 2). The remaining patella showed no evidence of damage or avascular necrosis (Figure 3). Further inspection revealed a fracture of the second-generation, highly cross-linked UHMWPE patellar component without visual evidence of wear. Appropriate rotational and axial alignment of the femoral and tibial components was confirmed. Revision was performed with a size 2, three-pegged, 7-mm patellar component (Sulene;

Lastly, acute polyethylene fracture must be considered. The findings of a truly catastrophic failure, in which the patellar component failed in a piecemeal fashion following acute trauma, sheds light on an important consideration in the use of second-generation, highly cross-linked UHMWPE. Although many advantages exist to the enhancement of polyethylene patellar components, including the potential for improved wear characteristics, cross-linking has been shown to reduce resistance to crack initiation and propagation.<sup>10</sup> Although no malposition of the compo-

nents was noted, abnormal tensile forces across the patella component could have been transmitted by altered patellofemoral kinematics. This combination could lead to the initiation of a small surface crack that propagates deeper into the component with continued impaction and an eventual acute fracture of the entire UHMWPE component.<sup>11</sup> ■

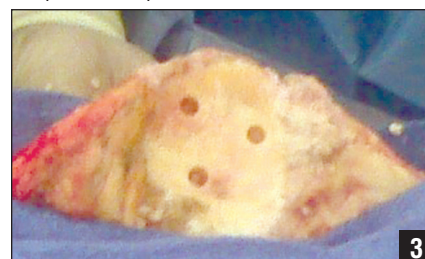
**Figure 3:** Photograph of the patellar surface at revision surgery showing no evidence of avascular necrosis or fracture.

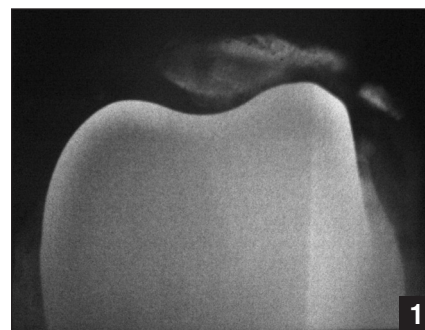
**Figure 1:** Preoperative Merchant radiograph showing a fracture of the patellar component.

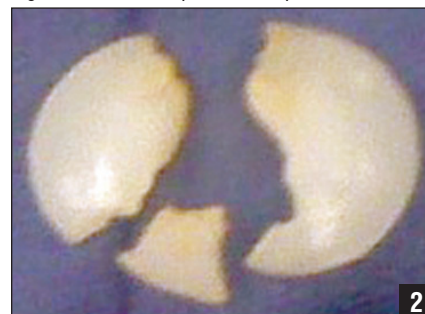
**Figure 2:** Photograph of the retrieved gross surgical specimen of the fractured second-generation, highly cross-linked ultra-high-molecular-weight polyethylene patellar component.

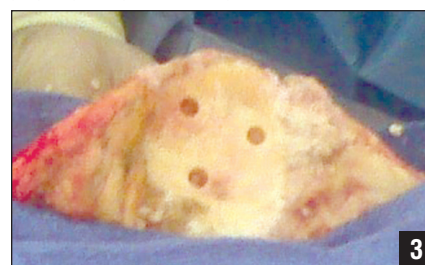
**Figure 3:** Photograph of the patellar surface at revision surgery showing no evidence of avascular necrosis or fracture.
