# Effects of Mine Blasting on Residential Structures

**Abstract:** Blasting is common in the coal industry to remove rock overburden so that the exposed coal can be mechanically excavated. The ground vibrations and air blast produced by blasting are often felt by residents surrounding the mines. There has been a trend for regulatory authorities, especially those concerned with the environment, to impose low limits on blast vibration levels in response to community pressure, based on human perception and response to vibration. This paper reports the findings of an extensive study on a house which was located adjacent to a coal mine. The house was monitored for over 1 year and was subjected to ground peak particle velocity (PPV) ranging from 1.5 to 222 mm/s. The house was instrumented with accelerometers to measure its dynamic response due to blasting and it was also monitored for cracks before and after each blast. Based on this study, ground motion amplifications along the height of the structure have been established. A simplified methodology presented in this paper has been used to estimate the ground PPV at which cracking is likely.

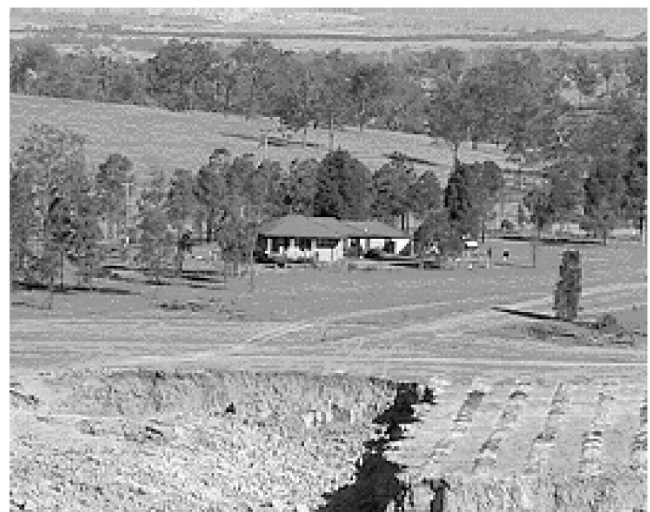
**Fig. 2.** Rix's creek house shown in background with section of overburden (foreground) ready for detonation

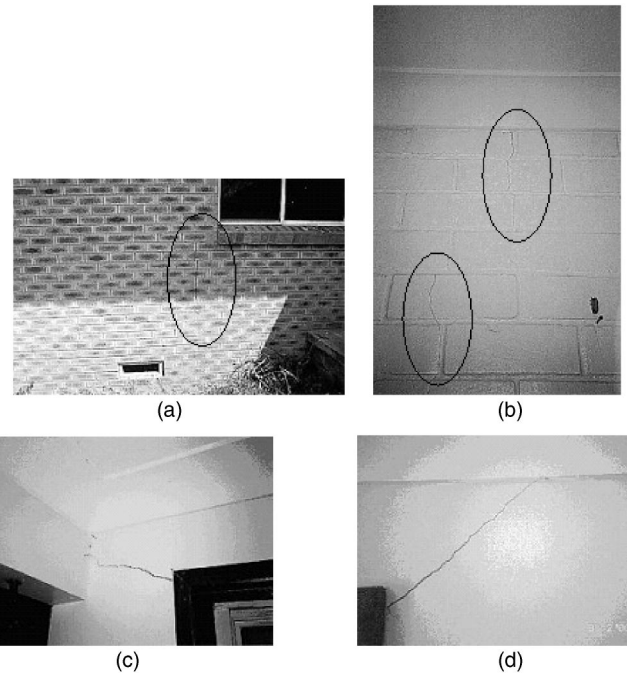
The condition of the house at the beginning of the monitoring appeared reasonable with little evidence of deterioration from environmental effects and previous blasting. The plasterboard and brickwork had a number of cracks ranging in size from fine (<1 mm) to noticeable but easily filled (<5 mm), scattered throughout the house.

Crack number	Location	Figure number	Description
1	Living room (internal)	—	Stepped crack in nonstructural brickwork
2	Kitchen (external)	3(a)	Vertical crack in veneer brickwork
3	Kitchen (internal)	3(b)	Vertical crack in structural brickwork
4	Kitchen (internal)	3(c)	45° crack in plasterboard
5	Laundry (internal)	3(d)	45° crack in plasterboard

**Fig. 3.** Sample of cracks in brickwork and plasterboard which were monitored (crack width and length measured before and after each blast)

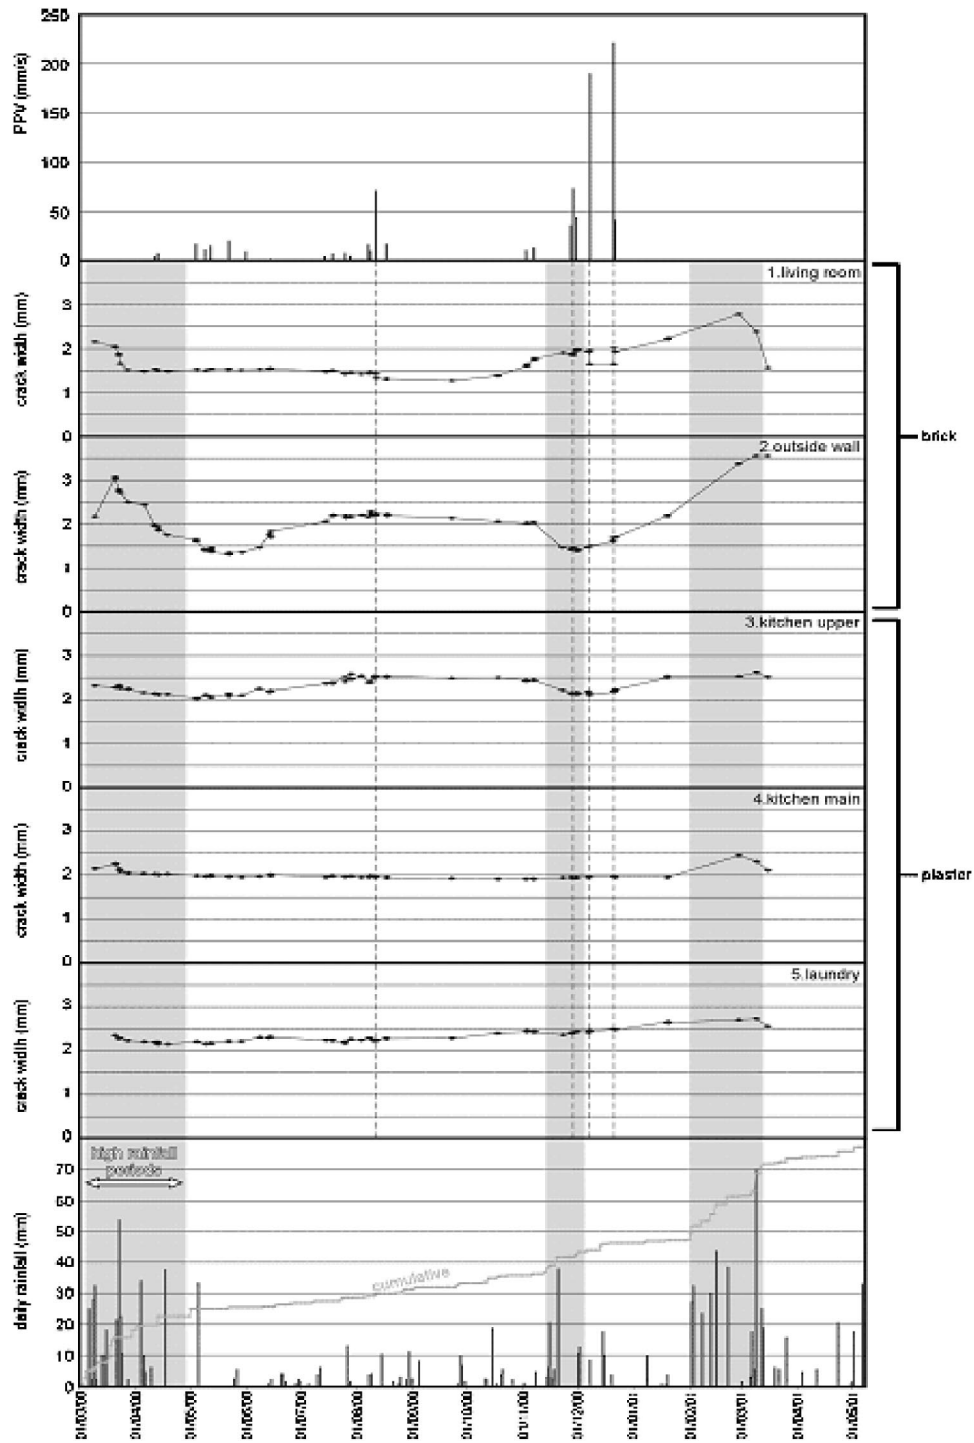
Cracks 1 and 2 were the most active as shown in Fig. 4. However, opening and closing of cracks seemed to be more sensitive to rainfall rather than blasting activities. For example, the width of crack No. 1 did not appear to be affected by the numerous blasts with PPV less than 20 mm/s over the period April 1–August 10, 2000. A permanent offset of 0.1 mm was measured following the blast on August 11, 2000, with a peak ground velocity of 70 mm/s. In contrast, the crack closed from a width of 2.2 mm (March 5, 2000) to 1.5 mm (March 25, 2000), following a period of heavy rainfall, and then remained constant at 1.5 mm up to July 2000. Between July and October 2000 the crack width reduced to 1.3 mm and then widened to 1.6 mm by November 2000. The blast of December 7, 2000 (190 mm/s) caused the crack to close from 2.0 to 1.7 mm and the next blast (220 mm/s)

Fig. 4. Crack width movement compared to peak particle velocity and rainfall

caused the crack to reopen to 2.0 mm. It is obvious from Fig. 4 that the movements associated with the rainfall (shrinking and swelling of soil) have a profound impact on the opening and closing of cracks. The total crack length measured for the whole house also displayed the same pattern. There was no significant change in total length of cracks for blasts less than 70 mm/s, but there was significant increase of crack lengths in some locations associated with periods of high rainfall.

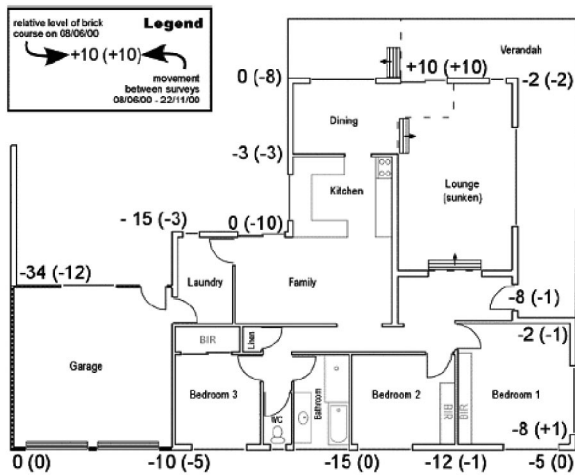
surveys indicated a maximum settlement of 12 mm and a maximum heave of 10 mm during the 5 months period as shown in Fig. 5. These measured movements are consistent with the predictions from geotechnical investigation.

Fig. 5. Level loop survey: June 8 and November 22, 2000
