A Liner Breakage in Total Hip Arthroplasty after Using 1st Generation Highly Cross Linked Polyethylene Mated against 36-mm Metal Head: A Case Report

Won-Kee Choi, MD, Myung-Rae Cho, MD, Seung-Bum Chae, MD, Dong-Young Kim, MD

Department of Orthopaedic Surgery, Daegu Catholic University College of Medicine, Daegu, Korea

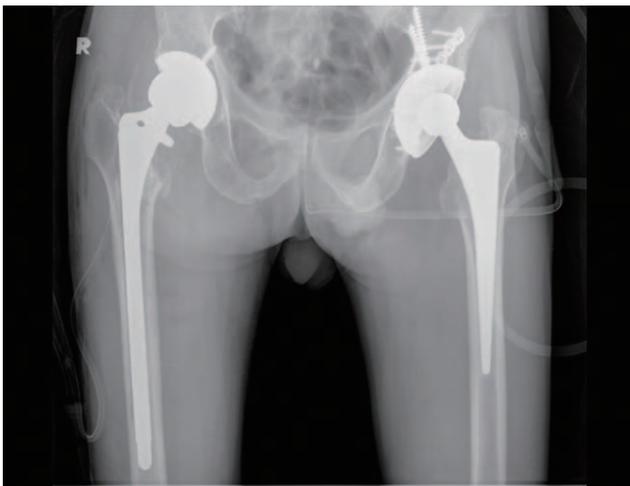
Fig. 1. We conducted 1st revision with 36-mm metal head mated with highly cross linked polyethylene (Longevity; Zimmer, Warsaw, IN, USA) as bearing surface with 54-mm acetabular cup.

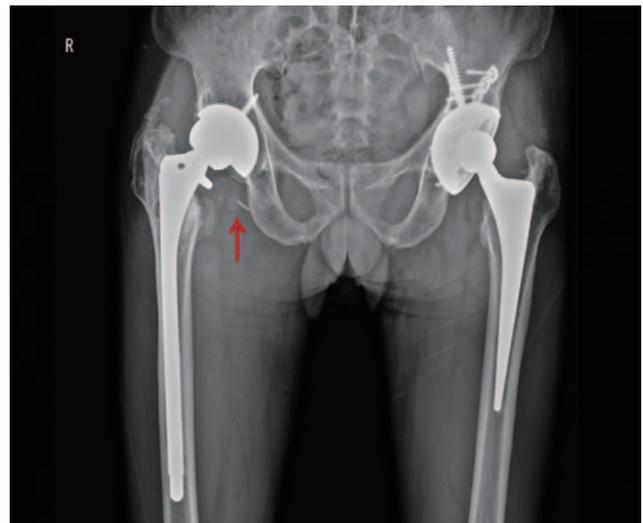
Fig. 2. Radiograph demonstrated eccentric femoral head position within acetabular cup, and radiopacity suggesting tines of the locking mechanism (arrow).

visited our center complaining an abrupt right hip pain developed without recent trauma history. Radiographs demonstrated eccentric femoral head position within acetabular cup and radiopacity suggesting tines of the locking mechanism on the infero-medial side of right hip joint (Fig. 2). On the basis of this finding, we suspected a liner breakage. In the 2nd revision, we identified metallosis (Fig. 3A). Also, we found a fragmentation of the Longevity liner at the superior quadrant (Fig. 3B), severe scratch damages in just below the neck portion of femoral stem and superior quadrant area of liner. After checking stable fixation status of femoral stem, and no damages in Morse taper of femoral stem, we conducted 2nd revision with 56-mm acetabular cup (Trilogy) and 36-mm metal head mated with HXLPE (Longevity) as bearing surface remaining femoral stem. Since leaving the hospital, there have not been special events.

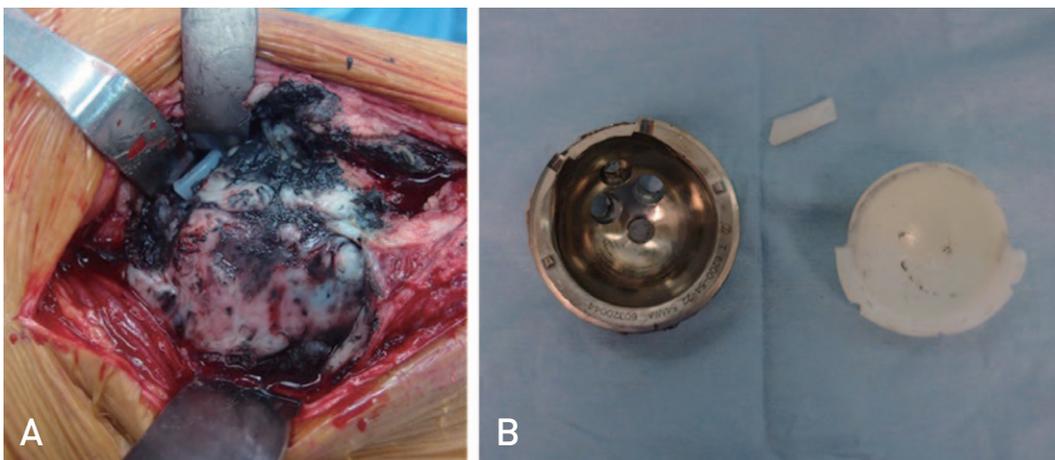
Fig. 3. We found a metallosis, liner fragment (A), and a rim breakage of the Longevity liner (Zimmer, Warsaw, IN, USA) at the superior quadrant (B).

This manufacture adopts a remelting method to remove remaining free radial. This method degraded mechanical properties, particularly the fatigue strength¹⁰. So, this liner may be vulnerable to crack formation due to impingement. In our case, we found superior quadrant liner rim fracture, and severe scratch damage in just below femoral neck portion as the counter-part of impingement.

On the basis of this findings, we speculate multiple factors including thin liner thickness, impingement between liner rim and femoral stem, and re-melting method to remove remaining free radial involved in HXLPE breakage of this case.

In conclusion, surgeon had better use thicker liner when it is possible and should avoid impingement between liner rim and femoral stem.

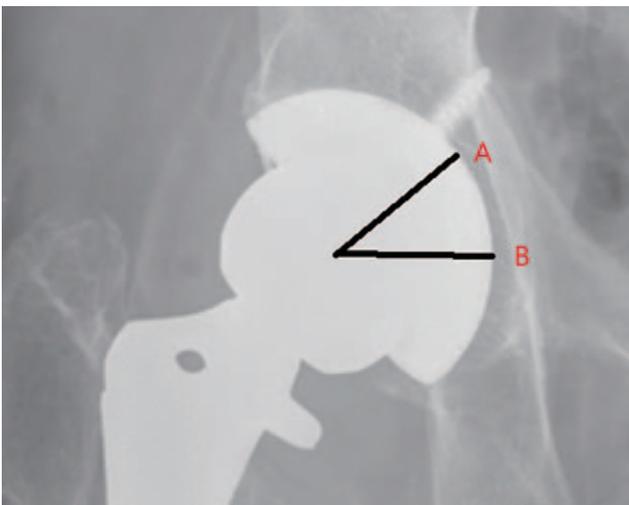
Fig. 4. A line: thickness of highly cross linked polyethylene (HXLPE) was 6.7 mm at pole. B line: thickness of HXLPE was 5.8 mm at 45° angle direction.

Possible hypothesis contributing liner breakage in our case were thin liner thickness, the increased brittleness of HXLPE due to remelting process, and impingement between liner rim and femoral stem. It is important to note that modular liner thickness is often specified on the basis of the nominal material thickness at the specific degree angle of the liner. First revision was conducted with 54-mm acetabular cup. Liner thickness when using 36-mm metal head coupled with HXLPE (Longevity) as bearing surface with 54-mm acetabular cup are 5.8 mm at 45° angle direction and 6.7 mm at pole respectively (Fig. 4). This thickness is the thinnest thing we can use when using 36-mm metal head. But the dimension of edge of liner is less than 5.8 mm. US Food and Drug Administration is approving of at least 3-mm HXLPE application. But, many hip simulator study demonstrated thinner polyethylene components showed that higher contact stress and wear rates². In a study of Berry et al.⁹, 10 cases of catastrophic acetabular liner failure were described. All failures occurred in patients who had acetabular liners implanted with thicknesses of less than 5 mm. So, we conducted 2nd revision with 56-mm acetabular cup to use thicker liner. Liner thickness when using 36-mm metal head coupled with HXLPE (Longevity) as bearing surface with 56-mm acetabular cup are 6.9 mm at 45° angle direction and 7.8 mm at pole respectively.
