The WWII German Heavy Artillery Battery AV 67 of Cleus Foz (Finistère-FR)

Giancarlo T. Tomezzoli

How to cite this paper: Tomezzoli, G. T. (2017). The WWII German Heavy Artillery Battery AV 67 of CleusFoz (Finistère-FR). *Archaeological Discovery*, 5, 61-78. <https://doi.org/10.4236/ad.2017.52004>

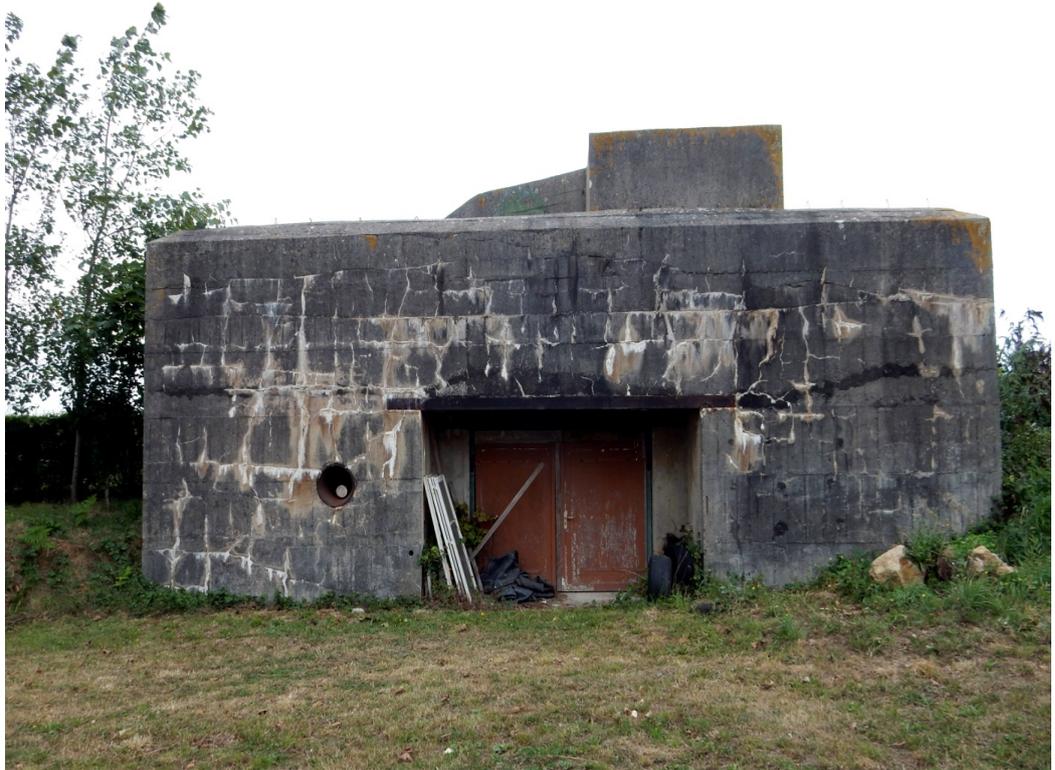
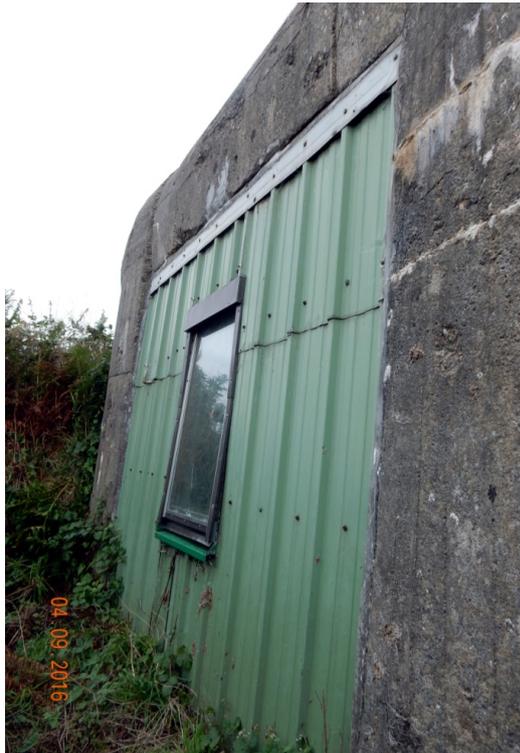
The *R669* (48°35'0.16"N, 4°33'3.75"W) (1) (Figure 1 & Figure 2), was similar to those described in previous articles (Tomezzoli & Pottier, 2016a), (Tomezzoli & Pottier, 2016b), except for a hexagonal emplacement on its coverage. The nature of the emplacement is unclear because of the absence of a gun support. It is possible that it hosted either one or more telemeters or a radar Freya for distance measurements, or a light *Flak* gun, like a 2 cm *Flak 30/38/Flakvierling* or 3.7 cm *Flak 18/36/ 37/43*, or a heavier gun, like a 88 mm or a 105 mm gun mounted on its own support. Because of its elevated position, the telemeter would have had an unobstructed field of view and the possible gun would have been effective both against air and field targets. The *R669* combat room probably hosted an *s.F.H.25* rough howitzer or different gun. The *R669* combat room front and rear side apertures were closed, respectively, by a metallic, green coverage provided with a window and a wooden, brown double door, both not of origin; so that the combat room interior was not accessible. However, looking through the window, it was possible to ascertain that it was cluttered by materials. The ammunitions for the gun were stored in an ammunition room inside the *R669*. Because no stair was present on the external concrete structure, the hexagonal emplacement was accessible only through the combat room. The opening of the exhausted combat gas pipe was clearly recognizable on the bunker rear side. The *R669* external concrete structure was in a good preservation state without damages due to combats.

Figure 2. R669-(1) rear side opening of the combat room closed by a wooden, brown double door, not of origin, on the left opening of the exhausted combat gas pipe, (2) front side aperture of the combat room closed by a metallic, green coverage provided with a window, not of origin, (3) combat room interior cluttered by materials, seen through the window.

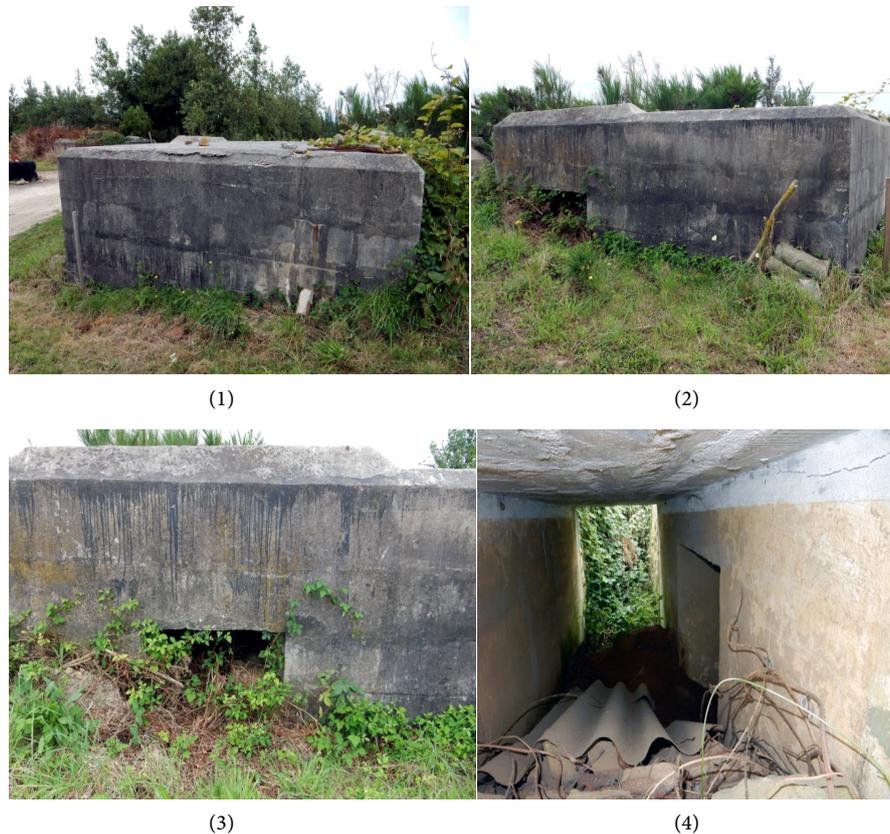
The *Vf*(2) (Figure 3), about 6 × 4 m, emerged about two meters from the terrain. It was provided with two entrances, only one of which provided with protection walls. A corridor, preserving its original wall pale ochre painting and ceiling white painting, connected the two entrances with the entrance of an interior single room. The entrances were obstructed by terrain and vegetation; so that the inspection of the interior was not possible. The absence on its coverage of chimney conduits suggested that this bunker was intended for storing materials rather than for hosting a group of soldiers. The emerging *Vf*(2) concrete structure was in a good preservation state without damages due to combats.

Figure 3. *Vf(2)*-(1) side view, (2) side view, (3) entrance obstructed by terrain and vegetation, (4) corridor with interior single room entrance.

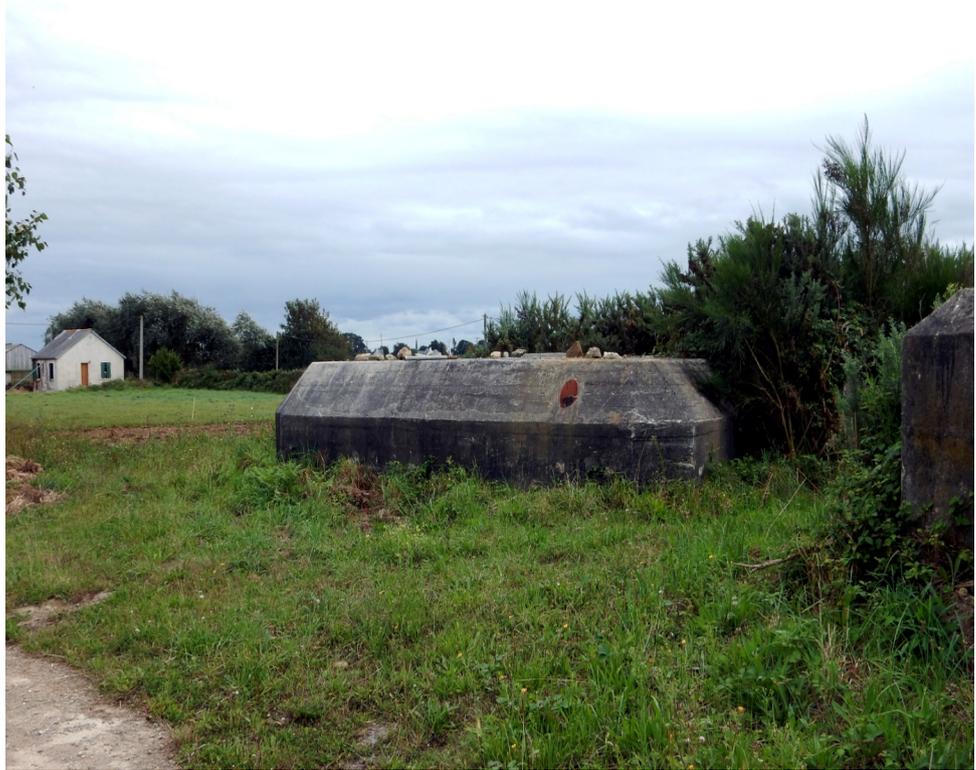
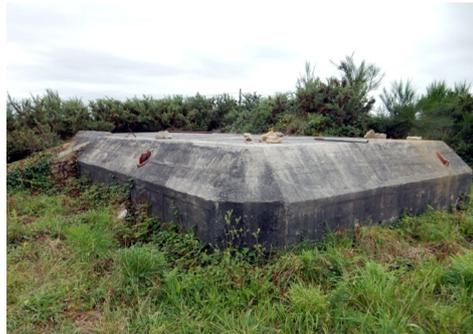
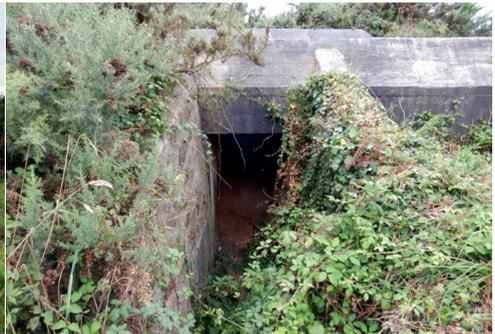
The *Vf*(3) (Figure 4), about 9×6 m, emerged about two meters from the terrain. It was provided with two entrances, both provided with protection walls. A corridor, preserving its original wall pale ochre painting and ceiling white painting, connected the two entrances with the entrance of an interior single room. The entrances were obstructed by terrain and vegetation; so that the inspection of the interior was not possible. The presence on its coverage of two chimney conduits suggested that it was heated if necessary and therefore intended for hosting one or two groups of soldiers. The emerging *Vf*(3) concrete structure was in a good preservation state without damages due to combats.

Figure 4. *Vf(3)*-(1) side view: on the coverage a chimney conduit, on the left circular open emplacement for *s.F.H.25*, on the right *Vf(2)*, (2) coverage with two chimney conduits, on the left bunker entrance, (3) coverage 1 m thick and entrance obstructed by the vegetation.

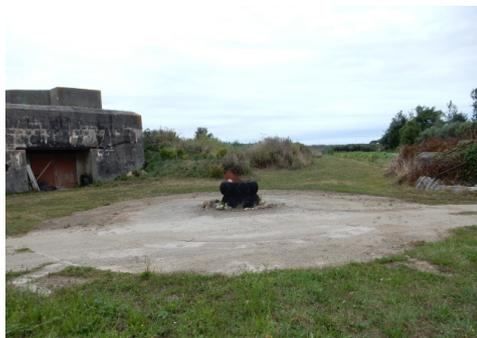
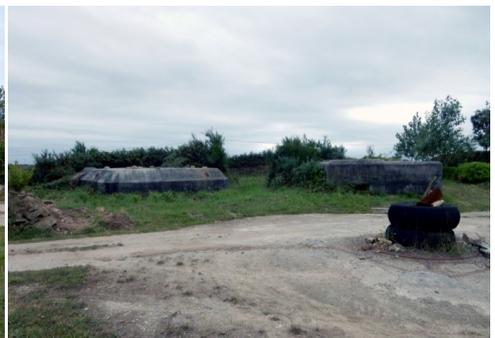
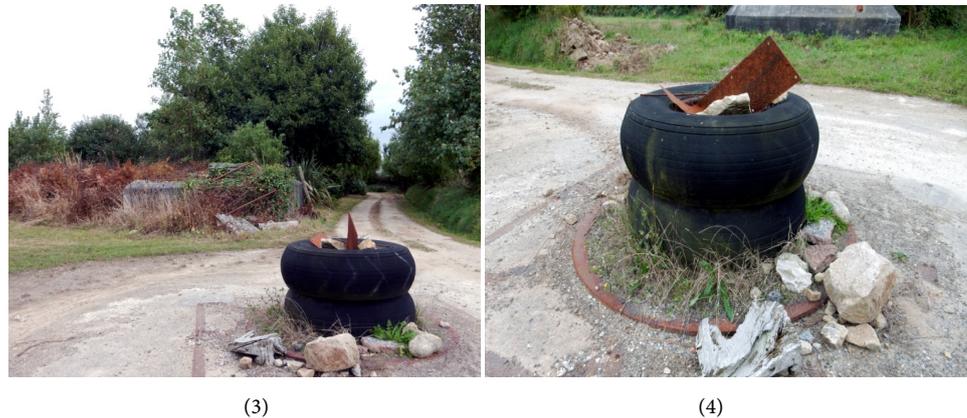
A circular open emplacement (4) about 10 m in diameter for *s.F.H.25* rough howitzer (**Figure 5**) was located near the *R669*. It was composed by:

- an external circular, metallic rail about 20 cm wide and about 8 m in diameter, flanked by square cavities; and
- an internal, square 2×2 m metallic plate provided with a raised metallic rim, a circular rail and, in the middle, a *s.F.H.25* carriage rotation pin, about 40 cm height, covered by two tires. The presence of the rail, the rim and the rotation pin, excluded a use of the open emplacement for a projector or radar.

Figure 5. Open emplacement (4)-(1) general view: on the left *R669*, on the right *Vf(5)*, (2) on the left *Vf(3)*, side view: on the right *Vf(2)*, (3) side view: on the left *Vf(5)*, on the right access road of the site, (4) square metallic plate provided with raised metallic rim, circular rail and carriage rotation pin covered by two tires.

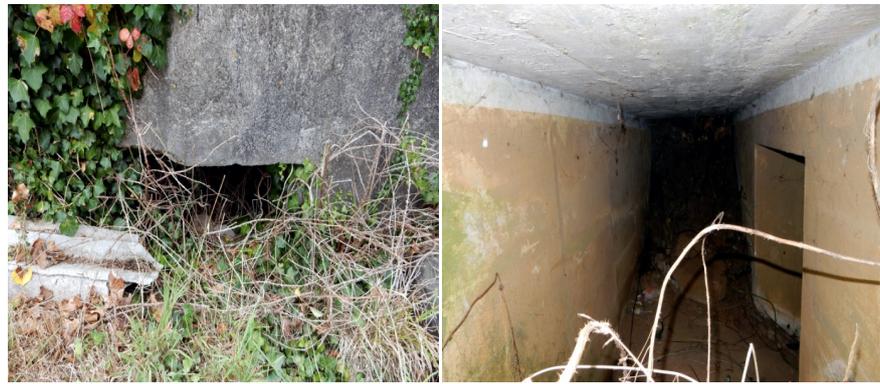
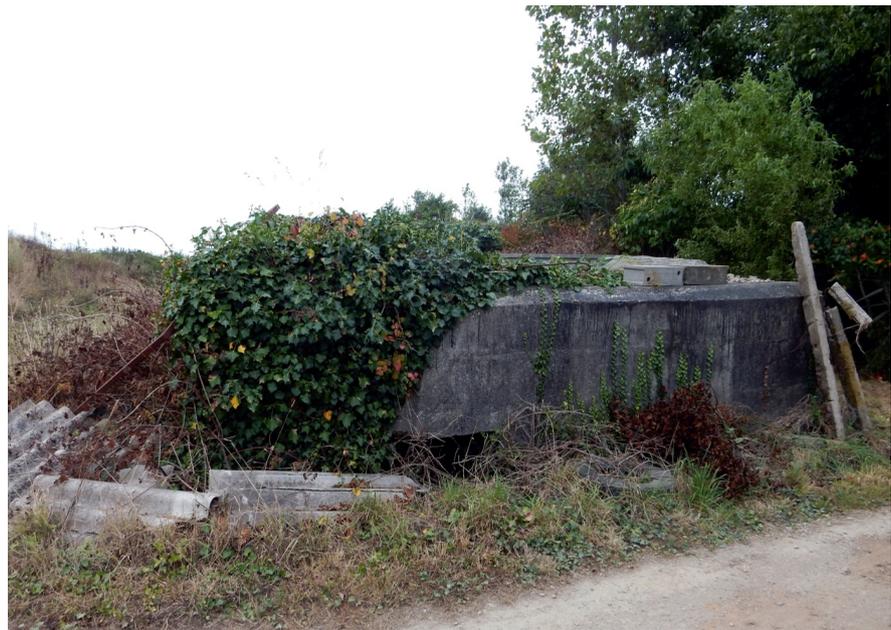
The *Vf(5)* (**Figure 6**), about 6×4 m, emerged about two meters from the terrain and was partially covered by vegetation. It was similar to *Vf(2)*, provided with two entrances, both without protection walls. A corridor, preserving its original wall pale ochre painting and ceiling white painting, connected the two entrances with the entrance of an interior single room. The entrances were obstructed by terrain and vegetation; so that the inspection of the interior was not possible. The absence on its coverage of chimney conduits, suggests that this bunker was intended for storing materials. The emerging *Vf(5)* concrete structure was in a good preservation state without damages due to combats.

Figure 6. Vf(5)-(1) entrance obstructed by terrain and vegetation, (2) internal corridor with interior single room entrance, (3) complete view.

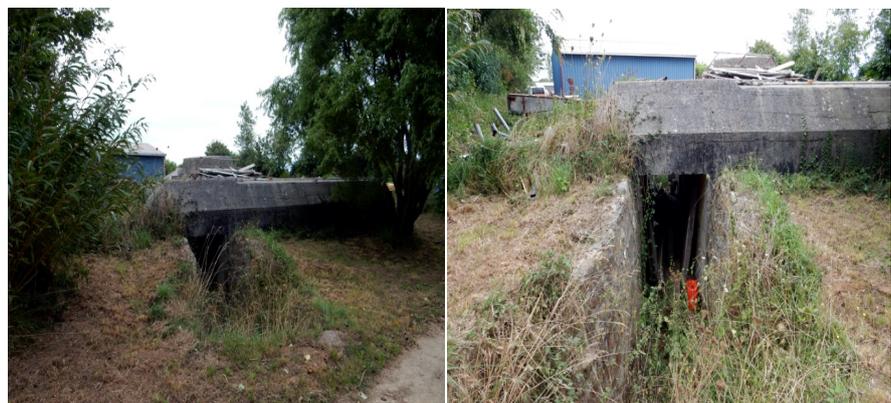
The *M134* (6) (**Figure 7**), 11.10×10.80 m, emerged about one meter from the terrain. It was provided with two entrances, both provided with a concrete access ramp and protection walls. A corridor connected the two entrances with the entrances of two interior ammunition rooms. The bunker entrances were obstructed by terrain and vegetation; so that the inspection of its interior was not possible. Because of its function of storing ammunitions, it was located relatively far from the *R669* and the open emplacement (4) (**Figure 1**). The emerging *M134* (6) concrete structure was in a good preservation state without damages due to combats.

Figure 7. M134 (6)-(1) emerging portion with entrance, (2) entrance having protection walls and access ramp obstructed by vegetation, on the foreground the agricultural shed (23).

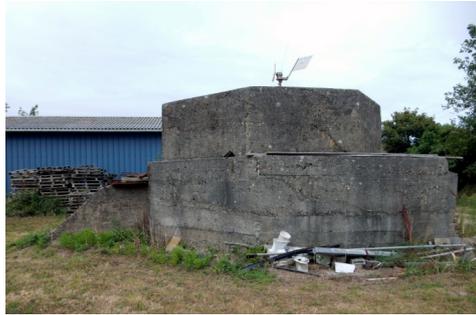
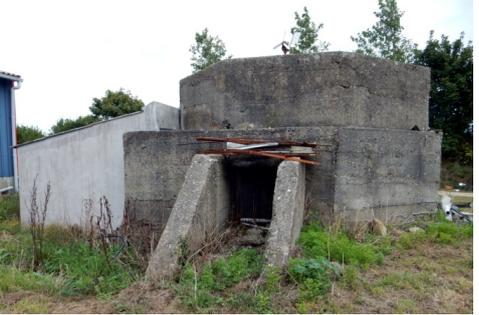
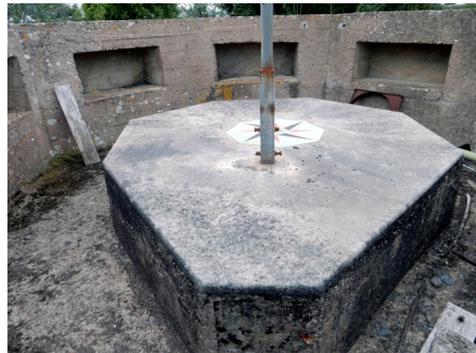
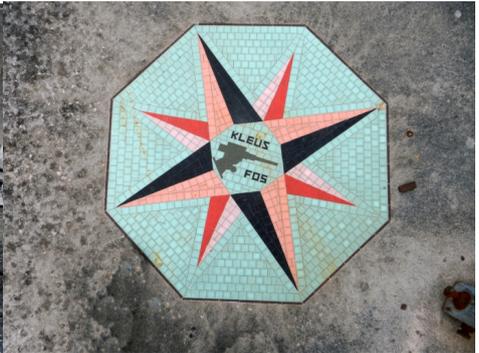
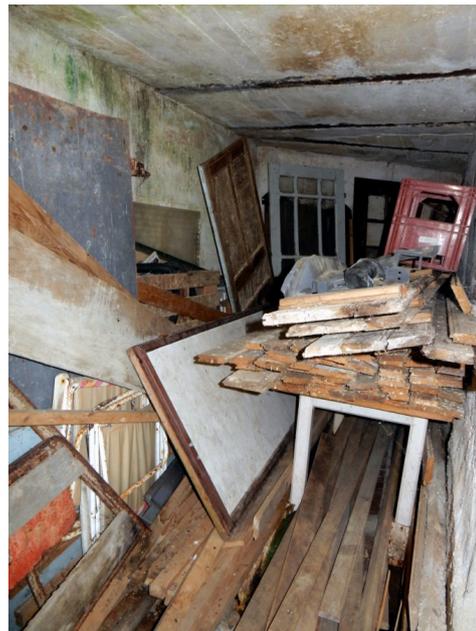
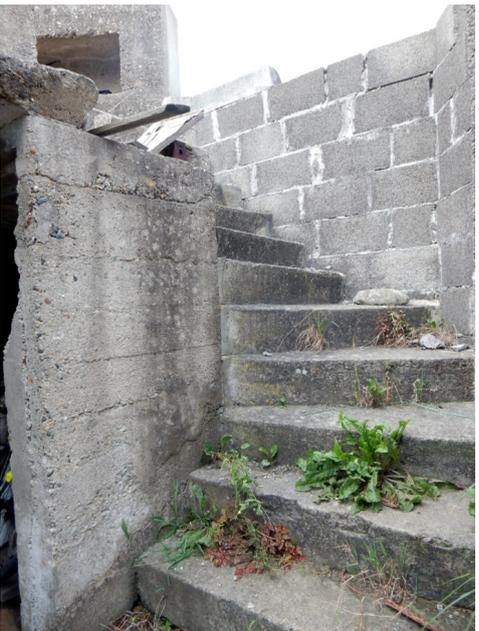
The *Flak Vf(7)* (**Figure 8**) ($48^{\circ}35'0.36''N$, $4^{\circ}33'0.07''W$) was formed by a concrete, inferior, cubic section, about 5×5 m, supporting a concrete, hexagonal gun emplacement. The gun emplacement was accessible through a spiral staircase provided with a concrete bricks protection wall. On the front side, leaned on the cubic section was a concrete annexed room. Its walls and coverage had a thickness of about 20 cm and a portion of them collapsed by structural reasons. On the rear side was the entrance provided with protection walls. The bunker inside was cluttered by materials and apparently all the original bunker furniture disappeared. The hexagonal gun emplacement preserved the ammunition niches and a concrete octagonal gun support. On the support no joint for fixing a gun, but rather a mosaic, probably of origin, showing an anti-aircraft gun, probably an 88 mm or a 105 mm gun with the inscription *CleusFos* and a mast of a small Aeolian generator. The kind of *Flak* gun hosted in the emplacement is unknown, but probably it was a light one like a 2 cm *Flak 30/38/Flakvierling* or 3.7 cm *Flak 18/36/37/43*. On the external *FlakVf(7)* bunker concrete structure the traces of the boards of the formwork were clearly visible. It was in a substantial good preservation state without damages due to combats, with the only exception of the collapsed portion of the annexed room.

Figure 8. *Flak Vf(7)*-(1) concrete, cubic section with superimposed hexagonal gun emplacement, (2) entrance with protective walls, on the left small shed leaning on the bunker, (3) octagonal gun support with mosaic and mast of a small Aeolian generator, on the foreground ammunitions niches, (4) mosaic probably of origin, (5) bunker inside cluttered by materials, (6) staircase to the hexagonal emplacement, (7) front side: annexed concrete room and access stair, on the top the small Aeolian generator, on the right the agricultural shed (23), (8) access ramp to a buried bunker near the *Flak Vf(7)*, (9) *R669* with hexagonal emplacement, (10) *Vf(8)* near to the gun emplacement (8).

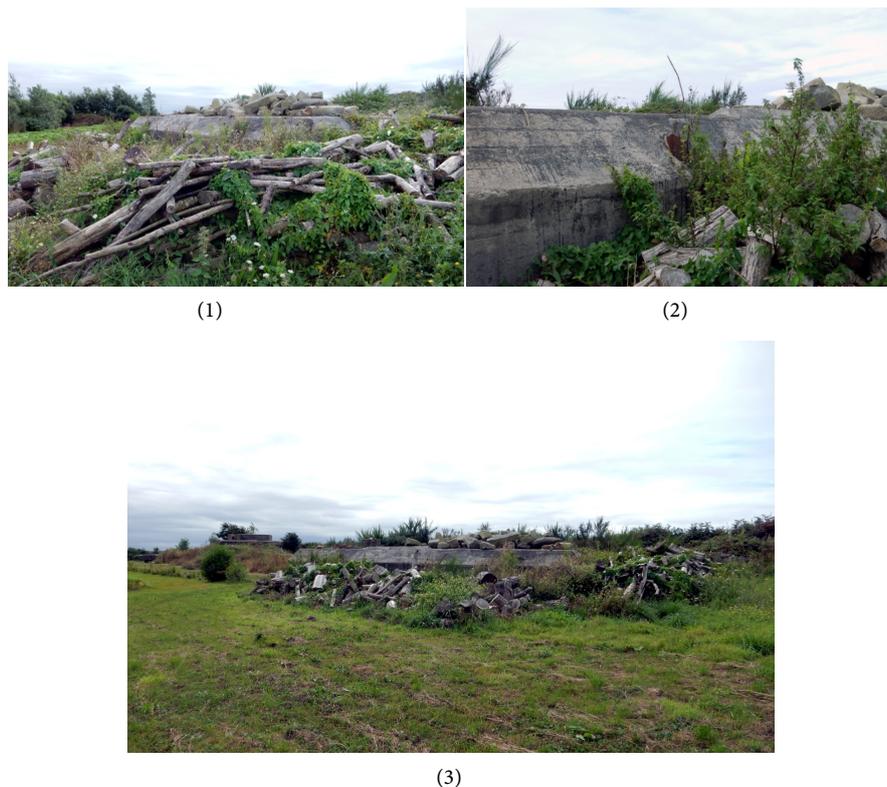
The *Vf*(12) (**Figure 9**), about 12×6 m, emerged about two meters from the terrain and was partially covered by piles of firewood. It was similar to *Vf*(9), provided with one entrance provided with protection walls. The entrance was obstructed by terrain and vegetation; so that the inspection of its interior was not possible. The presence on its coverage of two chimney conduits suggested that it was intended for hosting one or two groups of soldiers. The emerging *Vf*(12) concrete structure was in a good preservation state without damages due to combats.

Figure 9. *Vf*(12)-(1) side view, (2) coverage with chimney conduit, (3) complete view, on the left R669.

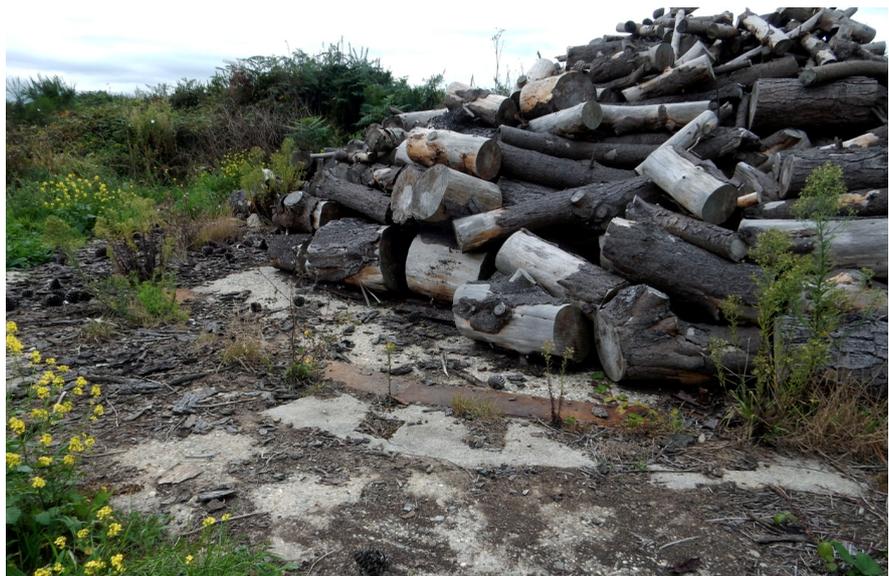
A circular open emplacement (14) for *s.F.H.25* rough howitzer (**Figure 10**) was located near the *Vf*(12) and *Vf*(13). It measured about 10 m in diameter. The internal, square 2×2 m metallic plate, the circular rail and the *s.F.H.25* carriage rotation pin were covered by a pile of firewood and therefore not visible. Only a portion of the external circular rail, about 20 cm wide, flanked by square

Figure 10. Open gun emplacement (14), in the middle external circular rail and square cavities.

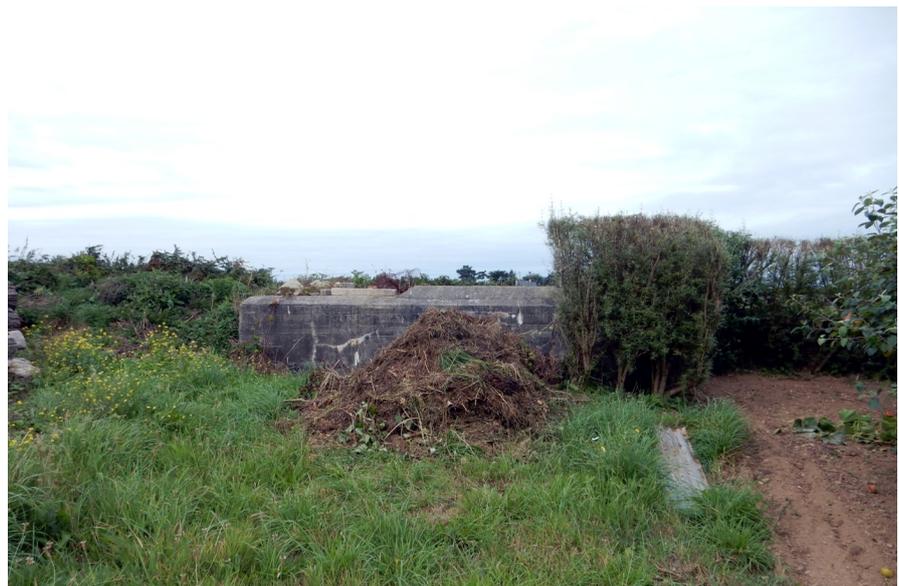
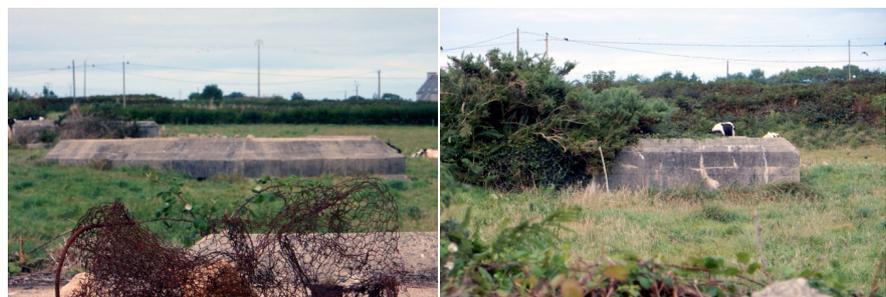
The *Vf*(15) (**Figure 1** and **Figure 11**), about 5×5 m, emerged about two meters from the terrain and was partially covered by vegetation. Its entrance/s did not emerge from the terrain; so that the inspection of its interior was not possible. The absence on its coverage of chimney conduits suggested that it was intended for storing materials for the *s.F.H.25* rough howitzer at the open emplacement (14). The emerging *Vf*(15) concrete structure was in a good preservation state without damages due to combats.

The *Vf*(16) (**Figure 1** and **Figure 11**), about 9×6 m, emerged about two meters from the terrain. It was similar to *Vf*(3), its entrances were obstructed by terrain and vegetation; so that the inspection of its interior was not possible. It was probably intended for hosting one or two groups of soldiers. The emerging *Vf*(16) concrete structure was in a good preservation state without damages due to combats.

The *Vf*(17) (**Figure 1** and **Figure 11**), about 4×4 m, emerged about two meters from the terrain. It was similar to *Vf*(11) and *Vf*(13), its entrances were obstructed by terrain and vegetation; so that the inspection of its interior was not possible. The emerging *Vf*(17) concrete structure was in a good preservation state without damages due to combats.

The *Vf*(18) (**Figure 1** and **Figure 11**), about 6×4 m, emerged about two meters from the terrain and was partially covered by vegetation. It was similar to *Vf* (2), provided with entrances obstructed by terrain and vegetation; so that the inspection of its interior was not possible. The absence on its coverage of chimney conduits, suggested that it was intended for storing materials. The emerging *Vf*(18) concrete structure was in a good preservation state without damages due to combats.

Figure 11. Bunkers-(1) *Vf(15)*, (2) *Vf(16)*, on the left *Vf(17)* and *Vf(18)*, (3) *Vf(17)*.

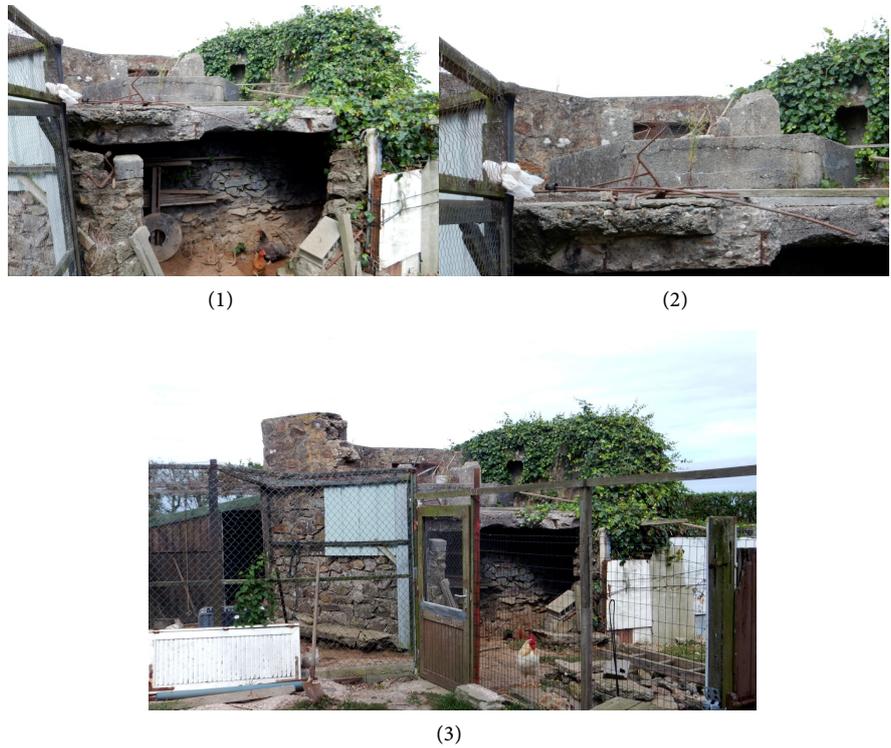
The *Flak Vf* (20) (**Figure 12**) ($48^{\circ}35'3''N$, $4^{\circ}33'0.12''W$) was integrated in a poultry house. It was similar to *Flak Vf* (7) but of poorer construction. It was built integrally with local stone bricks. A circular inferior section having a circular internal room supported a hexagonal gun emplacement. Its walls and coverage had small thick of about 40 cm and a portion of them collapsed by structural reasons. The hexagonal gun emplacement preserved the concrete gun support and the ammunition niches. The kind of *Flak* gun hosted in the emplacement is unknown, but probably it was a light one like a 2 cm *Flak* 30/38/Flakvierling or 3.7 cm *Flak* 18/36/37/43. The external bunker concrete structure was in a substantial good preservation state, with the exception of the collapsed portion, without damages due to combats.

Figure 12. *Flak Vf(20)*- (1) circular inferior section in local stone bricks, (2) circular internal room, (3) hexagonal gun emplacement: concrete gun support and on the foreground ammunitions niche.

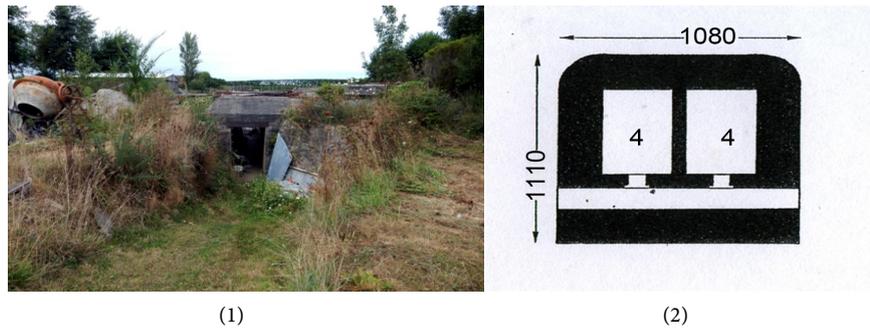
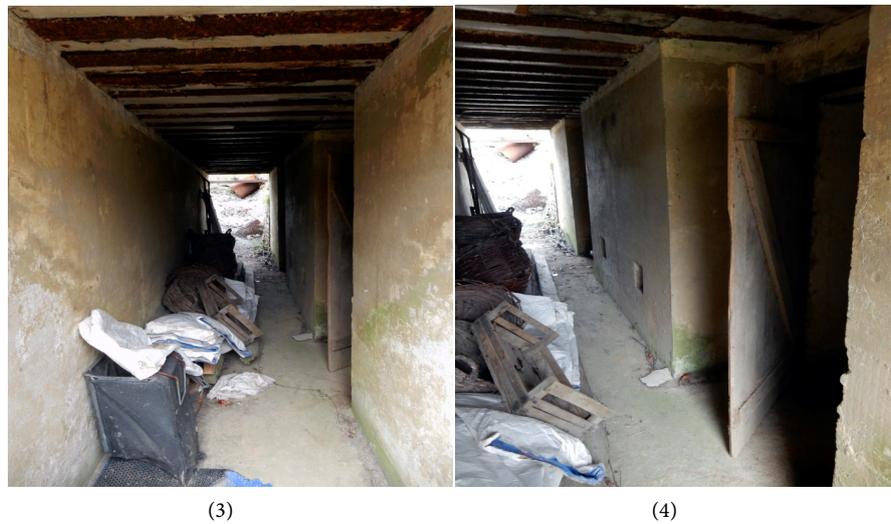
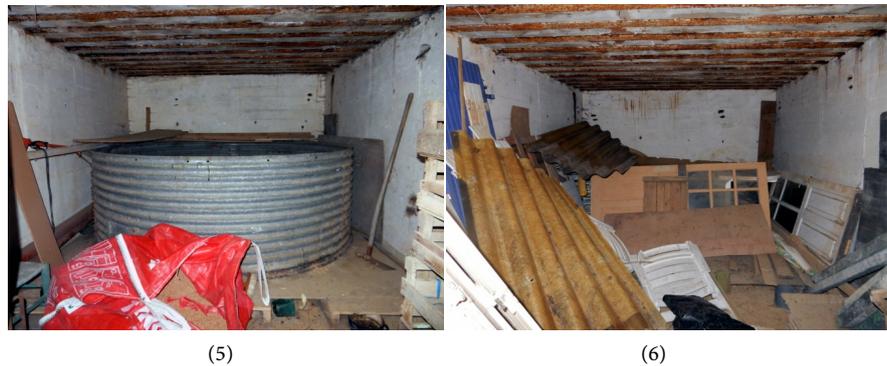
The *M134* (21) (**Figure 13**), 11.10×10.80 m, was buried in the terrain. It was provided with two entrances, both with access ramp and protection walls. A cor-

ridor, preserving its original wall pale ochre painting and metallic ceiling, connected the two entrances with the entrances of two interior ammunition rooms. The corridor entrances were not obstructed; so that the inspection of its interior was possible. Each ammunition room preserved the white painting of the walls, the metallic ceiling and a wooden door probably of origin. All the original room furniture disappeared and their interior was cluttered by materials. Because of its function of storing ammunitions, it was located relatively far from the *R669* and the open emplacements (**Figure 1**).

Figure 13. *M134* (21)-(1) entrance with concrete access ramp and protection walls, (2) *M134* plan: 4 ammunition room (Rudi 1988), (3) corridor with ammunition room entrances and metallic ceiling, (4) room door, (5) ammunition room, (6) ammunition room.

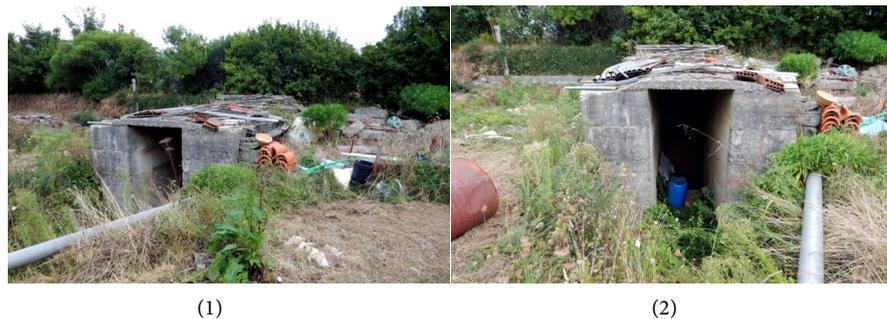
The *Vf(22)* (**Figure 14**), about 5.5×3.5 m, was buried in the terrain. It was provided with an entrance provided with access ramp without protection walls. The entrance was obstructed by vegetation, so that the inspection of its interior was not possible. Its coverage had small thick of about 30 cm. Its reduced dimensions and light coverage (**Figure 12**) suggested for it a secondary but important function, like that of water source protection or latrine.

Figure 14. *Vf*(22)-(1) entrance with access ramp without protection walls, (2) entrance obstructed by vegetation.
