A STUDY ON THE IDENTIFICATION OF FIRE HAZARDS ON BOARD: A CASE STUDY

Professional Paper

The RoRo ship MS UND ADRIYATIK was wrecked in February 2008 by a catastrophic fire. The causes of the accident included a combination of human, technical and organizational factors. In this study, the authors describe the accident, its chronology, and the dependencies involved. They then examine some of the erroneous series of human's operations, design and technical errors that led to the disaster and their organizational roots at the time of the accident. Risk-reduction measures can be costly, though; priorities must be set based on costs and benefits. This research suggests ways to support fire prevention efforts. Nine possible reasons were determined to perform a survey suitable for AHP technique. The purpose of this survey is to determine the order of possible explanations for this fire accident and possible provisions and precautions to be taken.

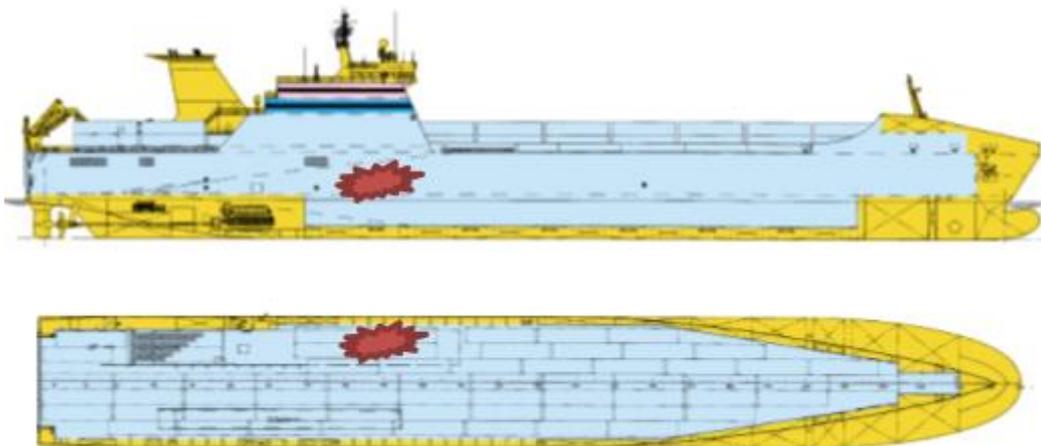
Fire, heat and smoke in the aft upper deck blocked access to lifeboats and all were trapped in the bridge area. They managed to escape to the fore-castle by descending down from the forward wall of accommodation using fire hoses and flag lanyards. After 15 minutes, the Captain had to give the order to abandon the ship as the fire approached dangerously close. All crew and truck drivers were rescued by about 07:00. The starting location of the fire is depicted in Fig. 1 [12].

Fig. 1 Starting location of the fire
