Proceedings of the National Seminar & Exhibition on Non-Destructive Evaluation

NDE 2009, December 10-12, 2009

Vibration Diagnostics as NDT Tool for Condition Monitoring in Power Plants

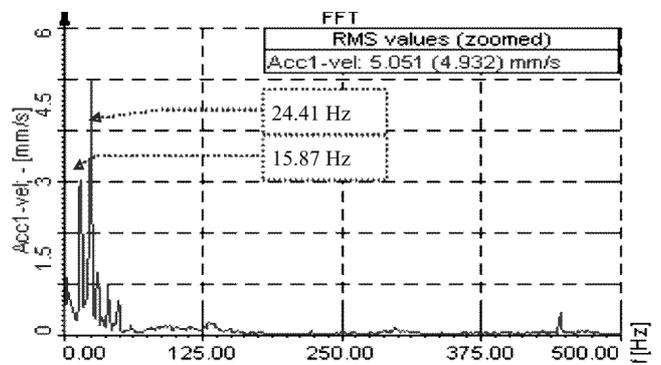
Fig. 2 : Vibration Spectra

Vibration spectra measurements were done on various locations on the pump and Fig. 2 shows the spectra recorded at the pump discharge location for 1500 RPM. It is inferred from the spectra that a well prominent peak at 65 % of the running speed is occurring at 1500 RPM.

The sub harmonic peak could be due to oil whirl or oil whip [4]. But since there is no relative motion between the sodium film in contact with the rotor in the case of hydrostatic bearing, these causes were ruled out. So the presence of sub harmonic peaks was attributed to rotor rub with some mechanical looseness. Time signal plots (Fig. 3) recorded during the operation supported the occurrence of intermittent rubbing/hitting of the rotor. Moreover the vibration levels were maximum at the discharge location and found to be increased with increase in running RPM. Based

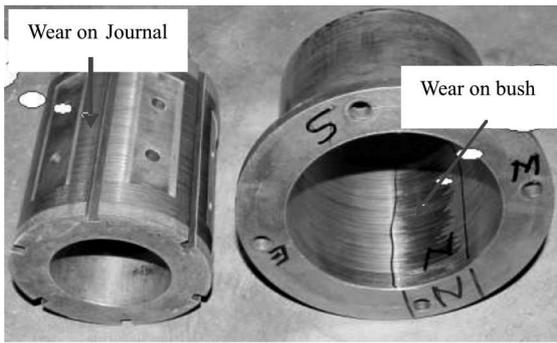
Fig. 4 : Bearing components

After dismantling the pump, it was found that hydrostatic bearing was damaged and the journal had worn out (shown in Fig. 4). To determine the cause of this rub, an analysis was carried out and it emerged that the suction line of the pump was not flexible enough to accommodate the thermal expansion due to which the pump assembly as a whole was moving by as much as 1000 microns, against the radial clearance of 110 microns between the journal and bush of the hydrostatic bearing, which was causing the rotor rub [5]. To improve the flexibility, an expansion bend (U-bend) was introduced in the suction line of the pump. Also, the pump vessel was aligned vertically and a guide in the labyrinth area, at the bottom, was provided to arrest the lateral movement of the pump vessel. After the corrections,

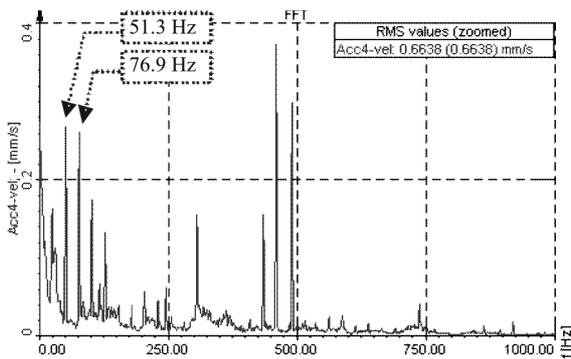
Fig. 5 : Vibration spectra

the deflection of the pump vessel reduced to 13 microns, well below the 110 micron limit. The overall vibration came down appreciably to 0.66 mm/s (Fig.5) compared to 5.05 mm/s earlier. Thus an effective vibration based condition monitoring program has resulted in considerable savings by identifying the system design fault in its early stage of operation and prevented any catastrophic damage to the vertical sodium pump internals.

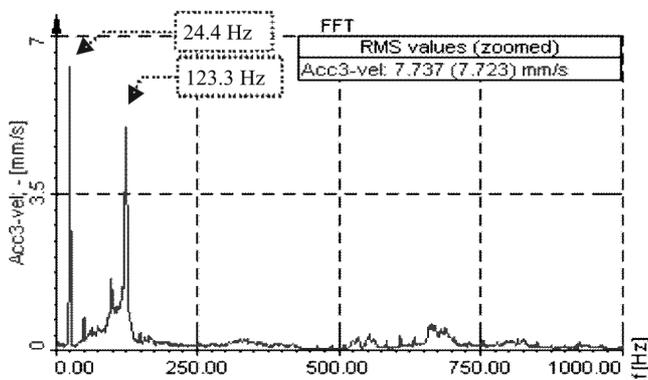
Fig. 7 : Vibration Spectra

Figure 7 shows a vibration spectra recorded from the pump drive end location in vertical direction. All the spectra indicated 1 x RPM and 5 x RPM peaks as predominant in the radial directions without many harmonics. This lead to the conclusion that the underlying problem is an unbalance type, but the cause of the unbalance was not clear. The 5 x RPM component led to the understanding that it could be Pump drive end bearing deterioration or problems with the vanes of the impeller since 5 x RPM lies in the range of bearing defect frequencies (1), which are calculated below and more over the 5 x RPM corresponds to the vane passing frequency (VPF) (Since impeller is having 5 vanes).

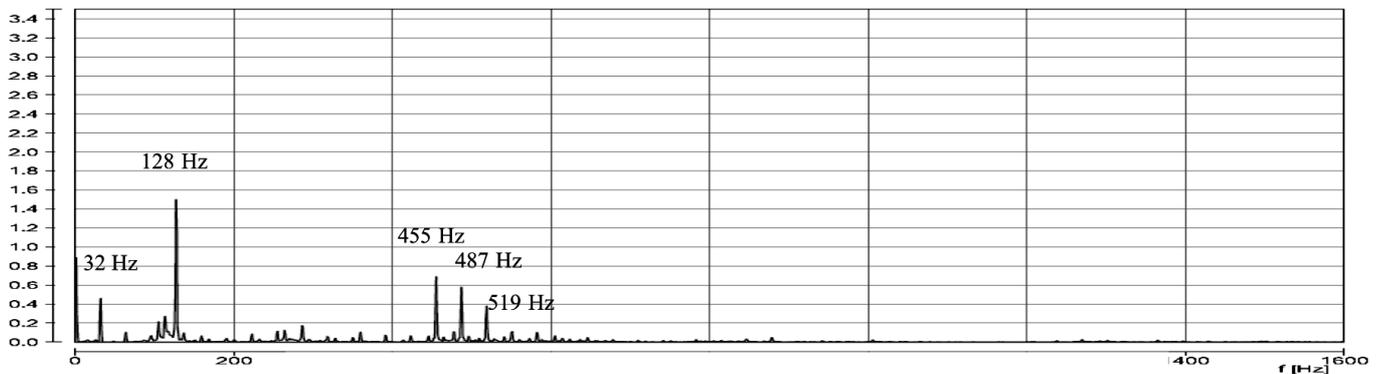
Fig. 11 : Vibration spectra during fault development

whereas the axial vibration value was 2.25 mm/s only. Fig.11 shows the vibration spectra taken from the motor non-drive end in radial direction during the development of the fault and Fig.12 shows the vibration spectra when the vibration value reached 5.4 mm/s. In Fig.11 the predominant frequency component is 128 Hz. The motor non-drive end uses SKF 6309 anti-friction bearing and for the current running speed, 128 Hz corresponds to the ball spin frequency of the bearing. The frequency components observed in Fig.12 is complex in nature showing multiple peaks spreaded over the entire spectra. Apart from the ball spin frequency, around 400 Hz multiple spectral peaks of nearly the harmonics of BPFO and BPF1 of the bearing were observed and were found to be at exact intervals of the running frequency 32 Hz. So it was concluded that the ball spin frequency peak was the first indication followed by the development of bearing tones confirms the fault with bearing/bearing support system [6].

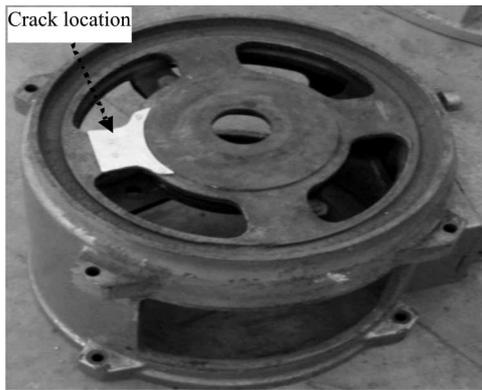
Fig. 13 : Bearing support block

Pump shutdown was scheduled and inspection was carried out at the motor non-drive end bearing location. A developed crack has been observed on the motor non-drive end bearing support block. Fig.13 shows the location of the crack. As the pump was required for various sodium loop experiments, the cracked location was reinforced with aluminium plates (Fig.13) and the pump has been brought back into service. After the maintenance the vibration values were found to be well within the limit and Fig.14 shows the corresponding vibration spectra.
