# Reconsidering the “MR Unsafe” breast tissue expander with magnetic infusion port: A case report and literature review

Rami Dibbs<sup>1</sup>, Bozena Culo<sup>2</sup>, Ravi Tandon<sup>3</sup>, Hugo St. Hilaire<sup>3</sup>, Frank G. Shellock<sup>4</sup>, Frank H. Lau<sup>3</sup>

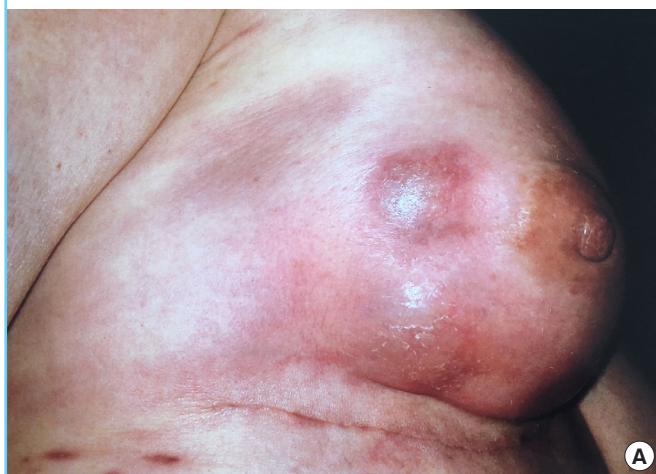
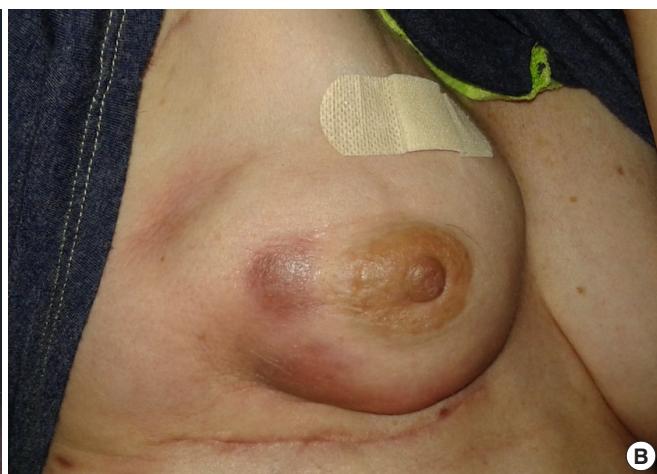
**Fig. 1. Expander loss following vehicular accident and MRI**

Five days later, the patient presented to the emergency department with right breast pain. On physical exam, the breast had two lesions, 2 cm in diameter, and associated erythema and swelling. She was diagnosed with cellulitis and was prescribed clindamycin. The cause of the cellulitis was likely associated with the trauma sustained from the traffic accident. The patient presented to her plastic surgeon the following day who also noted right inframammary fold erythema and the small lesions (Fig. 1). The saline in the TE was removed. Despite these maneuvers, the right breast continued to worsen and by 3 weeks post-MRI, the patient had impending TE exposure and required

(A, B) Clinical photographs showing inframammary fold erythema and blistering of the patient's right breast following motor vehicle collision with the patient as a pedestrian and subsequent magnetic resonance imaging (MRI).

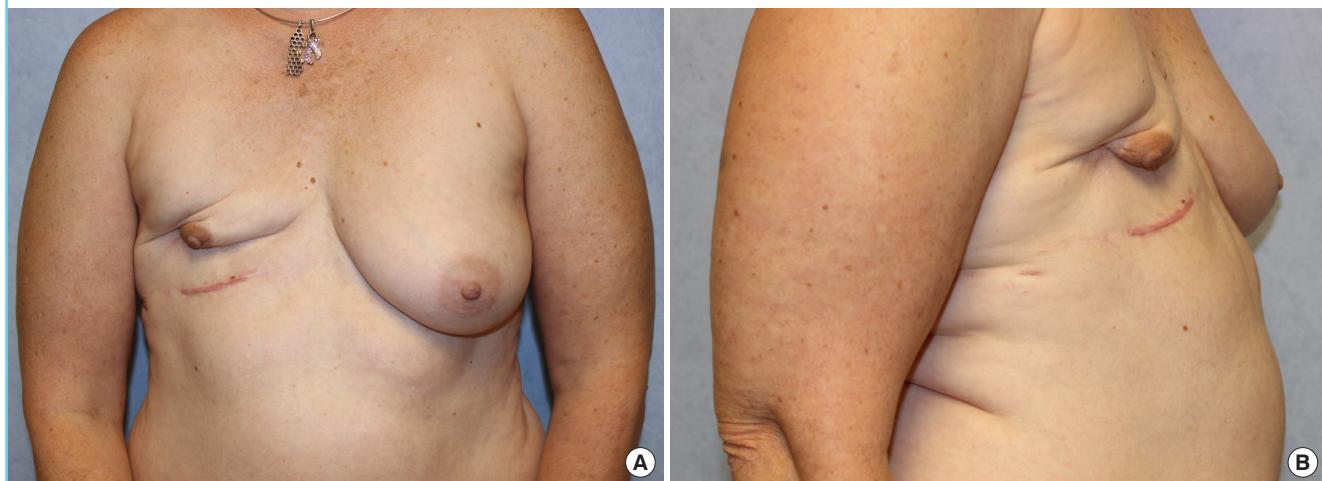
**Fig. 2. Acquired breast deformity following tissue expander explantation**

Clinical photographs demonstrating the patient's asymmetric chest after explantation of tissue expander with a magnetic infusion port. (A) Front view. (B) Side view.

explantation (Fig. 2). Intraoperatively, neither purulence nor fluid collection were present. One year later, the patient successfully underwent breast reconstruction with stacked deep inferior, epigastric artery perforator flaps (Fig. 3). At the time of autologous reconstruction, extensive scar tissue was noted at the mastectomy skin flaps, pectoralis muscle, periosteum, and encasing the internal mammary vessels.

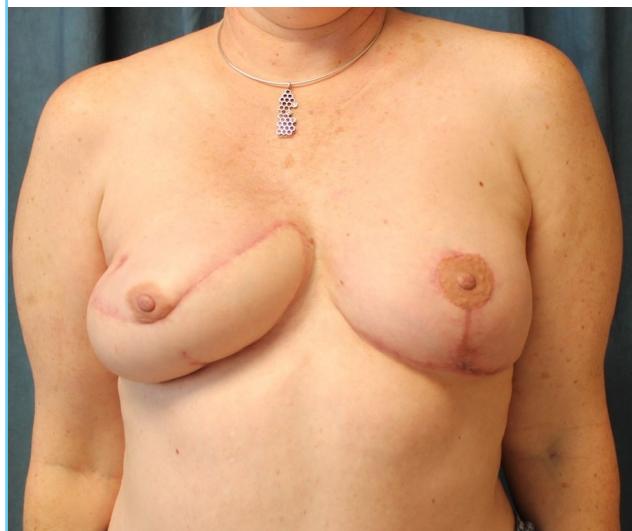
**Fig. 3. Delayed breast reconstruction using stacked DIEP flaps**

Patient after undergoing successful right breast reconstruction with stacked deep inferior epigastric artery perforator (DIEP) flaps.

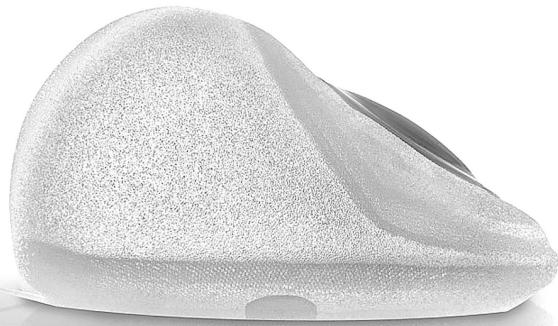
**Fig. 5. The ARTOURA Breast Tissue Expander**

Note the position of the magnetic infusion port and that it is covered with nonmetallic, nonconducting material, insulating and isolating it from the patient's tissue. Figure supplied by Mentor Worldwide LLC (Irvine, CA, USA).

A breast TE with a magnetic port is composed of a bladder with an outer shell made from silicone and an internal metallic infusion port to permit saline injections for implant expansion. A permanent magnet is incorporated into the implant to facilitate location of the port. Of note is that the metallic component is isolated and insulated from the patient by a layer of nonmetallic, nonconducting material (Fig. 5). Since the metallic component is small and has no direct contact with the patient's tissues, heating is not a realistic concern.
