## Case Report

# Inappropriate ICD Shocks for Inappropriate Reasons

Rakesh K Pai MD, Moeen Abedin MD and David A Rawling MD

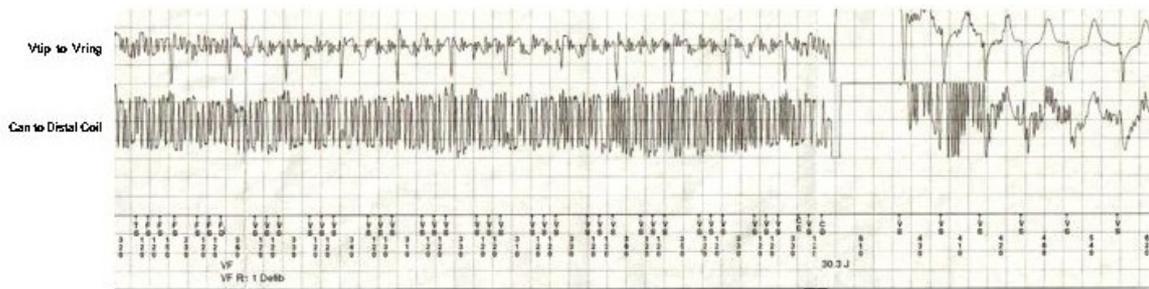
A 38 year old woman with normal left ventricular function, normal cardiac MRI, and a history of sustained monomorphic ventricular tachycardia at 240 beats per minute (left bundle morphology, superior axis) was implanted with a single chamber Medtronic Maximo VR 7232 (Medtronic Inc, Minneapolis, MN USA) implantable cardioverter-defibrillator (ICD) in 2001. The patient had never received an ICD shock over six years of follow-up. In the summer of 2007, the patient received a single ICD shock. The ICD interrogation (**Figure 1**) revealed a high frequency 50 Hz artifact on the ventricular channel sensed by the device as ventricular fibrillation, a 30 Joule shock was delivered. There was no evidence of ICD malfunction, with a ventricular sensitivity of 0.3 mV, R waves of 6.1 mV, with ventricular lead and shock impedances of 400 Ohms and 55 Ohms, respectively. Upon further questioning, it was discovered that the patient was swimming within two feet of an underwater pool light. The light had "shocked" several swimmers in the past. An electrician confirmed light malfunction due to improper grounding with evidence of current leak into the pool. We report an unusual case of an inappropriate ICD shock caused by the ICD sensing alternating current from an unexpected external source.

**Figure 1:** The near field ICD electrogram (V tip to V ring) is present on the top, and the ICD shock electrogram (Can to Distal coil) is on the bottom. Note the high frequency noise present on both sets of electrograms. The patient receives a single 30 Joule shock; however, the noise persists and only begins to dissipate after she receives the shock (last few seconds of the tracing) and begins to swim away from source of alternating current leak.

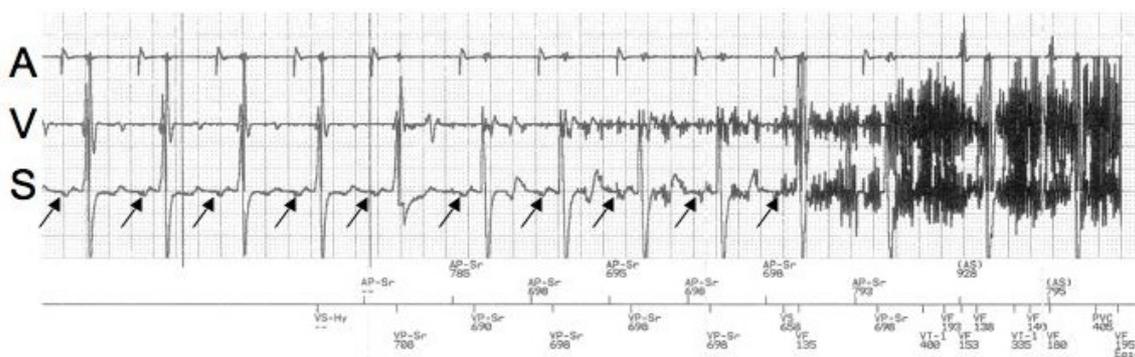
A 70 year old man with a history of ischemic cardiomyopathy, nonsustained ventricular tachycardia and sinus node dysfunction was upgraded from a dual chamber pacemaker to a dual chamber Guidant Vitality 2 DR ICD model T165 (Guidant Inc, St Paul, MN USA) in February of 2007. During ICD testing a single 20-Joule reverse polarity shock terminated VF. In June 2007, the patient presented for routine follow-up and during this visit he reported receiving a single ICD shock in March. He felt well and did not seek medical evaluation at that time. The ICD interrogation revealed a high frequency artifact on the ventricular channel sensed by the device as VF, and a single 20-Joule shock was delivered. In addition there were numerous stored EGMs demonstrating high frequency noise (**Figure 2**) recognized as VF but none were sustained long enough to trigger ICD therapy. There was no evidence of malfunction; R waves were 24 mV, capture threshold of 0.6 V at 0.5 ms, and the ventricular lead and shock impedances were 706 Ohms and 50 Ohms, respectively. The noise could not be reproduced by isometric maneuvers or with pocket manipulation.

**Figure 2:** The atrial sense channel electrogram (A) is present on the top, the near field ventricular sense channel (V) is present in the middle tracing, and the ICD shock (S) electrogram is on the bottom. Very high frequency pectoral myopotentials are present and sensed by the device as VF (marker channel) on both the V and S electrograms. In this particular tracing the episode was nonsustained and did not trigger ICD shock therapy. The presence of p waves and pectoral myopotentials on the shock electrogram is suggestive of reversal of DF-1 lead terminals, allowing for unipolar sensing from distal coil to the ICD can.

Inappropriate ICD shocks can be caused by SVT, lead fracture, electromagnetic interference, and set screw malposition. EMI can arise from the normal functioning of electrical appliances or from alternating current leak.<sup>1,2</sup> The Guidant ICD lead is an integrated bipolar lead, with ventricular sensing from the distal tip to distal coil. In the second case, the proximal and

distal ICD DF-1 pins were reversed in the header, resulting in a sensing circuit from the distal coil to the can. This broad unipolar sensing configuration allowed the detection of pectoral myopotentials, precipitating an inappropriate ICD shock.<sup>3,4</sup> A diagnostic clue for this etiology of inappropriate shock is the presence of p waves (**Figure 2; arrows**) on the ICD shock EGMs. The high frequency noise artifact is unlikely to be due to EMI, as there is no noise seen on the atrial lead. Furthermore, lead fracture is less likely given adequate sensing and capture thresholds with normal lead impedances. Surprisingly, the patient was successfully defibrillated at initial implant; however, the shock energy pathway from the proximal SVC coil to the distal coil and ICD generator can shunt energy away from the ventricles and is unproven in cardioverting ventricular arrhythmias. The patient was taken to the electrophysiology laboratory and proximal and distal DF-1 pin reversal was confirmed. The DF-1 distal and proximal lead terminal positions were corrected and VF was terminated with a single reverse polarity 14-Joule shock. The patient went home the same day and had no further complications. We present two unique cases of inappropriate ICD shocks due to EMI from an unexpected source alternating current and reversal of the proximal and distal DF-1 lead terminals of the ICD lead.
