## Case Report

# Computed Tomography Scan and ICD Interaction

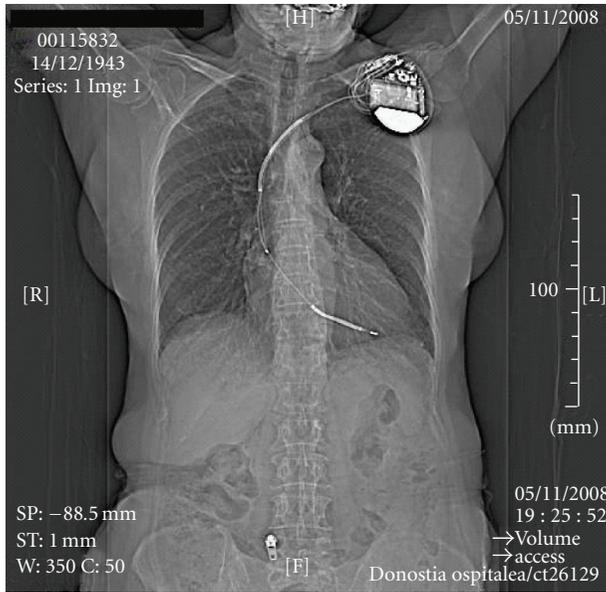
FIGURE 1: CT topogram. Initial topogram of the scan, showing the implanted device in the left pectoral zone and both electrodes. Arrows: date and time of scan.

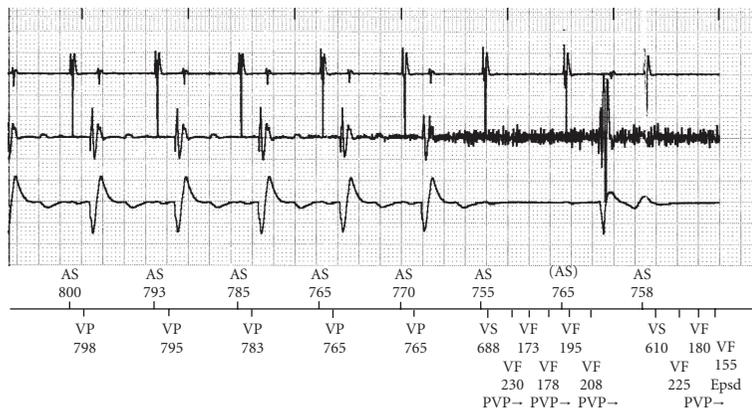
AS: Atrial sensing  
 VP: Ventricular pacing  
 VF: Ventricular fibrillation
