# CASE REPORT

# Case Report: A nine year follow-up for a pacemaker generator poly-tetra-fluoro-ethylene coating for allergic reactions to pacemaker compounds [version 1; referees: awaiting peer review]

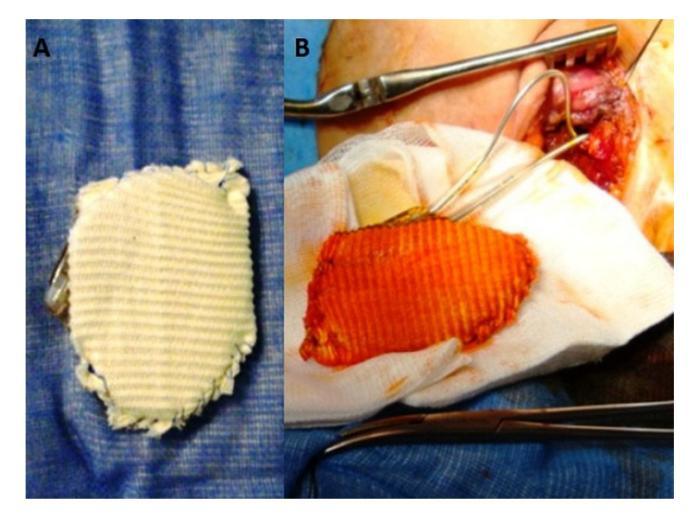
The patient underwent removal of the old pacemaker system and re-implantation of a new pacemaker system. The generator (Saint Jude Medical Victory XLDR) was entirely coated with PTFE sheet and implanted in the left chest wall in a retro pectoral position (Figure 1). The procedure was uneventful and the patient was discharged in good condition.

Figure 1. Poly-tetra-fluoro-ethylene (PTFE)-coated pacemaker implantation. (A) Entirely coated pacemaker generator with PTFE sheet; (B) coated generator connected to two leads implanted in retropectoral position.

Treatments of contact dermatitis have been described in various case reports. There is a role for topical corticosteroid that can reduce skin symptoms, but recurrence is common<sup>10</sup>. The only complete treatment is the removal of the allergen, and the use of a hypoallergenic material. One option, as described by Syburra *et al.* and Andrews and Scheinman<sup>1,11</sup>, is the use of gold-coated generator. PTFE sheet coating technique was first reported in Japan<sup>8,12–14</sup>. This technique seems to be an effective method despite theoretical risk of PTFE hypersensitivity. In our patient, lack of recurrence confirms pacemaker component allergy and effective-ness of PTFE coating to prevent it.
