Severe Periprosthetic Metallosis and Polyethylene Liner Failure Complicating Total Hip Replacement: The Cloud Sign

Amir Paydar, B.S., Felix S. Chew, M.D., Paul A. Manner, M.D.

Citation: Paydar A, Chew FS, Manner PA. Severe periprosthetic metallosis and polyethylene liner failure complicating total hip replacement: the cloud sign. *Radiology Case Reports*. [Online] 2007;2:115.

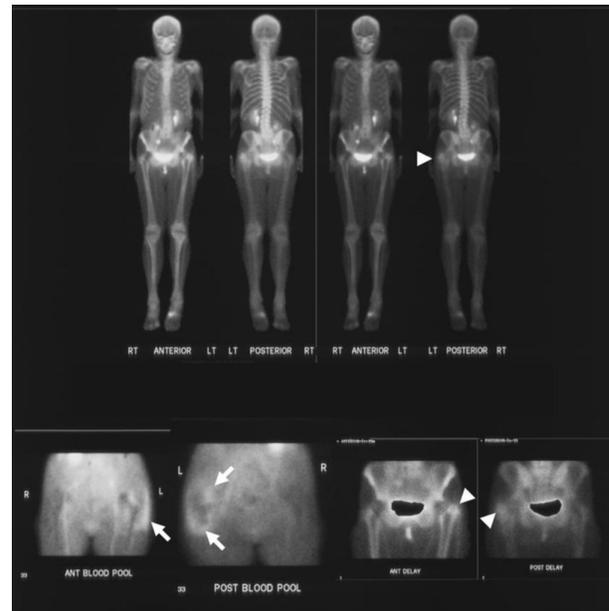
gross anatomical abnormalities. Subsequently, a bone scintigraphy study showed increased radiotracer uptake in the left hip periarticular region, suggesting active hyperemia and chronic inflammatory change, which were considered non-specific findings (Fig. 1).

Figure 1. 85-year-old female with metallosis of left total hip replacement. Anterior and posterior projections of a bone scintigraphy study using 30mCi IV technetium-99m-labeled methylene diphosphonate (Tc-MDP) in the 15-minute blood pooling and 3.0-hour delay phases were obtained. This scan demonstrates presence of bilateral THRs with significant increased uptake of Tc-MDP in the periprosthetic bony and soft tissues of the left hip joint in the blood pooling phase (arrows). Delayed phase scans also show mild Tc-MDP uptake in the left hip joint soft tissues (arrowheads). No abnormalities are visualized in the region of the right hip joint.

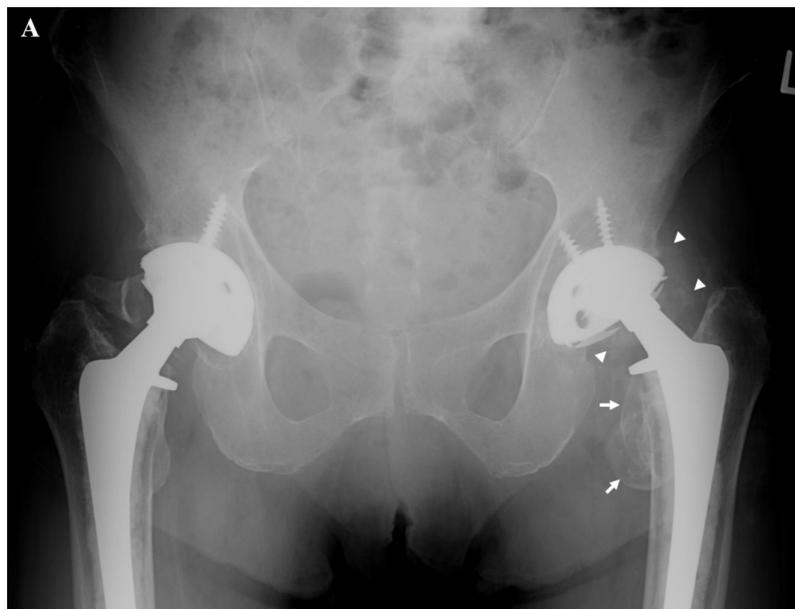
The patient opted for medical management at the time but, because of no significant improvement, was re-evaluated 6 months later. This time, pelvic radiographs showed eccentric position of the prosthetic femoral head within an otherwise intact left THR acetabular component (Fig. 2). The rapidity of this change suggested displacement or other catastrophic failure of the polyethylene liner rather than simply mechanical wear. This complication prompted immediate surgical management. During THR revision surgery, an anteriorly disengaged acetabular polyethylene liner with obvious full-thickness wear and resultant scuffing of the femoral head was noted. Also, remarkably abundant titanium metallosis extending throughout the entire joint with a large extension into both the iliopsoas and trochanteric bursa was observed. An extremely large amount of inflammatory tissue and metallosis was removed and a complete synovectomy with removal of bursae was carried out intra-operatively. The acetabular socket was also exchanged with retention of the femoral component. Post-operative pelvic radiographs demonstrated a well-positioned, well-fixed left THR with no signs of residual metallosis (Fig. 3).

Figure 2A. AP Radiograph of the pelvis shows eccentric position of femoral head within acetabular cup of left total hip replacement. The bubble sign (arrows) and cloud sign (arrowheads) are present in the periprosthetic region of the left hip joint. The right total hip replacement is intact, with incidental heterotopic ossification.

used in symptomatic patients suspected to have implant malfunction and may seldom show other atypical underlying complications, such as liner dislocation and metallosis. One of the major findings in the radiographic study of this patient included the eccentric positioning of the femoral stem in the acetabular cup in the left hip implant (Fig. 2A). Asymmetric alignment of the prosthetic femoral head within the acetabular cup on radiography is indicative of a complication involving the polyethylene liner, often excessive mechanical wear, but occasionally catastrophic displacement or fracture [5]. In such cases, where the polyethylene liner is anatomically dissociated, immobilization and careful monitoring is warranted for the patient and revision surgery should be performed urgently [1, 10].

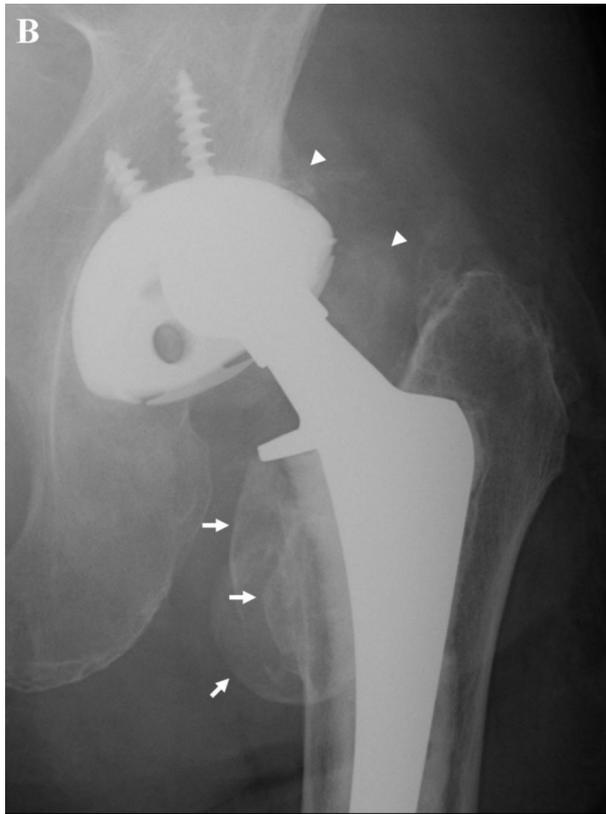
Radiographs of our patient's left hip also demonstrated the presence of the bubble sign, as described by Su et al (Fig. 2B-C) [4]. These bubble-like hyperdensities represent deposited metallic debris outlining the joint space. Other abnormal amorphous cloudy radiodensities in the periprosthetic region are also visualized in this study, a feature we have called the "cloud sign." These radiographic signs both indicate the presence of extreme metallosis in

the joint space and are consistent with the grade III classification of metallosis in this patient. Importantly, these signs are not detected in the post-revision radiograph (Fig. 3). This finding suggests that no residual metallosis remained in the joint capsule and the periarticular tissues after surgical debridement.

Figure 2B. AP radiograph of the right hip shows eccentric position of the femoral head within the acetabular cup. The bubble sign (arrows) and cloud sign (arrowheads) are present in the periprosthetic region of the left hip joint.

response in the periprosthetic soft tissues [1]. So, aggregation of polyethylene wear particles along with titanium debris, which most likely also occurred in our patient, may contribute to the formation of the bubble sign and the cloud sign.

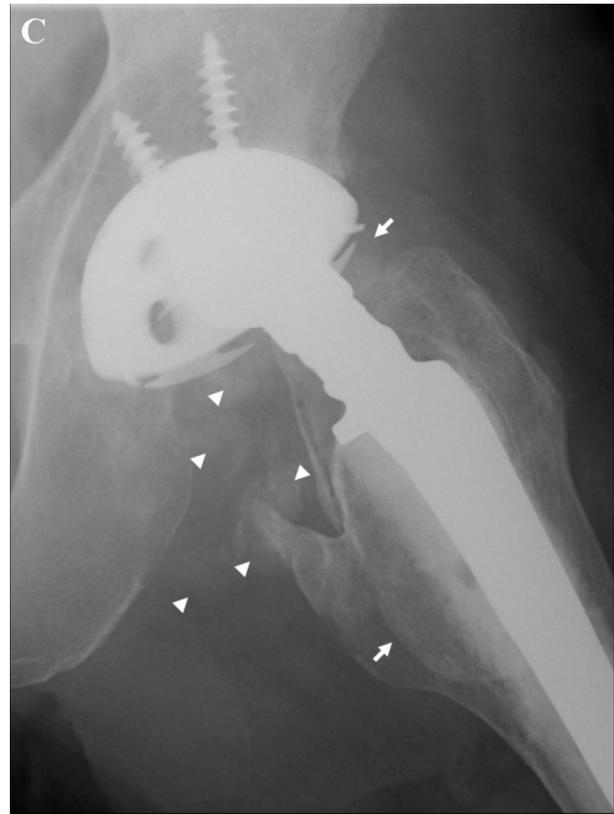
Figure 2C. Frog-lateral radiograph of the right hip shows eccentric position of the femoral head within the acetabular cup. The bubble sign (arrows) and cloud sign (arrowheads) are present in the periprosthetic region of the left hip joint.

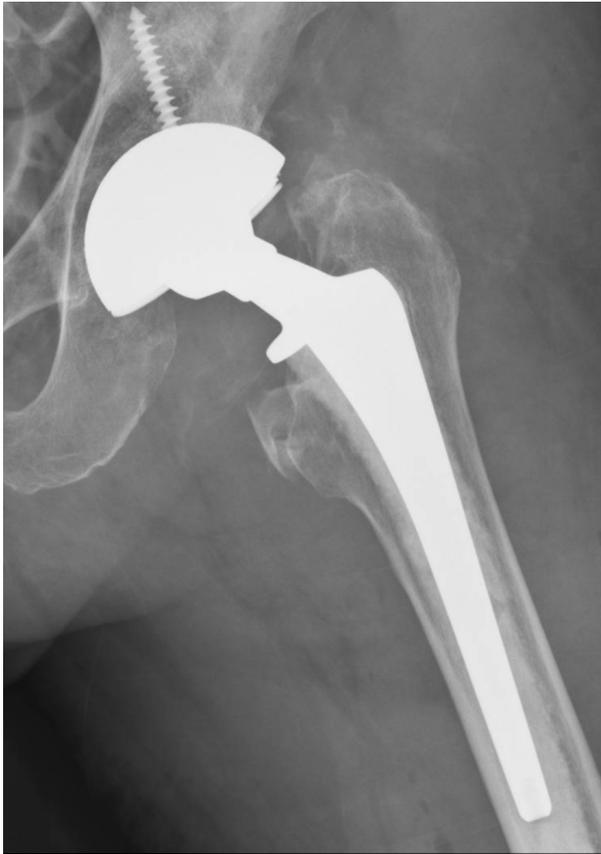
Figure 3. Frontal radiograph of the pelvis obtained after revision THR of the left hip joint demonstrates a well-positioned new implant. The femoral stem of the left prosthesis is now symmetrically fixed with anatomic alignment of the polyethylene liner within the medullary space of a new acetabular cup. No sign of residual metallosis is suggested.
