## **Ceramic on ceramic bearings in hip arthroplasty: State of the art and the future**

**J.R.T. Jeffers & W. L. Walter**

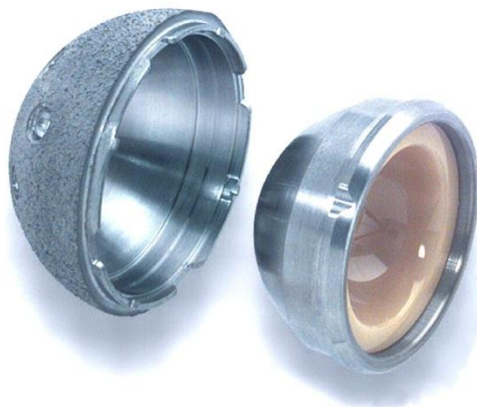
**Figure 3:** Photograph of the Stryker Trident acetabular cup

Liner chipping during insertion was a particular complication noted by D'Antonio, Capello and colleagues in their landmark prospective randomised study of ceramic and polyethylene bearings.<sup>21</sup> This may have been related to the design of the taper which, rather than continuing to the cup edge, transformed to a cylinder about 6mm from the rim of the cup and may have increased the risk of impacting a malseated liner. To protect the ceramic during assembly, the manufacturer encased the liner in a titanium sleeve that sat proud of the ceramic rim (Figure 2). This eliminated liner

Implant design also is a factor in liner canting, with a notably higher rate reported for the Trident device (Stryker, Mahwah, USA).<sup>25-27</sup> A particular feature of this device is that the ceramic liner is pre-assembled in a titanium sleeve which is then fitted to the titanium shell intraoperatively. The rim of the titanium sleeve sits proud of the outer shell and full seating of the device can therefore be difficult to check in the inferio-medial aspect. A further design aspect that may be relevant in liner canting is the mating taper angle. The most common liner taper angle is 19°, but the Trident device has a 10° taper angle. The smaller taper angle generates a smaller window of insertion for which the taper will engage, and may be related to the increased incidence of canting. Increasing the taper angle may ease the liner insertion, but generating the required normal force at the interface for static friction to keep the assembly together may be difficult to achieve.

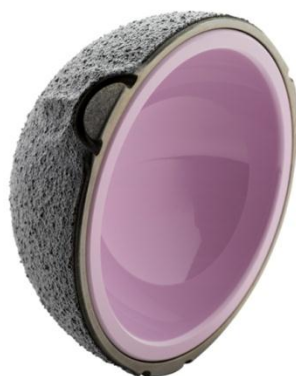
**Figure 4:** Photograph of the DeltaMotion acetabular cup

Considering THA, the DeltaMotion device (developed by Finsbury Orthopaedics, Leatherhead, UK, now manufactured by DePuy, Leeds, UK) is preassembled by the manufacturer and seems to overcome several of the concerns relating to the intra-operative assembly including chipping on insertion and liner canting (Figure 4). This also allows for a 5 mm wall thickness such that a 46 mm cup can take a 36mm bearing. A drawback of the preassembled design is the inability to use screws to achieve stability and the increased difficulty to achieve primary stability compared to a thin titanium shell. The device is more like a metal resurfacing cup in this regard, but these have achieved satisfactory long term fixation. The development of thin walled acetabular cups have also allowed for larger femoral heads and sizes up to 48 mm are now available from at least two different manufacturers. The theoretical benefits of large diameters in THA (>36 mm) are improved range of
