TRANSPORT INFRASTRUCTURE PERFORMANCE AND MANAGEMENT IN THE SOUTH ISLAND OF NEW ZEALAND, DURING THE FIRST 100 DAYS FOLLOWING THE 2016 M_w 7.8 “KAIKŌURA” EARTHQUAKE

This paper presents the impacts on South Island transport infrastructure, and subsequent management through the emergency response and early recovery phases, during the first 100 days following the initial earthquake, and highlights lessons for transportation system resilience.

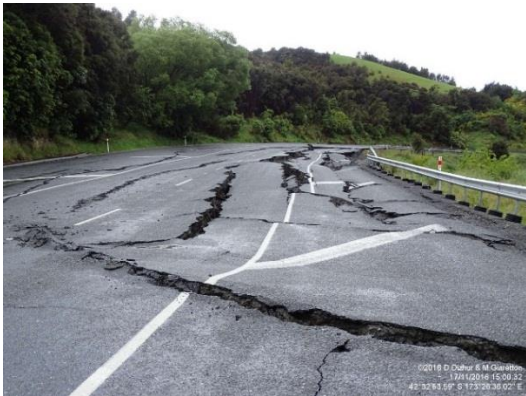
(a) Pavement cracking on SH1 due to slope instability. Photo credit: Dizhur & Giaretton

Ground movements caused severe road cracking due to slope failure beneath the carriageway (Figure 5a) and vertical and horizontal displacement due to fault rupture (Figure 5b), making the roading network impassable at a number of locations immediately after the event (Stirling et al. [2] provides an overview of fault rupture locations and impacts). Road damage due to slope instability beneath the carriageway was repaired in the first few days following the earthquake in all locations apart from those inaccessible due to other damage typologies. The earthquakes also increased the risk of co-seismic hazards. Co-seismic landslides (Figure 5c) and rockfalls (Figure 5d) closed the road in a number of places, and have presented one of the greatest challenges in repairing the road requiring a substantial amount of time and effort to clear. A more complete summary of landslides and their impacts is presented in Dellow et al. [4].

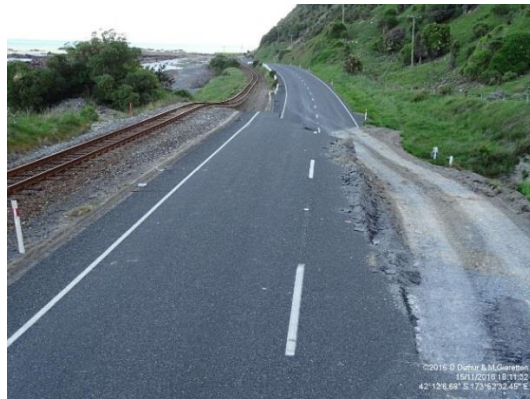
(b) Pavement rupture due to fault rupture and subsequent access ramp. Photo credit: Dizhur & Giaretton

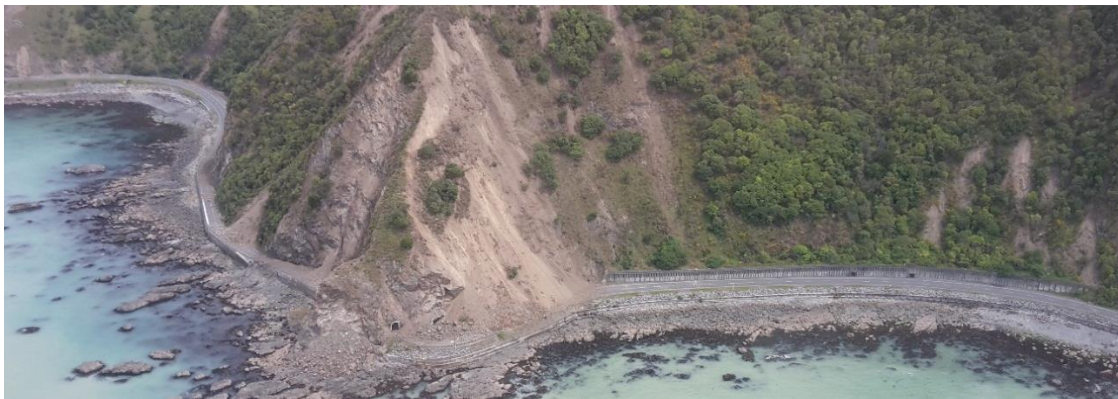
(c) Landslide on SH1, north of Kaikōura. Photo credit: Tonkin & Taylor

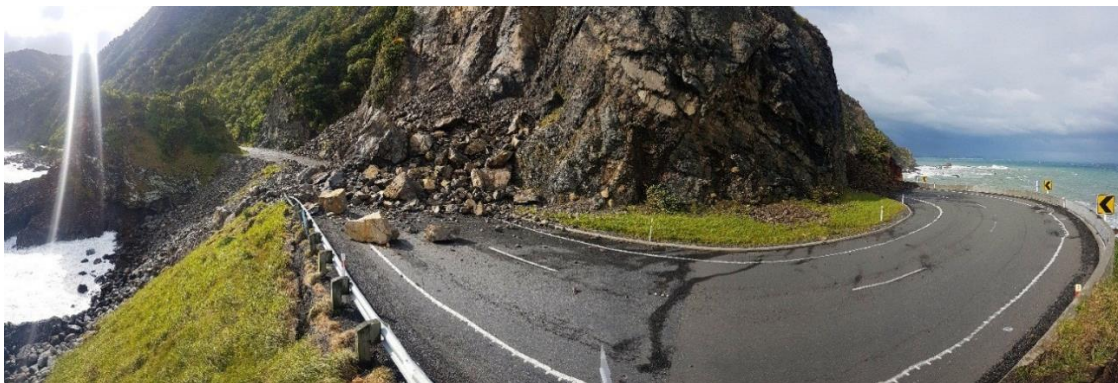
(d) Rockfall on SH1, north of Kaikōura. Photo credit: Dizhur & Giaretton

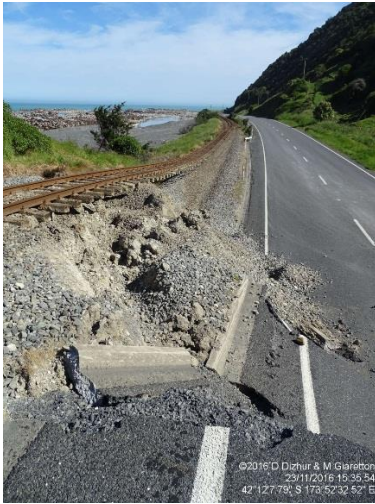
(a) Rail line suspended by fault rupture (angle 1). Photo credit: Dizhur & Giaretton

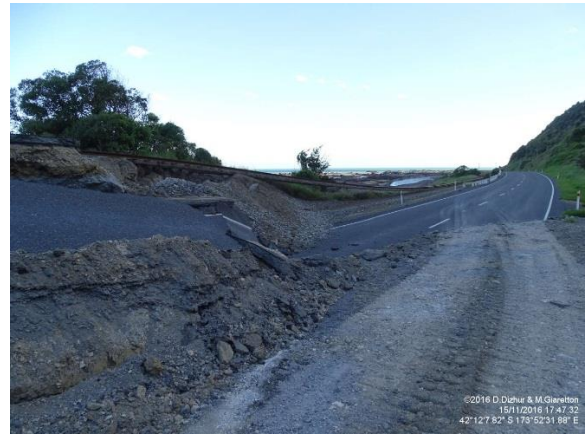
(b) Rail line suspended by fault rupture (angle 2). Photo credit: Dizhur & Giaretton

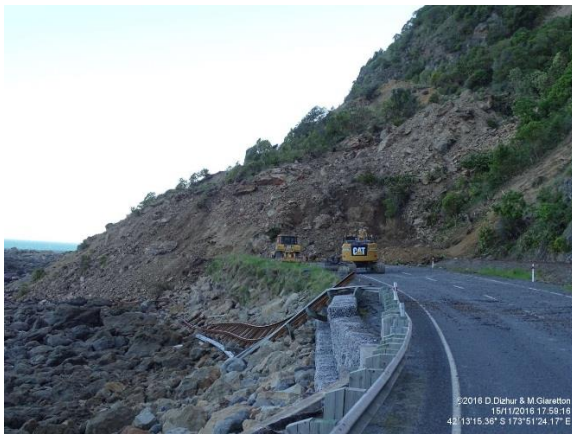
(c) Large offset of rail track due to landslide Photo credit: Dizhur & Giaretton

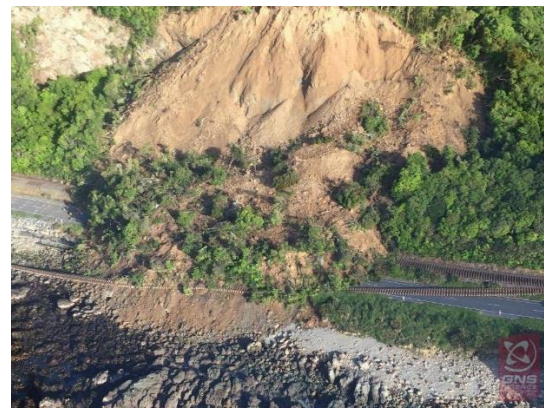
(d) Large offset of rail track due to landslide Photo credit: William Ries, GNS Science

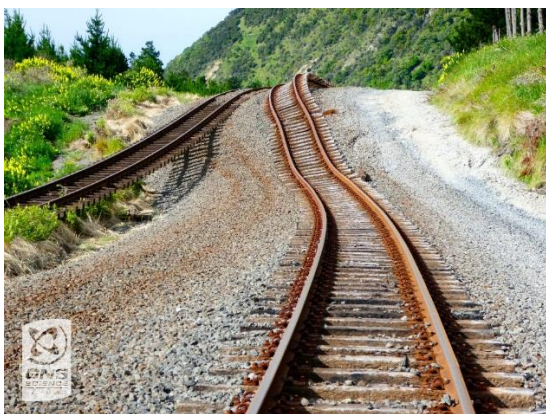
(e) Rail tracks severely distorted and misaligned due to fault rupture. Photo credit: William Ries, GNS Science

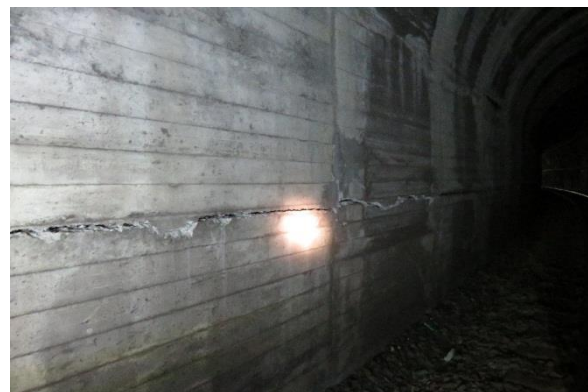
(f) Cracking of tunnel wall. Photo credit: KiwiRail.

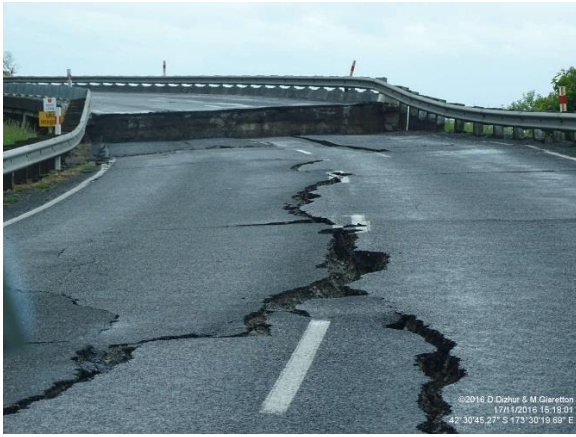
(a) Oaro bridge approach failure and pavement cracking. Photo credit: Dizhur & Giaretton

Although the bridge structures withstood the earthquakes well, demonstrating considerable robustness, many bridge approaches were damaged due to settlement and horizontal movement (Figure 8a), thereby making some bridges impassable. Approach reconstruction through the placement of fill and resealing quickly made the majority of these road bridges usable again. In some locations diversions were put in place to bypass damaged road bridges (such as the Oara Bridge in Figure 8a that crosses rail lines), and along Route 70 one bridge was replaced by a temporary Bailey bridge alongside the repair to other parts of the Route to allow for access. Displacement is a greater problem for rail lines than roads, whether vertical or horizontal (Figure 8e). However, given the damage to other parts of the rail network, this damage is not immediately critical, and repair can be scheduled accordingly.

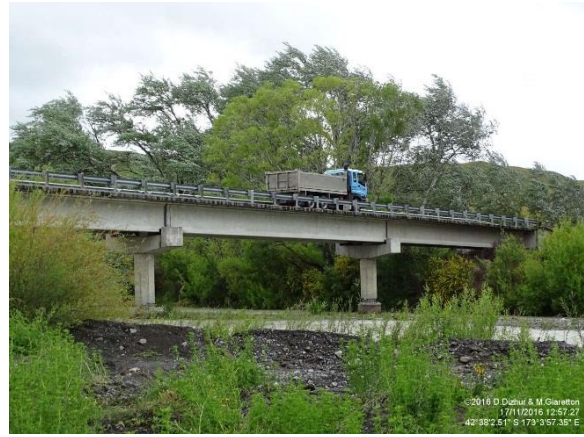
(b) Lower Mason bridge with damaged supports. Photo credit: Dizhur & Giaretton

The vast majority of bridges performed well during the earthquake, with most being allowed to re-open after inspection in the first few days after the earthquake. Some bridges with damage to their piers were cleared for use before repairs were completed (Figure 8b, Figure 8c, Figure 8d).

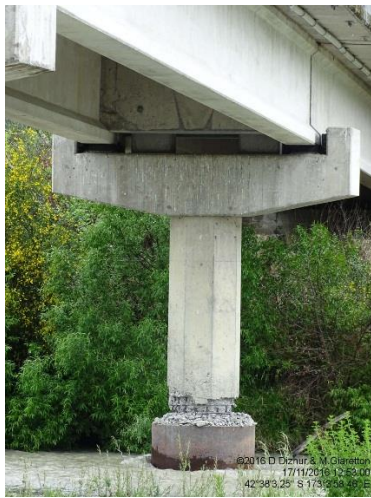
(c) Lower Mason bridge support damage. Photo credit: Dizhur & Giaretton

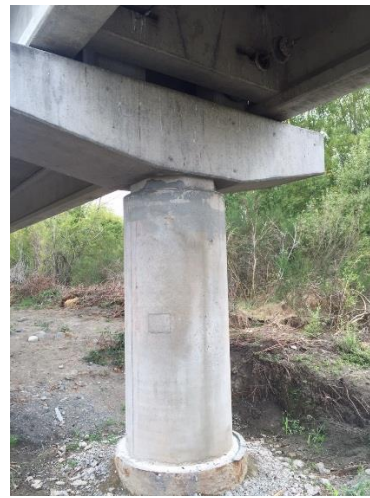
(d) Lower Mason bridge support repair. Photo credit: Liam Wotherspoon, UoA

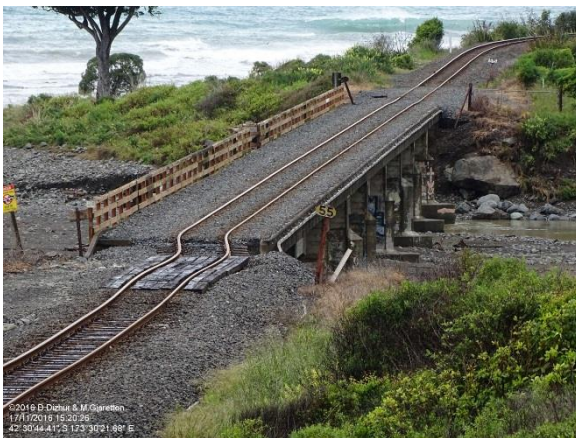
(e) Rail bridge 97 MNL approach offset and rail alignment failure. Photo credit: Dizhur & Giaretton

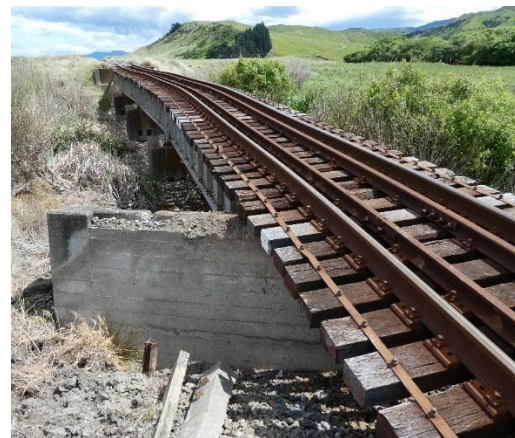
(f) Rail bridge 129 MNL span dislocated from abutment due to Kekerengu Fault rupture. Photo credit: Tim Little, VUW.

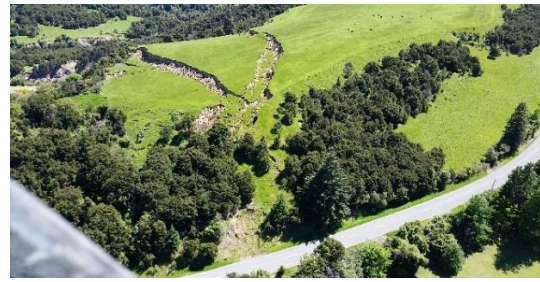
(a) Ruptured ground with increased landslide risk to the road. Photo credit: Aurecon, 2016

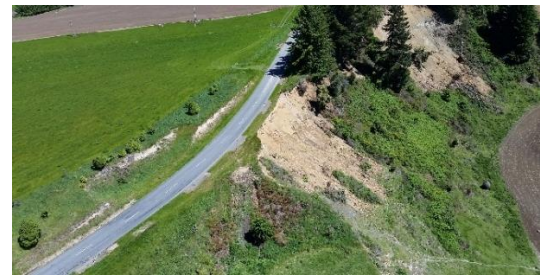
(b) Landslide undercutting road, slumping potential. Photo credit: Aurecon, 2016
