# New Technique for Removal of the Ulnar Intramedullary Nail Failed to Remove: Broken Assembly Piece in the Nail

Department of Orthopaedic Surgery, Konyang University College of Medicine, Daejeon, Korea

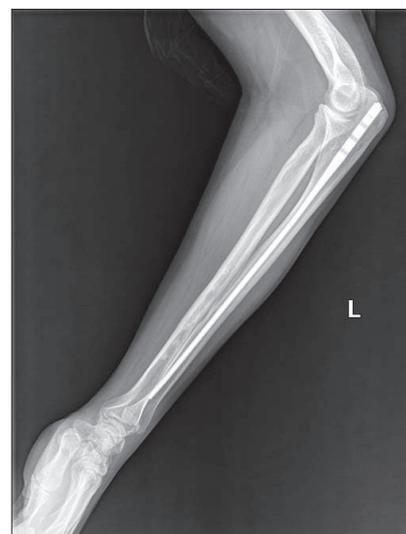
**Fig. 1.** Radiograph showing a broken particle of the assembly device in the proximal part of the intramedullary nail.

In February 2010, a 39-year-old man fractured both bones of the forearm after his arm was caught in a conveyor belt; he underwent a surgery at another hospital. An intramedullary forearm rod (Acumed, Hillsboro, OR, USA) was used in the ulna (Fig. 1). Nineteen months after surgery, an attempt was made to remove the implant; it failed be-

cause the threaded portion of the nail remover was broken while being connected to the nail (Fig. 1). Two years after the failed surgery, the patient visited us with complaints of occurrence of left elbow pain, without having any new trauma. A partial defect of the triceps tendon with severe pain and tenderness around the scar of nail insertion was

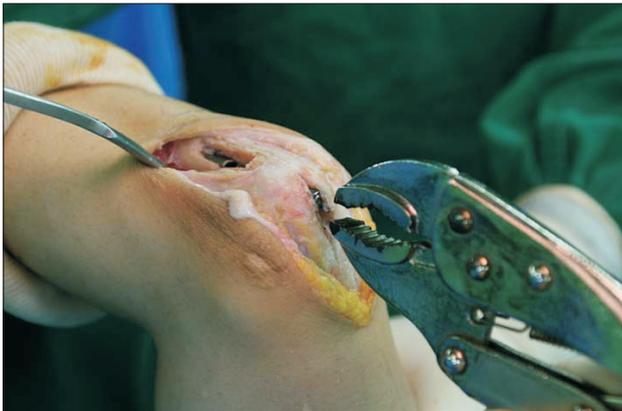
**Fig. 2.** A nail moved 1 inter-interlocking hole distance, but not enough to grip.

through the triceps brachii tendon. We gripped the end point of the nail by a vise grip and used a hammer to remove it; however, the proximal part of the nail was damaged, and the vise grip and nail were separated (Fig. 2). This issue occurred recurrently. Finally, we hit the distal most part of the interlocking hole, and moved the nail to a two inter-interlocking hole distance. Subsequently, we could hold the nail precisely using the vise grip (Fig. 3), and were successful in removing the nail. The bony window was repaired using the stored bony segment. We finished the operation after repairing the triceps brachii tendon and the skin. Based on the authors' experience, we propose a surgical technique that can easily remove the nail, and minimize size of the bony window and damage to the triceps brachii.

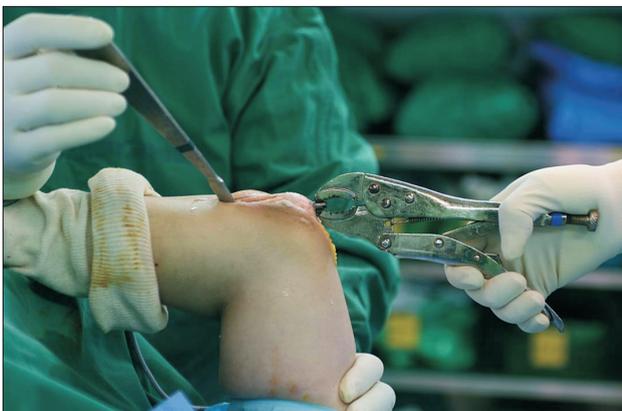
**Fig. 3.** A nail tip exposed enough to grip after being moved 2 inter-interlocking hole distance.

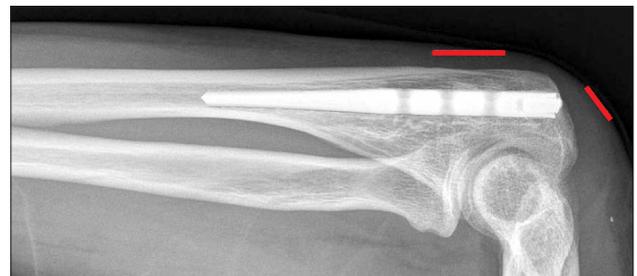
**Fig. 4.** A mimetic diagram. Red line indicates 2 skin incisions. (This is not real image, but schematic representation of the nail.)

We recommend 2 skin incisions to minimize the total incision length. The distal incision is approximately the size of 2 inter-interlocking holes, and the proximal incision is about 1 cm, big enough to pass the nail (Fig. 4).

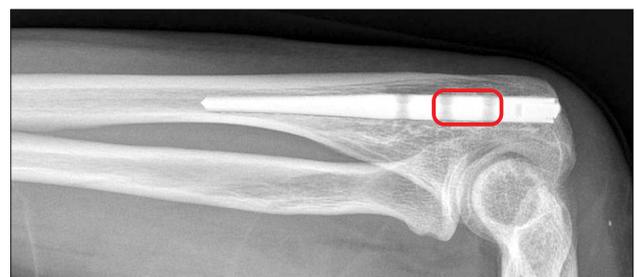
**Fig. 5.** Red rectangle means 1 inter-interlocking hole sized bony window. (This is not real image, but schematic representation of the nail.)

Only needs one inter-interlocking hole length of the bony window. It needs to be placed on the proximal 2 interlocking holes, and not on the distal hole (Fig. 5).

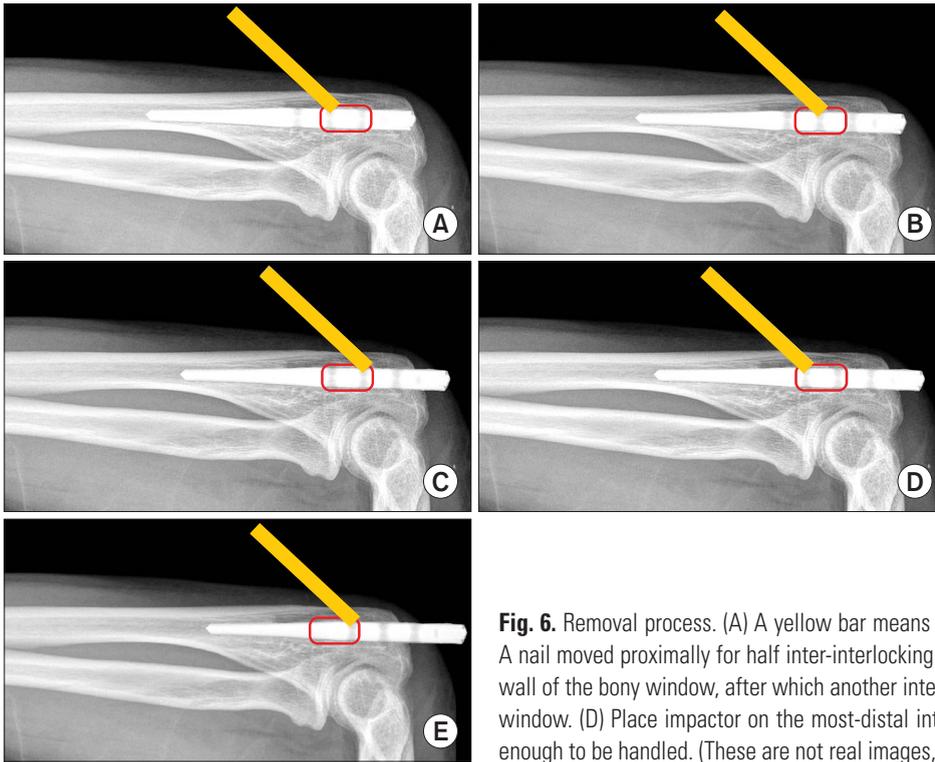
**Fig. 6.** Removal process. (A) A yellow bar means impactor on the central interlocking hole. (B) A nail moved proximally for half inter-interlocking hole length. (C) Impactor meets the proximal wall of the bony window, after which another interlocking hole appears at the distal part of the window. (D) Place impactor on the most-distal interlocking hole. (E) Final step: a nail exposed enough to be handled. (These are not real images, but schematic representations of the nail.)

In the bony window, an impactor is inserted on the distal hole, and tapped proximally by the mallet (Fig. 6A). When the hole is moved to proximal part of the bony window (Fig. 6B), a new interlocking screw hole appears in the distal part of the window (Fig. 6C). The impactor is then laid on the new distal interlocking hole and tapped again (Fig. 6D). In this process, the triceps brachii tendon can be carefully monitored, without being impacted by the nail in any way. The nail is then exposed enough to be gripped firmly (Figs. 3 and 6E). After the nail removal, the triceps brachii tendon is sutured and the bony window is covered, using the bone that was removed to make the window.
