Energy Saving Technology for Lowering Air Leakage of Sintering Pallets and Dust Collectors in Sinter Plant

Jia-Shyan Shiau¹, Tsung-Yen Huang¹, Shih-Hsien Liu¹, Chia-Ming Hsieh² and Po-Yi Yeh²

2. Iron Making Department, China Steel Corporation, Chung Kang Rd., Hsiao Kang, Kaohsiung 81233, Taiwan

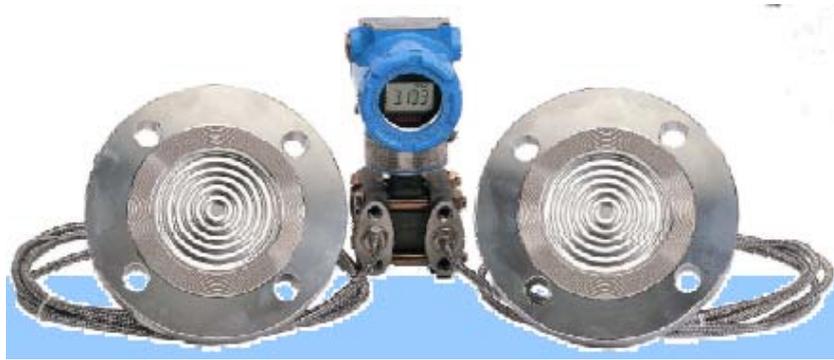
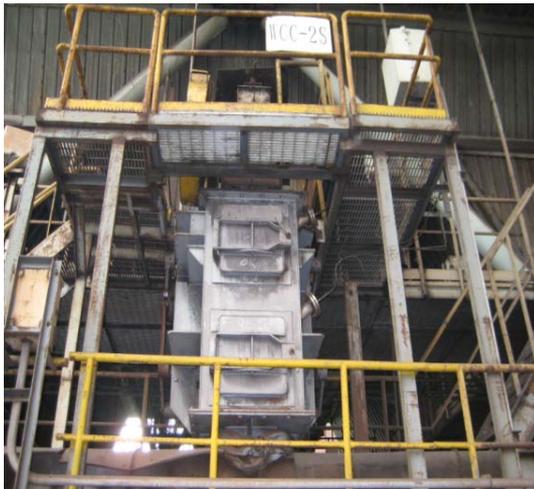
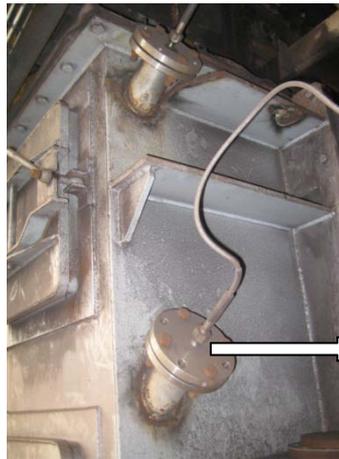
(a) Capillary type of differential pressure gauge

(b) DCV

(c) Installing differential pressure gauge on the DCV

Fig. 3 Installing of differential pressure gauge on the DCV below the EPs of SPs in CSC.

A capillary type of differential pressure gauge was installed on the DCV below the EPs of sinter plants. It was examined by identifying the pressure pattern to detect air leakage inside discharging valve and the stability of the device during the periodic operation of DCV. The sensor of differential pressure gauge was mounted directly external to the pressure source to measure pressure variation (input), then the digital signals (output) was transmitted to microcomputer by the capillary. The main advantage was that no dust clogged the pipe conveying the pressure signal to general pressure transmitter. However, if a large amount of dusts or pollutants appeared in the pressure source, the sensor may be polluted and worsen the measurement accuracy. Therefore, the franges (embedded sensors) were used to connect to DCV in 45-degree angle down for reducing dust pollution, as shown in Fig. 3.

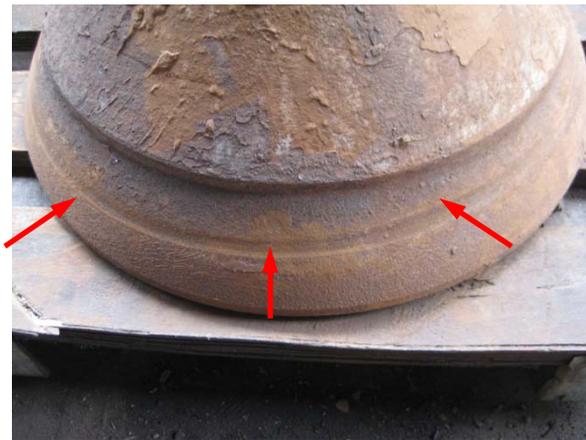
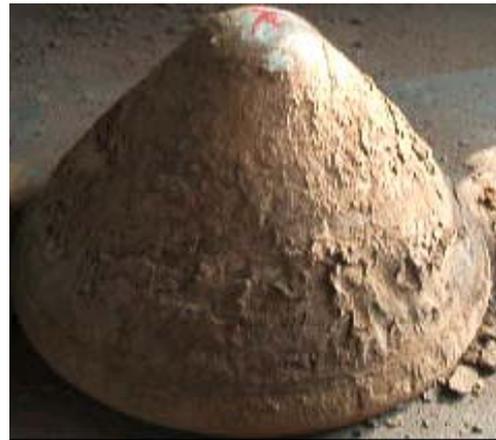
(a) Mechanical abrasion

(b) Dust accumulation

Fig. 16 Observations after removing DCV.

In order to understand what factors contribute to air leakage inside DCV, the DCV was removed to observe the surface of the cones when the pattern of

differential pressure was appearing like the curve (11/25). Two cases can be found between the cone and its above contact ring, that is, mechanical abrasion or dust accumulation as Fig. 16. The main mechanism for air leakage was further investigated, the removed DCV (which was not cleaned) was reinstalled, then the water leakage was observed by pouring water from the top of DCV. Similarly, the case of cleaned DCV was also tested. The results displayed that both cases were obvious water leakage as Fig. 17, however, the latter case was more serious. It can be deduced that the main factor causing air leakage is the gap between the metal cone and metal ring due to the mechanical abrasion.

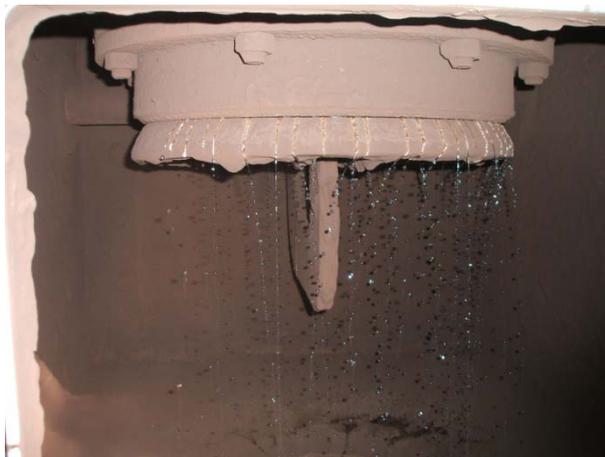
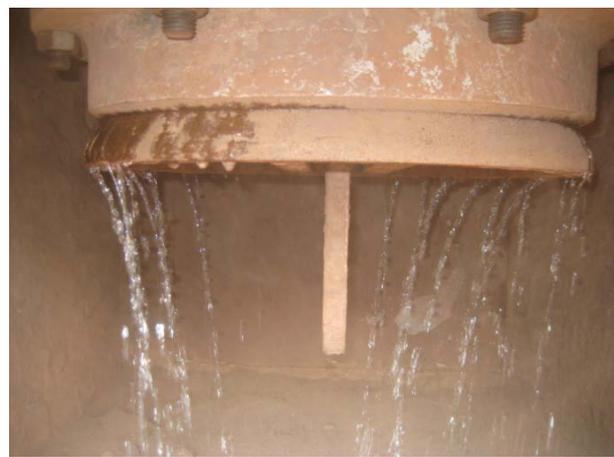
(a) Removed DCV is not cleaned

(b) Removed DCV is cleaned

Fig. 17 Observation of water leakage by adding water from the top of DCV.
