# Abiotic Determinants of the Historical Buildings Biodeterioration in the Former Auschwitz II – Birkenau Concentration and Extermination Camp

The paper presents the results of a study conducted at the Auschwitz-Birkenau State Museum in Oświęcim on the occurrence of biodeterioration. Visual assessment of the buildings revealed signs of deterioration of the buildings in the form of dampness, bulging and crumbling plaster, and wood fiber splitting. The external surfaces, and especially the concrete strips and ground immediately adjoining the buildings, were colonized by bryophytes, lichens, and algae. These organisms developed most intensively close to the ground on the northern sides of the buildings. Inside the buildings, molds and bacteria were not found to develop actively, while algae and wood-decaying fungi occurred locally. The factors conducive to biological corrosion in the studied buildings were excessive dampness of structural partitions close to the ground and a relative air humidity of above 70%, which was connected to ineffective moisture insulation. The influence of temperature was smaller, as it mostly affected the quantitative composition of the microorganisms and t

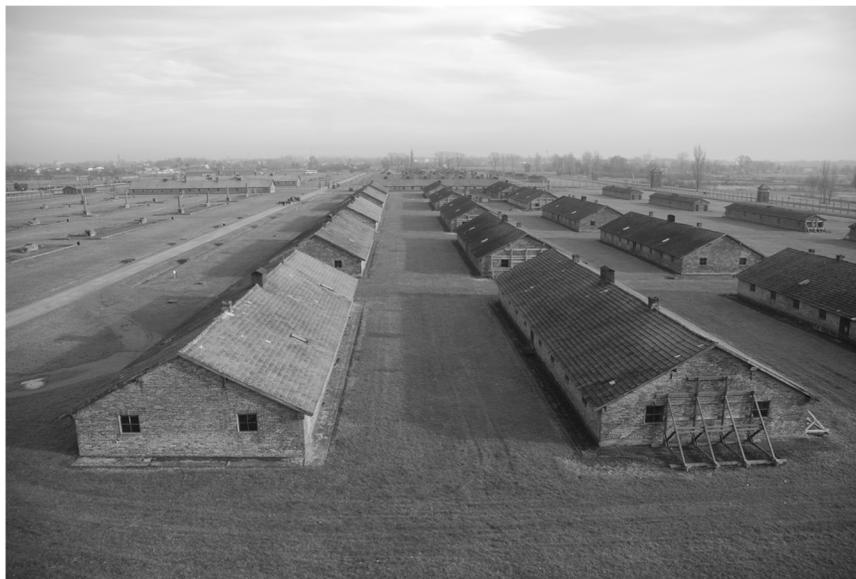
**Figure 1. Brick barracks in section BI (photo by Ł. Szoblik).**  
doi:10.1371/journal.pone.0109402.g001

The study involved 6 barracks (no. B-70, B-66, B-113, B-114, B-124, and B-138) located in sections BIa and BIb. The studied barracks were selected among all the buildings in this area based on macroscopic assessment of the level of deterioration. The studied buildings were residential brick barracks, with entrances from the north, closed to visitors. The studied area and a diagram of a typical building are presented in Figs. 1 and 2.

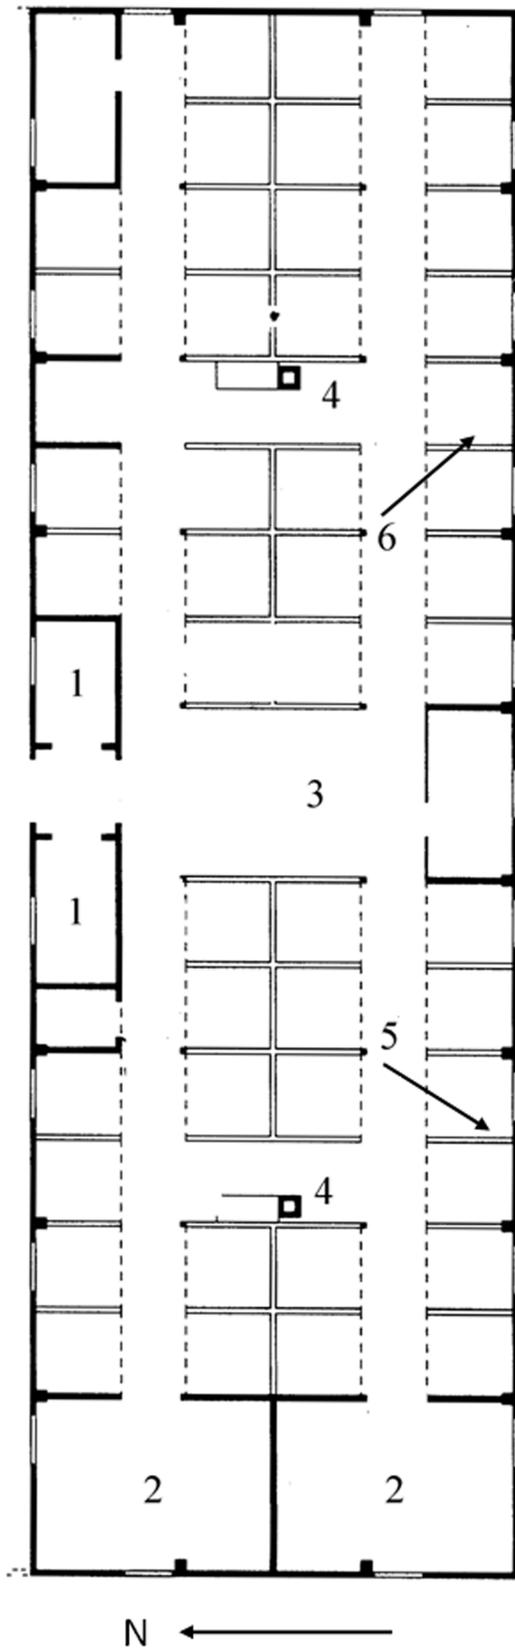
**Figure 2. A diagram of the barracks: 1-block master's room and storeroom; 2-washroom, 3-middle part of building; 4-stove; 5-bunk bed partitions; 6-bunk beds.**  
doi:10.1371/journal.pone.0109402.g002

Samples for microbiological tests were collected from the interior of the buildings, including both mineral materials (plaster, bricks) and wood (bunk bed planks, door frames, floors). A total of 39 samples were collected. Samples for microbial analysis were taken from the following sites inside buildings: block master's room and storeroom, washroom, and the main part of building, and included mineral materials such as plaster and brick from construction walls, bunk bed partitions and floors, as well wood from floors and bunk beds (Fig. 2).

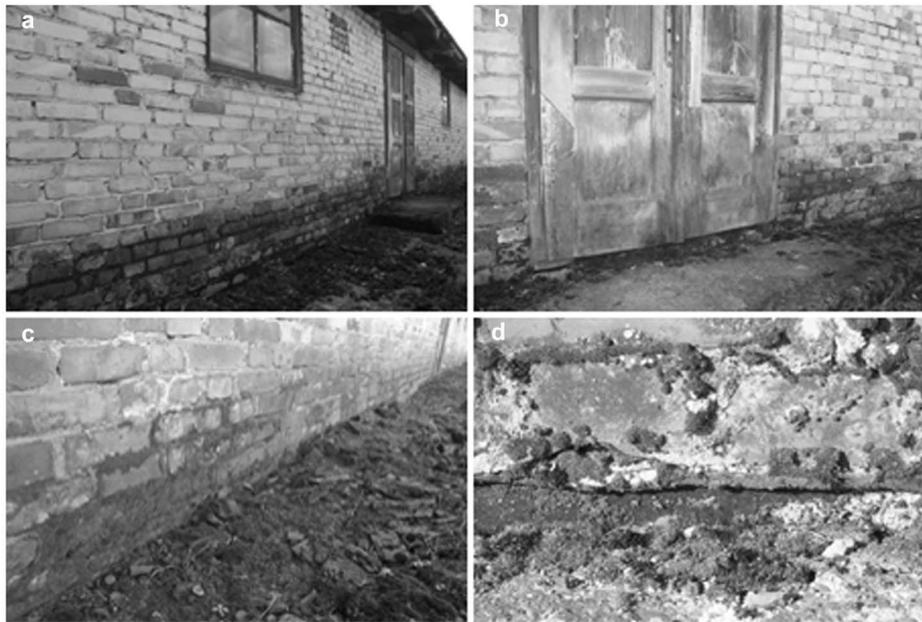
**Figure 3. Biodeterioration symptoms of external part of buildings (numerical value of deterioration in a 4-point scale).** a) capillary rise of groundwater; area adjacent to the building covered by concrete rubble mixed with soil (3– intensive changes); b) door colonized by algae and cyanobacteria, mosses and lichens on the ground (2– moderate changes); c) concrete rubble mixed with soil, colonization by algae and mosses (3– intensive changes); d) colonization by lichens and mosses, horizontal moisture insulation damaged (3– intensive changes). doi:10.1371/journal.pone.0109402.g003

encompassed by concrete strips, but they were cracked with many holes. The ground surrounding the other barracks was covered by brick and concrete rubble mixed with soil (Fig. 3a, c). In the area immediately adjacent to the buildings, especially on their northern side, large lichen and bryophyte populations were found, which spread onto the walls to a height of approximately 1 m, and also invaded the roofs in isolated colonies (Fig. 3a, d). The area affected by these organisms diminished with distance from the ground. Locally on door and walls the colonization by algae and cyanobacteria were observed (Fig. 3b). Five buildings had some horizontal moisture insulation in the form of tar paper or membrane, but those materials were cracked, especially on the northern side. Despite this insulation, the northern walls of the buildings (B-113, B-114, B-124, and B-138) were damp up to 0.8 m as a result of capillary rise of groundwater (Fig. 3a).

The external parts of the buildings were colonized by bryophytes, lichens, and, to a lesser extent, algae (Fig. 3). They main genera found on mineral surfaces were *Bryum* (bryophytes), *Diadlesmis* and *Chlorella* (algae), *Chroococcus* (cyanobacteria) and *Lecanora* and *Protopermaliopsis* (lichens). A greater diversity of lichen species was found on mineral surfaces, which may result from the considerable variety of the chemical composition of such substrates (mortar, bricks, roof tiles, concrete rubble). Mineral substrates were colonized by 20 bryophyte species, the predominant genera being *Bryum* and *Barbula*, 25 lichen species, mostly of the genera *Lecanora*, *Caloplaca*, and *Lepraria*, as well as 9 species of algae and cyanobacteria. The growth of those

microorganisms presents a risk to the durability of the external structural elements of the buildings. As a result of metabolic processes, algae release lactic, oxalic, succinic, acetic, and pyruvic acids, which cause erosion and degradation of the substrates [3,36]. Biofilms containing algae developing on wooden surfaces lead to wood destruction, as algae accumulate in their cells water periodically available in their environment, thus increasing moisture in the area they cover.

Bryophytes colonizing the surfaces of structural elements damage them mechanically with their rhizoids. Moreover, they maintain elevated moisture of the substrate by accumulating water in their cells, which enables the development of other microorganisms. Lichens considerably accelerate the decomposition of substrates producing, both acidic and alkaline metabolites [37]. As lichens are poikilohydric organisms (capable of absorbing large amounts of water, thus increasing their weight and volume), they break up the surface layer of the substrate. Their rhizoids penetrate the cracks and absorb the chemical elements necessary for growth, thus causing chemical changes in the substrate, sustaining water in pores, and promoting mechanical erosion. Lichen mycobionts produce so-called lichen acids, which may form metal complexes with, e.g., silicates, bind the calcium contained in the substrate, and dissolve SiO<sub>2</sub> [4].

Preventive actions against the development and expansion of microorganisms should first of all include the removal of the technical causes of excessive dampness. To this end, it is advisable to carry out the necessary construction works and regulate the rivers to prevent future flooding of the studied area. However, in all such works, priority should be given to preserving the authenticity of the memorial site.

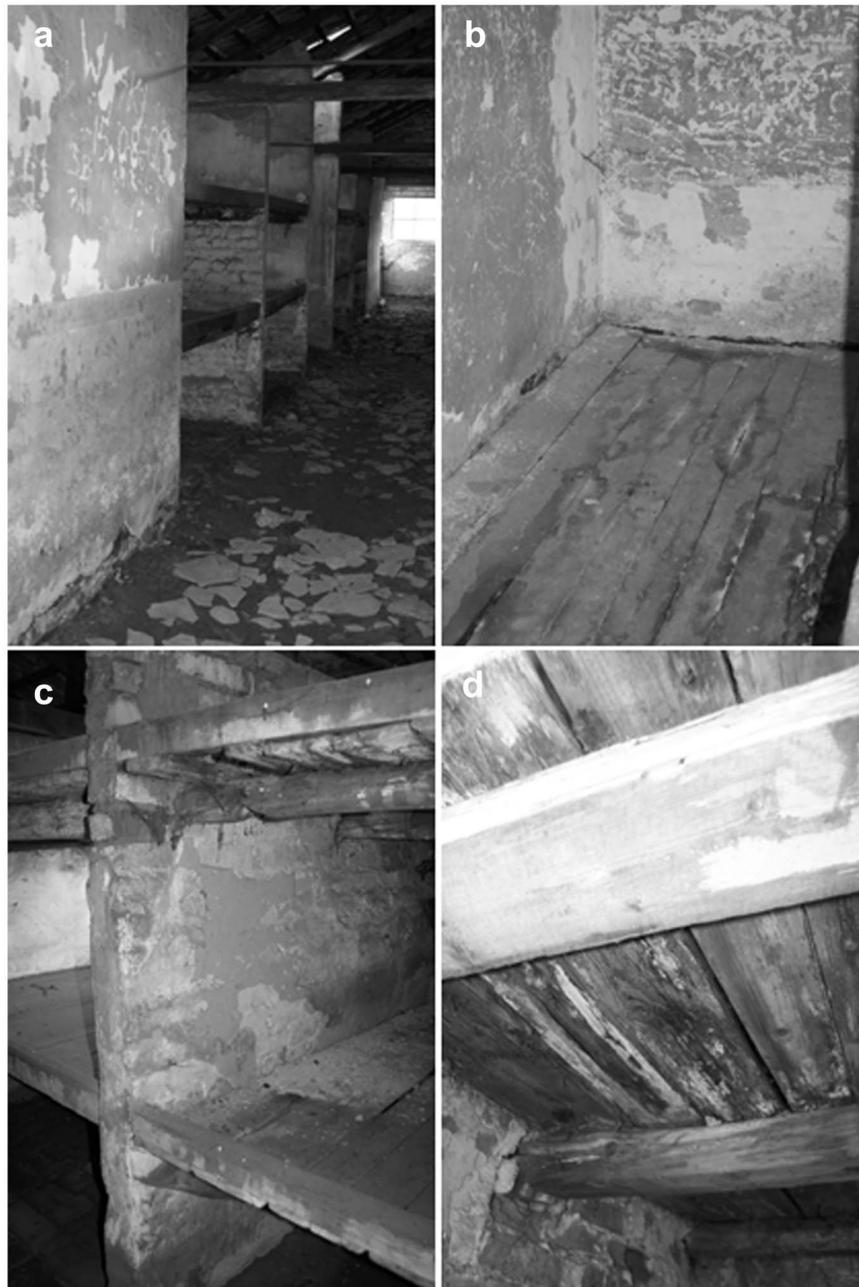
**Figure 4. Biodeterioration symptoms of internal part of buildings (numerical value of deterioration in a 4-point scale).** a) the middle part of building, damages of the floor (3– ground floor: intensive changes, 2– walls: moderate changes); b) block master’s room and storeroom, damages of the wood floor, algae and cyanobacteria colonization (3– ground floor: intensive changes, 1– walls: small changes); c) bunk bed partitions, bulging and crumbling plaster (3– intensive changes); d) damages of bunk beds board caused by wood-decaying fungi (2– moderate changes, locally).

Inside the brick buildings, bulging and crumbling plaster, peeling paint, crumbling bricks and concrete floor slabs, and wood fiber splitting in bunk beds and floors were observed (Table 1, Fig. 4a–c). On interior surfaces, no signs of microbial contamination typical of molds or bacteria (biofilms, discolorations) were found. However, the consequences of dampness were visible. Macroscopic effects of wall deterioration were noted in the area immediately adjacent to the floor and up to approximately 0.5 m. Algae populations inside the buildings most often developed on cracked concrete floor slabs, wooden structural elements, and on those bricks which formed the floors in the washrooms (especially

near the windows). In building B-70, some wood-decaying fungi were found on wooden bunk beds (Fig. 4a, d).

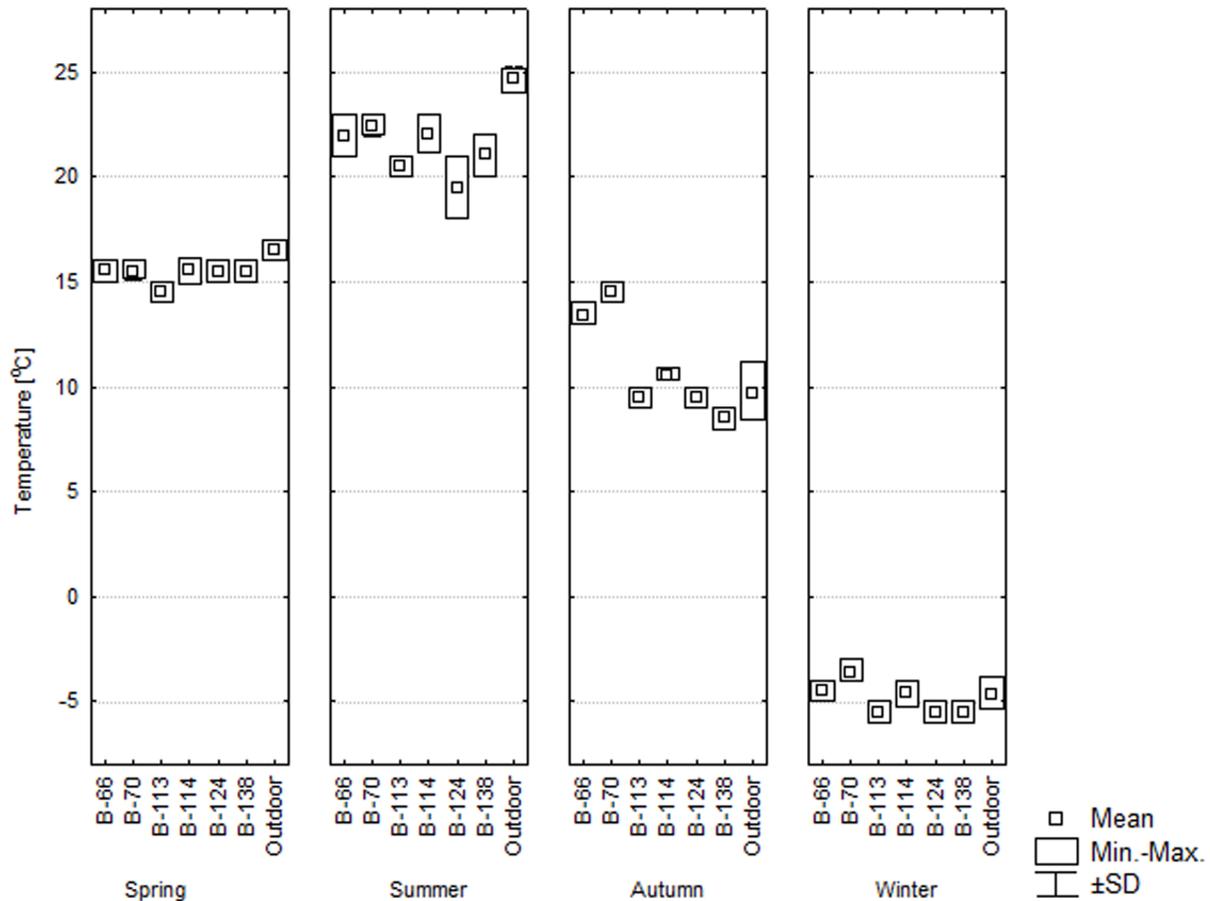
**Figure 5. Temperature inside the studied buildings [°C]; SD values did not exceed  $\pm 1.4^{\circ}\text{C}$ .**  
doi:10.1371/journal.pone.0109402.g005

Figs. 5 and 6 present the microclimatic parameters inside and outside the examined buildings. The mean air temperature inside the buildings was from 3.5 to 22.5°C, depending on the season. In the spring, it was similar to the outside temperature. Only in barrack B-113, it was lower by 1.9°C ( $p < 0.05$ ). During the Summer, the temperature inside all the buildings was by 2.5°C–5.4°C lower than outside ( $p < 0.05$ ). In the Autumn, the temperature inside two barracks (B-66 and B-70) was higher by about 5°C than outside ( $p < 0.05$ ), while the temperature in the other buildings was similar to the outside temperature. In the wintertime, temperatures below freezing point were found in all the buildings; in two buildings they were similar to the outside temperature, while in the others they were higher or lower by

approximately 2°C ( $p < 0.05$ ). The temperatures inside the buildings were rather stable as variation between different measurement points in a given building did not exceed 3°C.

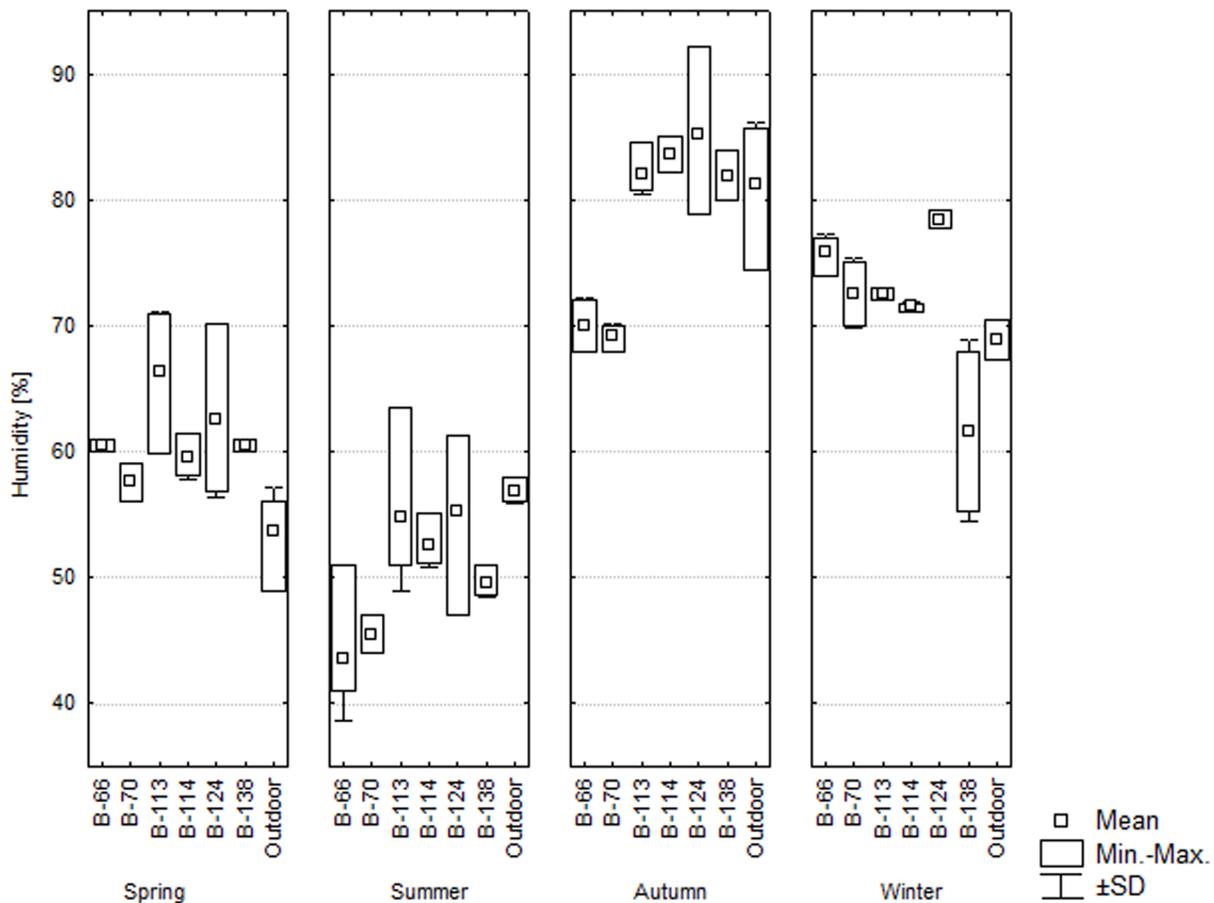
**Figure 6. Relative air humidity in the studied buildings [%].**  
doi:10.1371/journal.pone.0109402.g006

Throughout the year, relative air humidity in the barracks ranged from 42.8% in the summertime to 85.3% in the autumn. During the spring, RH levels were higher by 3.9%–12.3% inside all the barracks (except for B-70) than outside ( $p < 0.05$ ). In the summertime, RH levels ranged from 43.6% to 54.8% and were lower indoors than outdoors. In the autumn, relative humidity was the highest among the studied seasons, as it exceeded 80% and was similar inside and outside most buildings. Only in barracks B-66 and B-70, RH was considerably lower than outside (by approximately 10%,  $p < 0.05$ ). In the wintertime, relative humidity was higher by approximately 5% inside barracks B-66, B-113, B-114, and B-124 than outdoors ( $p < 0.05$ ). During the spring, summer, and autumn, RH differences between different places inside the barracks reached 14%, which may indicate variation in the dampness of building materials. It was found that locally, especially in the washrooms, relative humidity was very high and exceeded 90% (building B-124 in the autumn). Building B-124 was also characterized by the highest deterioration index (0.67). The humidity and temperature conditions in the studied barracks, especially in the autumn, are conducive to microbial growth [6,7,29,30]. In the wintertime, a relative humidity of more than 70% would also promote the development of microorganisms, but low temperatures considerably inhibit their activity. Such conditions, however, are favorable for psychrotrophs (cold-tolerant organisms).

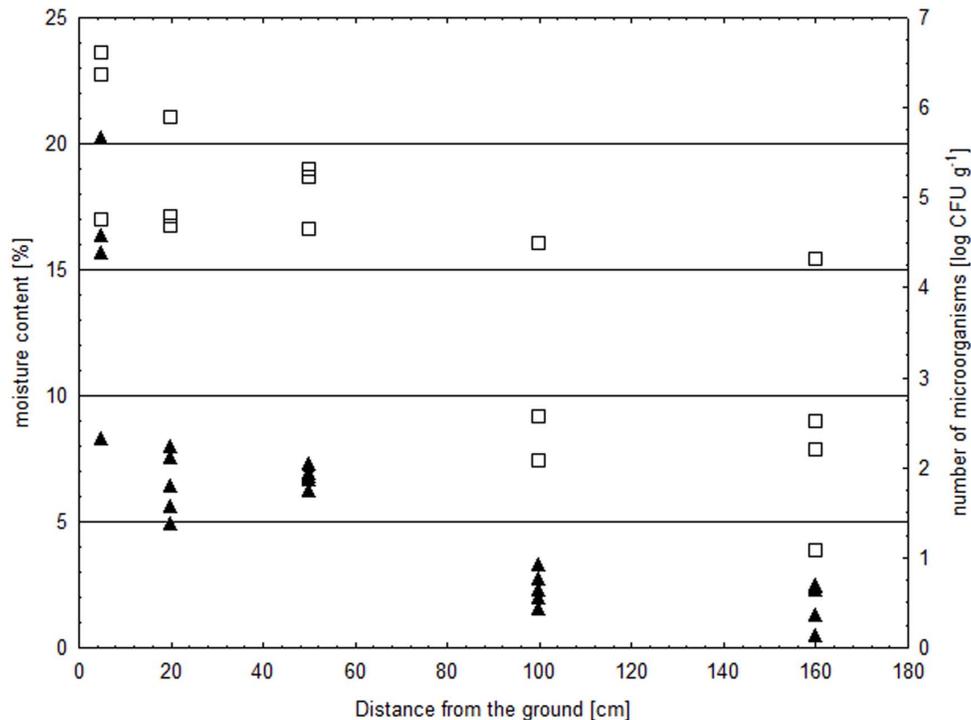
**Figure 7. Moisture content and microbial counts in mineral materials depending on distance from the ground: ▲ moisture content [%]; □ number of microorganisms [log CFU g<sup>-1</sup>].**  
doi:10.1371/journal.pone.0109402.g007

It was found that moisture content by mass decreased with distance from the ground (Fig. 7). Up to a height of 5 cm, moisture content amounted from 8.3% to 20.2%, which indicates that the walls were damp [6]. The brick collected from the washroom of barrack B-124 were characterized by both the highest moisture content (20.2%) and the microbial contamination was  $4.0 \times 10^6$  CFU g<sup>-1</sup>.

The samples of mineral materials collected from areas located 20 cm above ground were also most heavily contaminated with microorganisms (more than  $10^6$  CFU g<sup>-1</sup> of material). Moisture content in the higher parts of the walls, above 50 cm, did not exceed 3%, which may be considered acceptable [6], while the number of microorganisms was lower by 1.5 to 5 log units than that observed in areas located close to the ground. Moisture content in the wood from the floor of the block master's room and storeroom in barrack B-124 was from 23.4% to 71%, depending on the sampling site (data not presented). The dampest areas were affected by wood-decaying fungi.
