# Spontaneous Dissociation of Anatomic Medullary Locking A Plus (AML A Plus) Femoral Component at the Head-Neck Interface

**Case Report:** A 31 year old active male patient presented with spontaneous dissociation of the Anatomic Medullary Locking A Plus (AML A Plus) Femoral Component at head and neck interface 10 years after surgery. At revision surgery, wear of the acetabular liner and head and neck taper was noted. Definitive treatment required complete revision of the femoral component and change of acetabular liner.

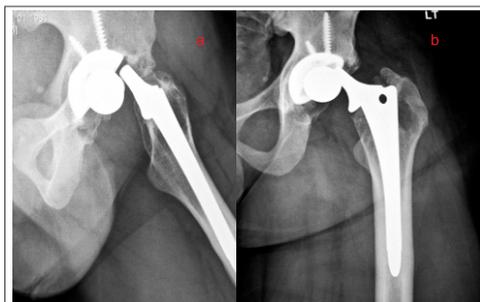
**Figure 1 a & b:** a and b: Radiographs of the left hip showing dissociation of the components at the head and neck interface without dislocation

In January 2012, at the age of 31 years, he presented with acute onset pain and inability to move left hip while he was turning in bed. Plain radiograph of the hip confirmed dissociation of the components at the head and neck taper junction without dislocation (Fig 1a and b). Due to anticipated difficulties in closed reduction, open reduction was performed. It was noted that there was wear of the acetabular liner and wear at the head and neck taper. Implants were reduced and patient was advised revision of total hip prosthesis.

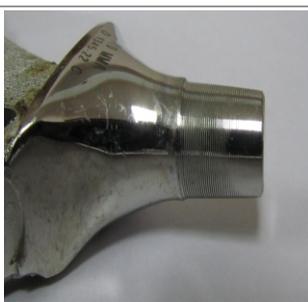
**Figure 2 :** Closeup of retrieved femoral component showing wear of the trunnion

As the facility for revision surgery was not available at our centre, he was referred to a higher centre for revision hip surgery. In April 2012, the revision surgery was performed using trochanteric osteotomy when it was noted that the acetabular shell and femoral stem were well fixed but there was failure of taper as seen by wear of the trunnion (Fig 2), which did not engage the femoral head taper, and there was wear of the acetabular liner (Fig. 3). Similar changes of wear were noted in the dissociated head component. No abnormal reaction or changes in the peri-prosthetic tissues were noted.

Intra-operatively, attempts at attaching the new femoral head component with 2 different trunion changes failed, hence the full coated femoral stem was removed using proximal femur split. Femoral component was revised in full and acetabular liner was changed as the shell was well fixed.

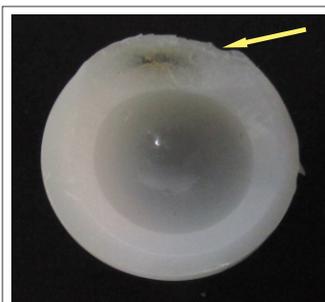
**Figure 3 :** Retrieved acetabular liner showing wear at the superior aspect (Solid arrow)

In the present case multiple risk factors for corrosion and dissociation can be recognized. At surgery wear of the polyethylene acetabular liner was noted together with corrosion at the taper. The patient was young with higher activity level thereby exposing the modular prosthesis to high mechanical loading and had his primary surgery done 10 years before the dissociation. Though it is difficult to confirm or refute, human error including, intra-operative factors like surface contamination, asymmetric fit of the head may have contributed to the corrosion at the head-neck interface.
