THE ENVIRONMENT EFFECT ON OPERATION OF IN-VESSEL MIRRORS FOR PLASMA DIAGNOSTICS IN FUSION DEVICES

V.S.Voitsenya*, Ch.Gil¹, V.G.Konovalov, A.Litnovsky², M.Lipa¹, M.Rubel³, A.Sagara⁴,
A.Sakasai⁵, B.Schunke¹, T.Sugie⁵, G. De Temmerman⁶, K.Yu.Vukolov⁷, S.N.Zvonkov⁷,
P.Wienhold²

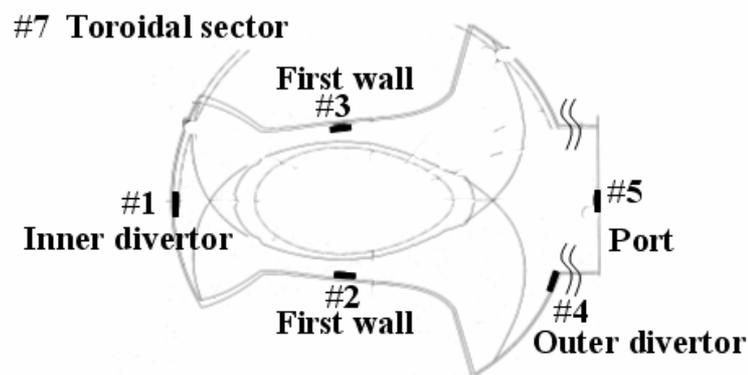
Fig. 1. The scheme of locations of SS mirror samples inside the LHD vessel.

Three SS mirrors with size 20x10x1 mm were mechanically polished, cleansed in an ultrasonic bath filled with acetone, and then the spectral reflectance at normal incidence was measured in the wavelength range 200-700 nm. The samples were installed inside the LHD vacuum vessel in locations indicated in Fig. 1 by numbers 1, 3, and 5: the sample #1 was positioned near the divertor region, #3 – close the plasma edge, and #5 – quite deeply in the diagnostic port in the same poloidal cross section and in the same plane as #1 (central plane). After samples were removed the reflectance was again measured in the same way, and the surface of samples were analyzed by several methods: Auger electron spectroscopy (AES), ion backscattering technique (RBS) using 1.5 MeV He⁺ ion beam, scanning electron microscopy (SEM), profilometry, and ellipsometry at the wavelength 632.8 nm. These data are presented in detail in [4].

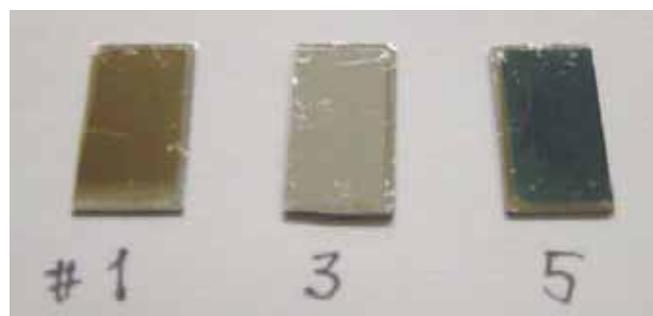
Fig. 2. The photos of samples after they were taken out of the LHD vacuum chamber.

The photos of Fig. 2 show how mirror samples looked just after finishing their exposure in LHD vacuum vessel. As a result of exposure in LHD the reflectance of all samples has changed from the identical initial level, Fig. 3.

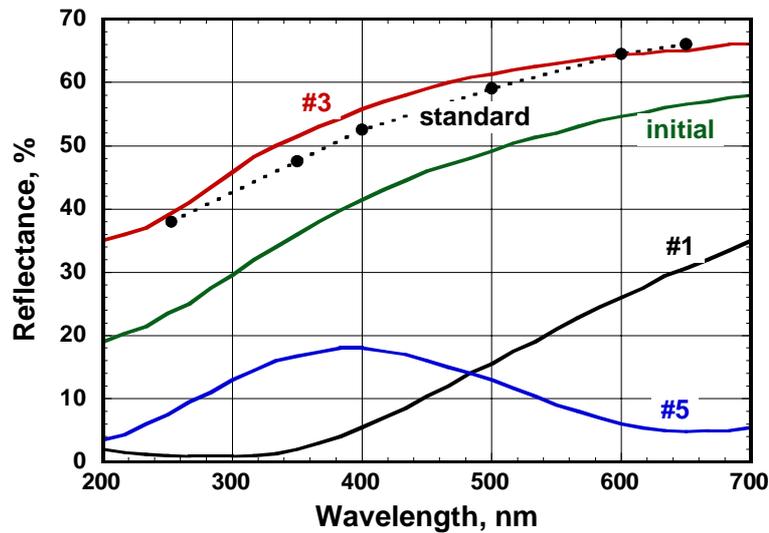
Fig. 3. Spectral reflectance of SS mirror samples before (marked as “initial”) and after exposure inside the LHD vessel (curves marked as #1, #3, and #5). Solid points show the typical spectral reflectance of a SS mirror subjected to cleaning by low temperature deuterium plasma after polishing and washing in an ultrasonic acetone bath.

The reflectance of mirrors #1 and #5 dropped strongly as a result of appearance of the contaminating films. From spectral dependence of reflectance one can conclude that the film on sample #5 is thicker than on the #1 sample. At the same time, the reflectance of sample #3 increased significantly and became close to what is usually observed when after rinsing in a

After rinsing in the ultrasonic bath the samples are cleaned by low temperature plasma of an ECH discharge in deuterium, as shown by solid points (the curve “standard”). This effect is connected with not full cleaning of all three mirrors before they were installed inside the LHD vessel from contamination by some organic film appeared due to rinsing samples in acetone. This initially existed film was fully cleaned from sample #3 due to plasma impact but became over coated by new films (to be immured) at samples #1 and #5. The high level of reflectance for mirror sample #3 measured after exposure samples in LHD was supported by very high quality of surface as follows from profilometry measurements (Fig. 4) and analysis of the SEM photos (not shown).

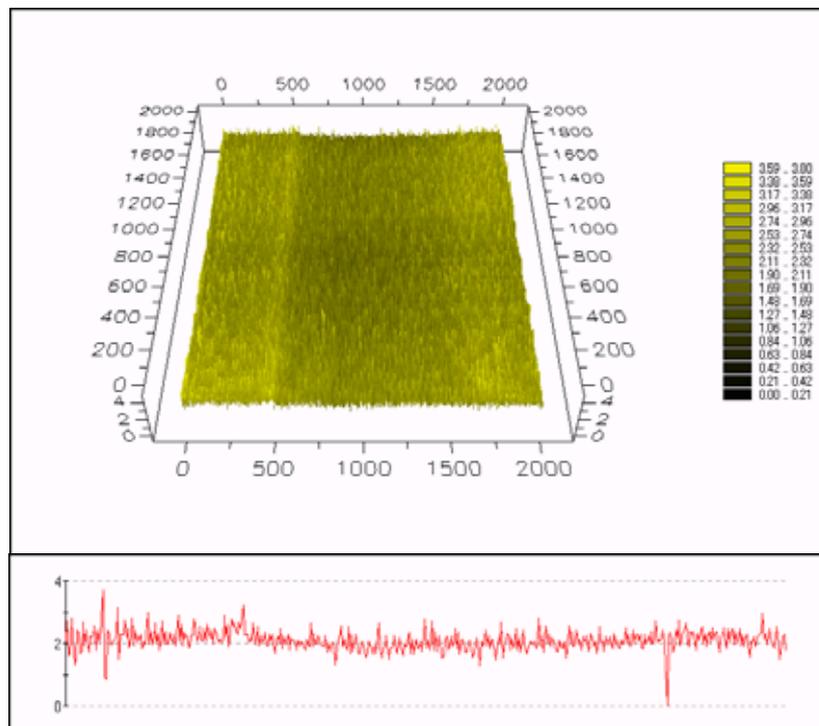
Fig. 4. Results of profilometry measurement of the surface morphology of the sample #3 after exposing in the LHD.

The mirror placed in the nearest location to the hot plasma became to be cleaner than it was initially. The full erosion of this sample found by measurement of the surface profile did not exceed $0.15\mu\text{m}$. Such small net erosion seems surprising if one takes into account the long time of glow discharge conditioning and large number of working discharges. Probably the balance between sputtering by CXA during working discharges and by plasma ions during conditioning, on the one side, and contaminant deposition, on the other side, was almost zero, only with minor preponderance of sputtering erosion over deposition.

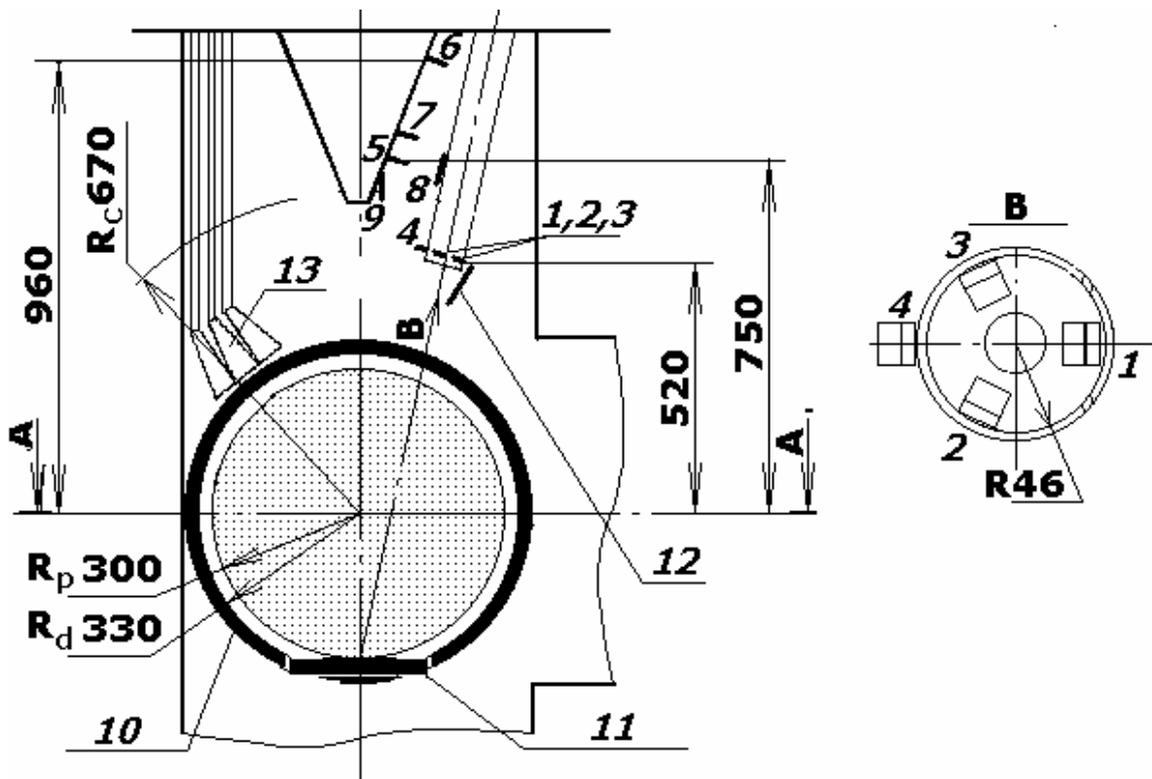
Fig. 5. The layout of experiments in T-10.

1-9 – mirrors (note, mirror #7 is in the shade of mirror #5), 10 - ring carbon based limiter, 11 - movable graphite limiter, 12 - shutter, 13 – ECRH antenna. Rc – radius of toroidal magnetic coils; Rp – plasma radius; Rd – radius of ring limiter.

Polished mirror samples of SS316 (10×10 mm² and 20×20 mm², 4 mm thick) were used for experiments. They were exposed in diagnostic port of limiter section of T-10 at different distances from plasma as shown in Fig. 5 [6].

Thin SS shield protected a part of each sample with ~ 0.1 mm gap between shield and mirror surface. Samples fixed in 1-3 positions were shutter-protected during vacuum vessel (VV) conditioning. The positions of mirrors 1-6 were frontal to plasma. Besides, in 2003 mirrors 8-9 were placed edgewise to plasma and one mirror located in frontal position, 7, was shadowed by sample 5.

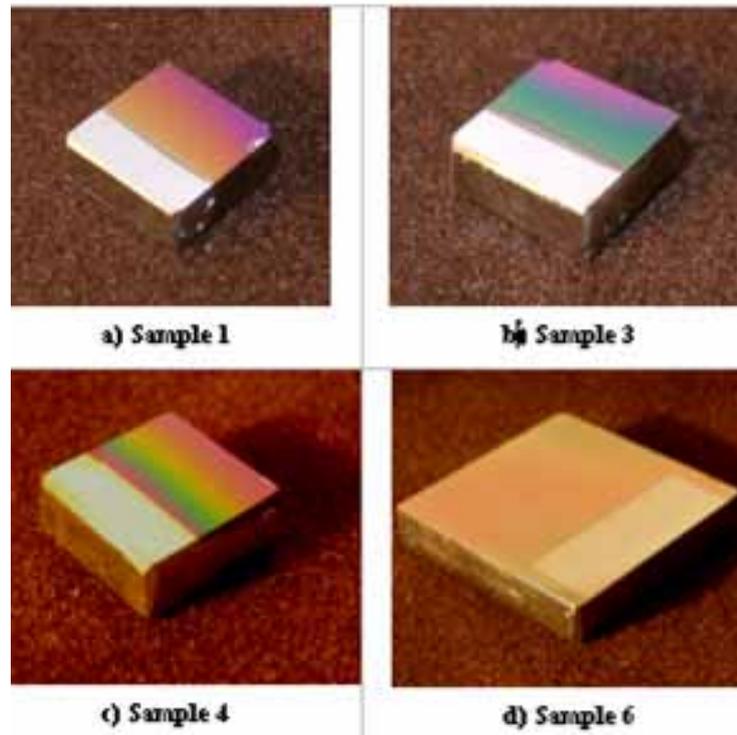
Fig. 6. Photos of samples after finishing the 2002 year campaign. Lighter parts of mirrors were closed during whole exposure time. The deposit has quite homogenous, fine-dispersed structure. On mirrors protected by shutter during conditioning it grew with the rate 0.2 nm/s in 2002 and 4 nm/s in 2003.

looked shining and smooth and the color of deposits varied from golden-crimson to violet-green. The screened parts of mirrors practically did not change by sight, Fig. 6. The deposits not only decrease the reflectance of mirrors but also distort the spectrum of reflected radiation because of interference phenomenon.

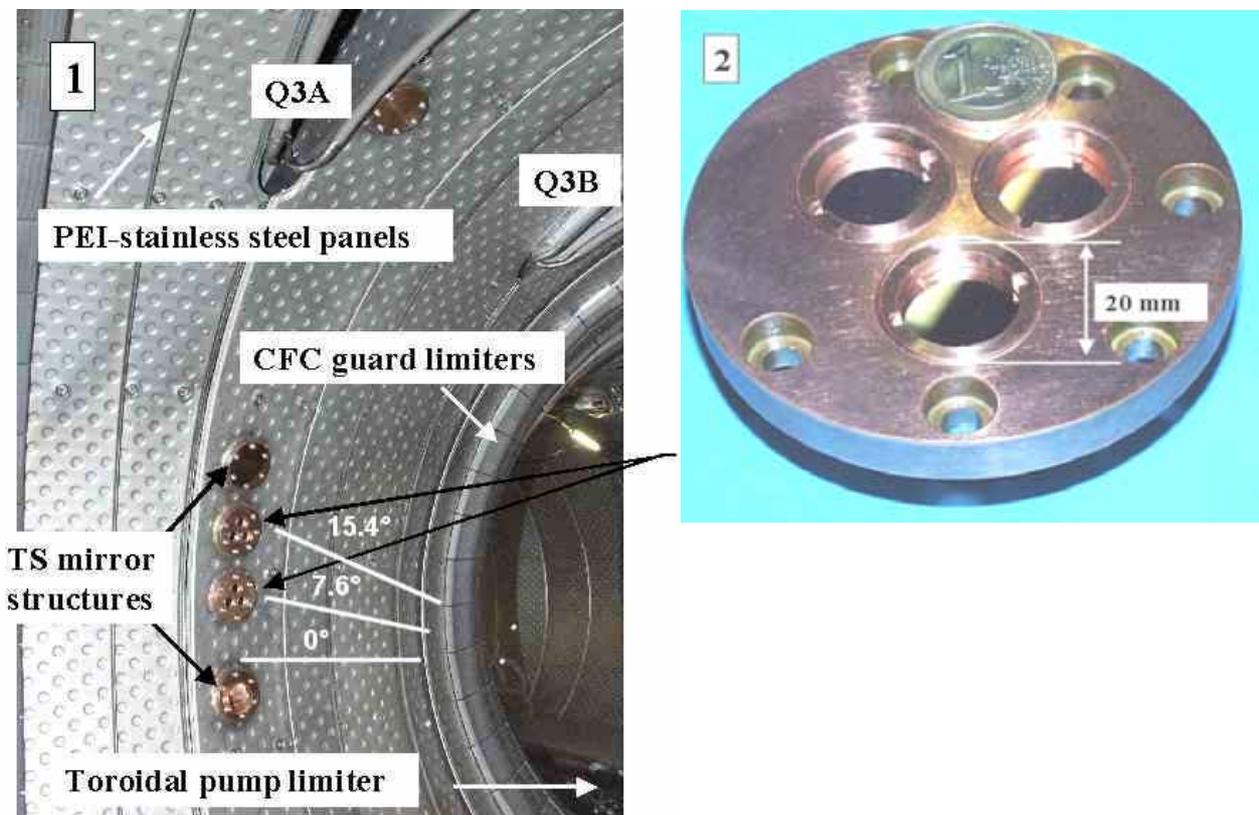
Fig. 7. Mo, SS and Cu mirror samples assembled in CuCrZr ring holders and fixed on Tore Supra vessel wall at high field side.

The mirror samples of 22 mm diameter and 4 mm thickness have been installed on the high field side of the TS plasma vessel. They were located at $\theta = 7.5^\circ$ and 15° out of the equatorial plane (Fig. 7) and positioned roughly 140 mm from the LCFS. The reflecting surface of all mirrors were oriented parallel (not inclined) to the toroidal field direction. The mirror assembly allowed contact cooling via the first wall steel panels. 2D- thermohydraulic finite element calculations of the mirror sample assembly showed temperatures not exceeding $\sim 150^\circ\text{C}$ for a typical “Gigajoule” operation scenario (~ 1 MW radiated plasma power loss during 36 s of pulse length).

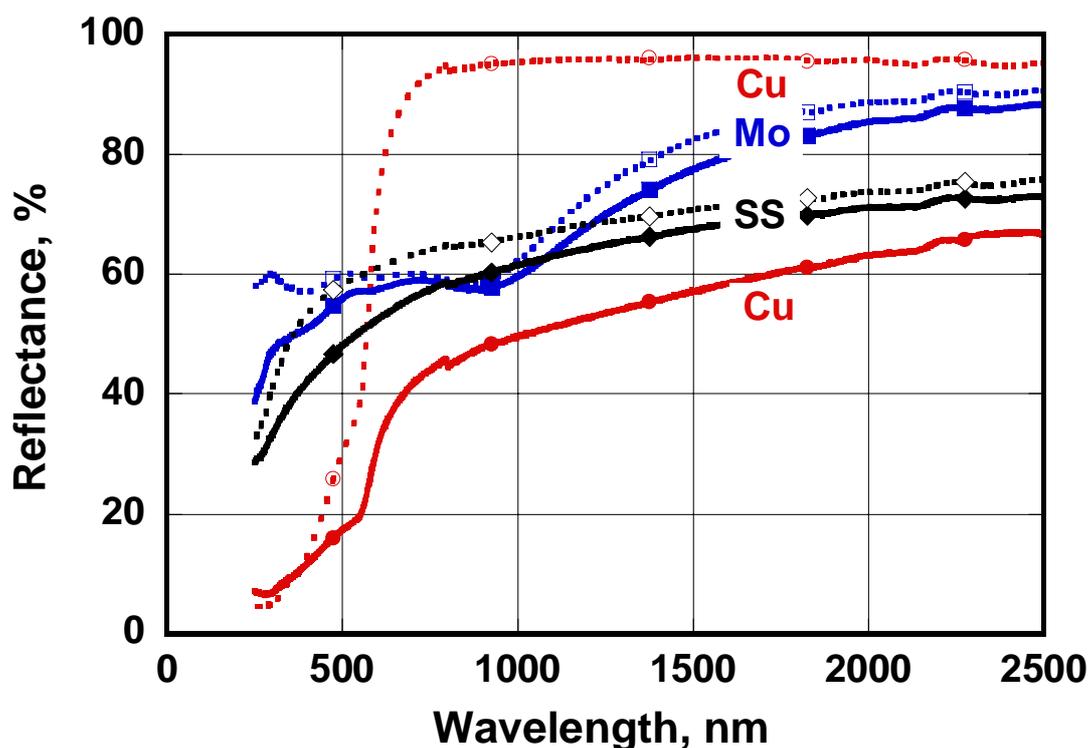
Fig. 8. Reflectance of mirror samples before (dotted lines) and after (solid lines) exposure inside Tore Supra.

Total and diffusive reflectance values were measured before and after exposure in the Tore Supra tokamak by means of a spectrophotometer ($\lambda=250-2500$ nm) and significant change of reflectance was observed for all samples, but especially for Cu, as Fig. 8 shows. From measurements by con-focal microscopy the surface roughness of the Cu mirror samples after exposure increased by factor 7 and a net erosion profile depth amounted $\sim 2.8 \mu\text{m}$, while the surface roughness of the sc Mo samples did not change with a net erosion profile depth only $\sim 0.12 \mu\text{m}$.

It was found that all exposed mirror samples became not only eroded but also coated with some deposited layers what is the main reason for change of the total reflectance.

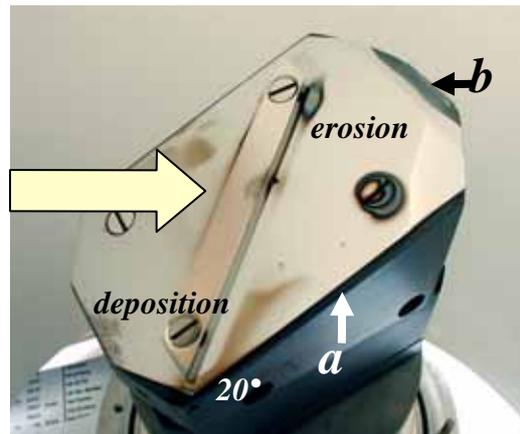
Fig. 9. Photograph of the mirror holder after exposure in the erosion dominated zone. The large mirror (a) is mounted 20° inclined on the graphite carrier, the small mirror (b) on the rear side perpendicular to the toroidal direction.

Polycrystalline mirrors from molybdenum were placed in the SOL plasma of TEXTOR [10]. The photograph in Fig. 9 shows the experimental set-up and the appearance of mirrors after exposure. One large mirror (115mm x 74mm) was fixed inclined at 20° to the toroidal fluxes. The mirror was partly protected by an aluminium bar which created a shadow. Outside the shadow some deposition becomes visible. One small mirror was placed for comparison at the rear side of the holder perpendicular to the toroidal direction. All mirrors were polished mechanically and had optically been pre-characterized.

In the first experiment the edge of the mirror closest to the plasma was kept at a distance of 8 mm from the LCFS (plasma radius 46 cm) which is an erosion dominated zone in TEXTOR. It was exposed to 30 neutral beam heated (increasing from zero up to 1.3 MW) plasma pulses (line averaged density $n_e = 1.5 \times 10^{19} \text{ m}^{-3}$) with a total exposure time of 197 s. These conditions caused strong temperature rises (>1000°C for $\approx 3\text{s}$) of the edge of the small mirror. The temperature of the large mirror measured by a pyrometer rose to 400-750 °C during the discharges. For the second experiment the closest edge of the mirrors to the plasma were placed at LCFS+25mm to cover primarily the deposition dominated zone. They were exposed to 58 (partially neutral beam heated) discharges with varying plasma density ($n_e = 1.5$ to $4.5 \times 10^{19} \text{ m}^{-3}$) and a total exposure time of 312 s. The bulk temperature achieved 150°C, local temperature rises have not been observed. Carbon deposition up to thicknesses of more than 200 nm took place except in

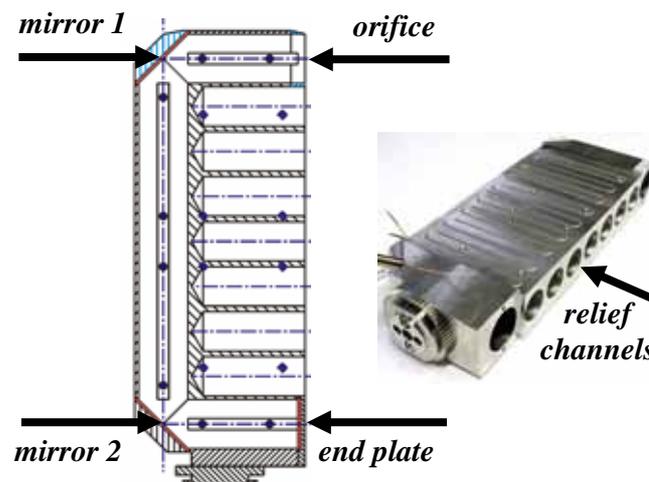
Fig. 10. Periscope system with mirror 1 (closest to the plasma), mirror 2 and the end plate. The tubes (35mm) are wrapped inside with exchangeable steel foils fixed at the wall by bars. The photograph shows the stainless steel body without end plate. Relief channels reduce weight.

The set-up of a periscope-like system on TEXTOR simulates the ITER diagnostic ports transmitting the plasma radiation to further distant sensors. Two plane mirrors were installed in tubes facing each other at a distance of 275 mm. The mirrors are oriented 45° with respect to the line of sight. The orifice (35 mm diameter) is oriented perpendicular to the toroidal direction.

The second end was closed with a polished end plate as is shown in Fig. 10. The SOL fluxes hit the first mirror under 45°. Carbon transport inside and deposition can be investigated after dismantling of the system. The deposition patterns on exchangeable steel foils wrapped inside the tubes complete this information. The stainless steel body can be heated up to about 500°C. Mirrors made from TZM (99% Mo, 0.1% Zr, 0.5% Ti) were used for the pilot experiment. The edge closest to the plasma was kept at 25 mm from the LCFS and the system exposed to 89 (partly neutral beam heated) plasma pulses ($n_e = 1.5$ to $4.5 \times 10^{19} \text{ m}^{-3}$) with a total plasma exposure time of 1047 s. The temperature was 150 °C.

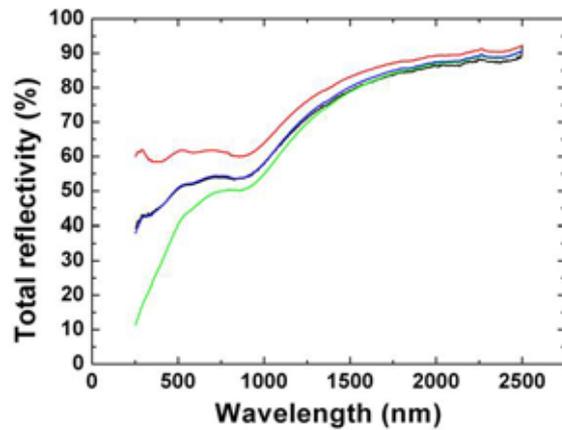
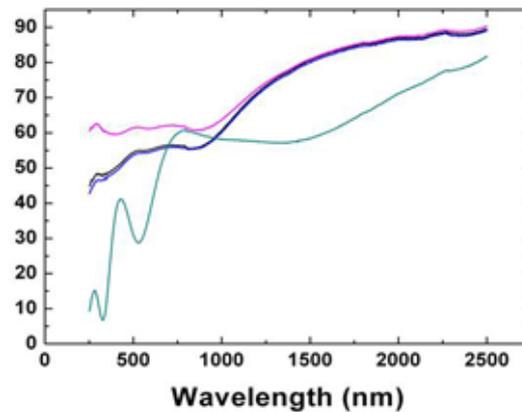
Fig. 11. Total reflectivity R_{tot} depending on wavelength measured on the molybdenum mirrors before and after exposure in a protected area (1) and after exposure in the deposition (2) and erosion (3) area. The mirrors (a) were exposed for 197 s in the erosion dominated zone (edge at LCFS+8mm) and (b) and for 312 s in the deposition dominated zone (edge at LCFS+25mm).

space resolution of ≈ 10 mm. Fig.11 shows examples for the wavelength dependence of the total reflectivity R_{tot} found on the two large mirrors. The central curves (1) represent the total reflectivity measured before and after plasma exposure at a location protected by the aluminum bar. The lines stay below the values given for polycrystalline molybdenum in literature [11]. As soon as deposition begins (curve 2 in Fig.11a) the reflectivity decreases by absorption in the film (thickness ≈ 30 nm). The drop is most pronounced in the UV region and levels off in the IR. In addition to absorption, the reflectivity can be distorted significantly due to destructive and constructive interference in thicker deposits. The example (curve 2, Fig. 11b) was measured on the mirror plate exposed deeper into the SOL (LCFS+25mm) where carbon deposition dominates and a film up to about 220 nm thickness was formed.

Surprisingly, an increase of R_{tot} was measured on surface areas which suffered from net erosion (curves 3). The increases are similar, independent whether the target mirror was exposed near the plasma edge (Fig. 11a) or deeper into the SOL (Fig. 11b). This increase is most pronounced ($\Delta R_{\text{tot}} \approx 10\text{-}20\%$) for short wavelengths and almost vanishes (1-3%) beyond about 1500 nm.

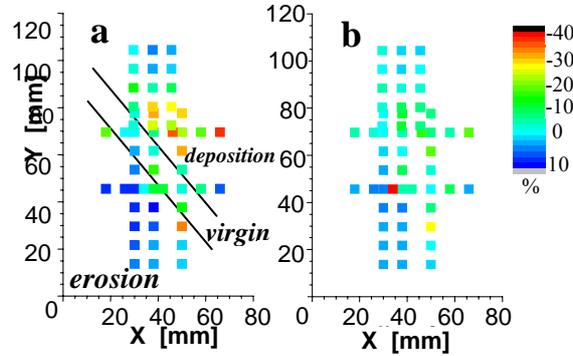
Fig. 12. Differences $\Delta R_{\text{tot}} = R_{\text{after}} - R_{\text{before}}$ given in colours at different surface locations for $\lambda=250$ nm (a) and 500nm (b). The co-ordinates x and y cover the mirror dimension (74mm x 115mm).

exposure the local changes were much larger. Fig. 12 shows the N differences $\Delta R_{\text{tot}} = R_{\text{after}} - R_{\text{before}}$ measured on the mirror exposed at LCFS+8mm. The differences are highest for $\lambda=250$ nm (a) and achieve more than +12% (dark blue) in the eroded part of the mirror, while reductions of -30% (deep red) occur in areas covered with deposits. In protected or shadowed areas ΔR_{tot} is in the scatter range ΔR observed before exposure (blue green). For increasing wave lengths (b) the changes are less pronounced. The intensity of the diffuse reflected light has also been measured at the identical locations, but contributes little since the differences do not exceed about $\pm 2\%$ on this mirror plate.

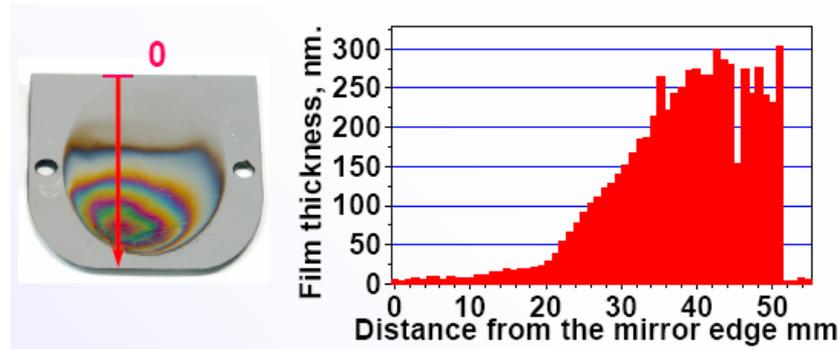
Fig. 13. The thickness of carbon-based film deposited on the mirror #1 of the periscope system.

Mirror #1 exposed in the periscope for 1047 s showed a radial decaying deposit with a maximum thickness of about 300 nm, Fig. 13, as follows from electron probe micro-analysis (EPMA). The thickness corresponds to a deposition rate of about 0.4 nm/s (inclination angle 45°). Although the deposition rate on mirror 1 is high, no detectable deposition was found on the following mirrors and walls.

The deposition rate of ≈ 0.4 nm/s on mirror #1 (inclination angle 45°) in the periscope is less than found on the 20° inclined mirror (0.7 nm/s) at the comparable radial position. This might partly be due to the fact that roughly one half of the carbon entering the orifice becomes deposited on the inner tube wall, visible there as a transparent deposit. Part of the carbon will likely be re-eroded from mirror #1. It is surprising therefore that no further deposition could be detected on the following walls and mirrors. One reason could be that the exposure time of 1047s is too short to grow a detectable layer. Another reason might be the pressure built up in the closed system which prevents the hydrocarbon radicals to penetrate deeper. Enhanced re-erosion of freshly formed deposits [15] may also play a role.

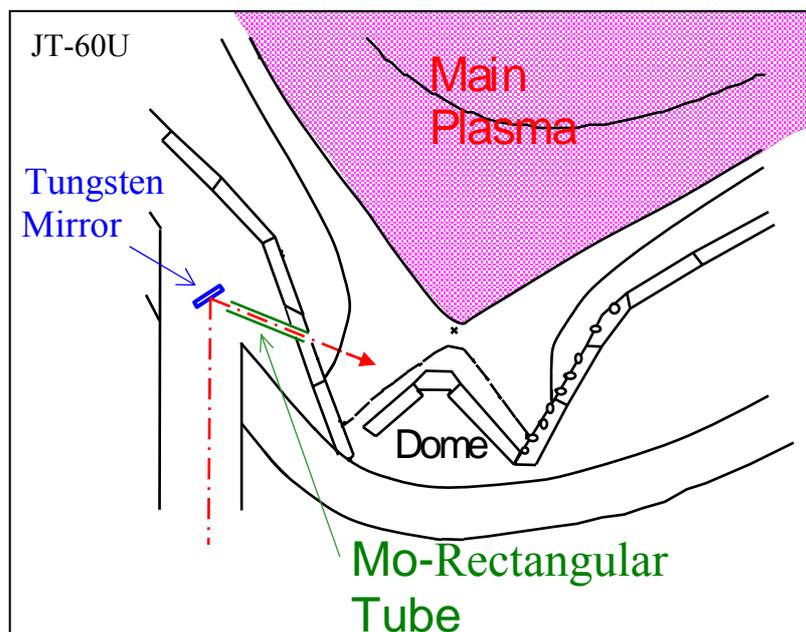
Fig.14. Disposition of W mirror for measurement of VUV and UV radiation emanating by the divertor plasma in JT-60U.

In JT-60U, a tungsten plane mirror was installed near the divertor to measure impurity lines emitted in the divertor with a vacuum ultra violet (VUV) spectrometer.

magnetic field line. The temperature of the mirror is around 300 °C since the vacuum vessel of JT-60U is 300 °C during the operation. The normal pulse length of JT-60U is about 15 sec. Under the condition, the reflectivity degradation of the mirror is not serious. VUV spectral lines can be observed with good S/N ratios after ~ 4000 shots of JT-60U.

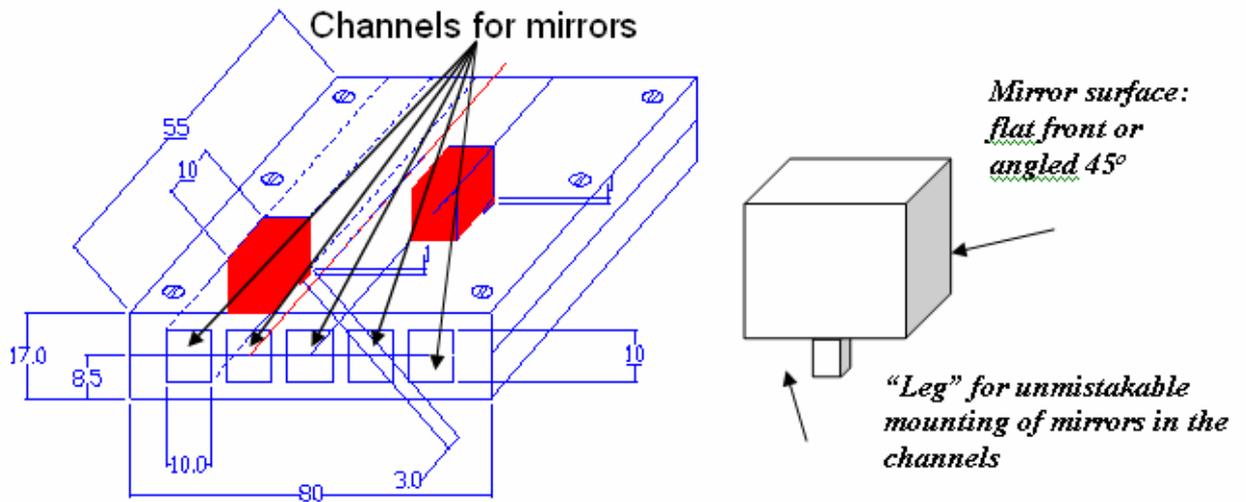
Fig. 15. A schematic view of a cassette and a mirror block for the test in JET.

Fig. 15 exemplifies a design of a stainless steel cassette with several channels in which the mirrors are mounted. The number of channels in a cassette, three or five, is dependent on the

The cassettes are of a “pan-pipes” shape and they are composed of two detachable plates. The construction enables studies of deposition both inside the pan-pipes channels and on the mirror surfaces. Moreover, the exposure of mirror surfaces at various inclination angles and aspect ratio with respect to plasma is possible. Effects of sample temperature on deposition in the divertor may be studied by comparison with the QMB data [16]. Figures 15 a-c show the location of mirrors and other deposition monitors in the divertor base and the inner carrier. The arrangement of devices in the outer divertor is similar to that in the inner leg (see Fig. 15 d). There are also cassettes placed on the main chamber wall (Fig. 16) protected by magnetic shutters which open when the magnetic field is on. This ensures avoiding the deposition of beryllium during its evaporation on the JET wall. Installation of all the deposition monitoring devices in the JET vessel is compatible with remote handling [17]. The construction phase and commissioning of the diagnostic tools for TRS (including FMT) is to be ready for installation in 2004. The experiment itself will be carried out in 2005 until the next opening of the JET vessel.

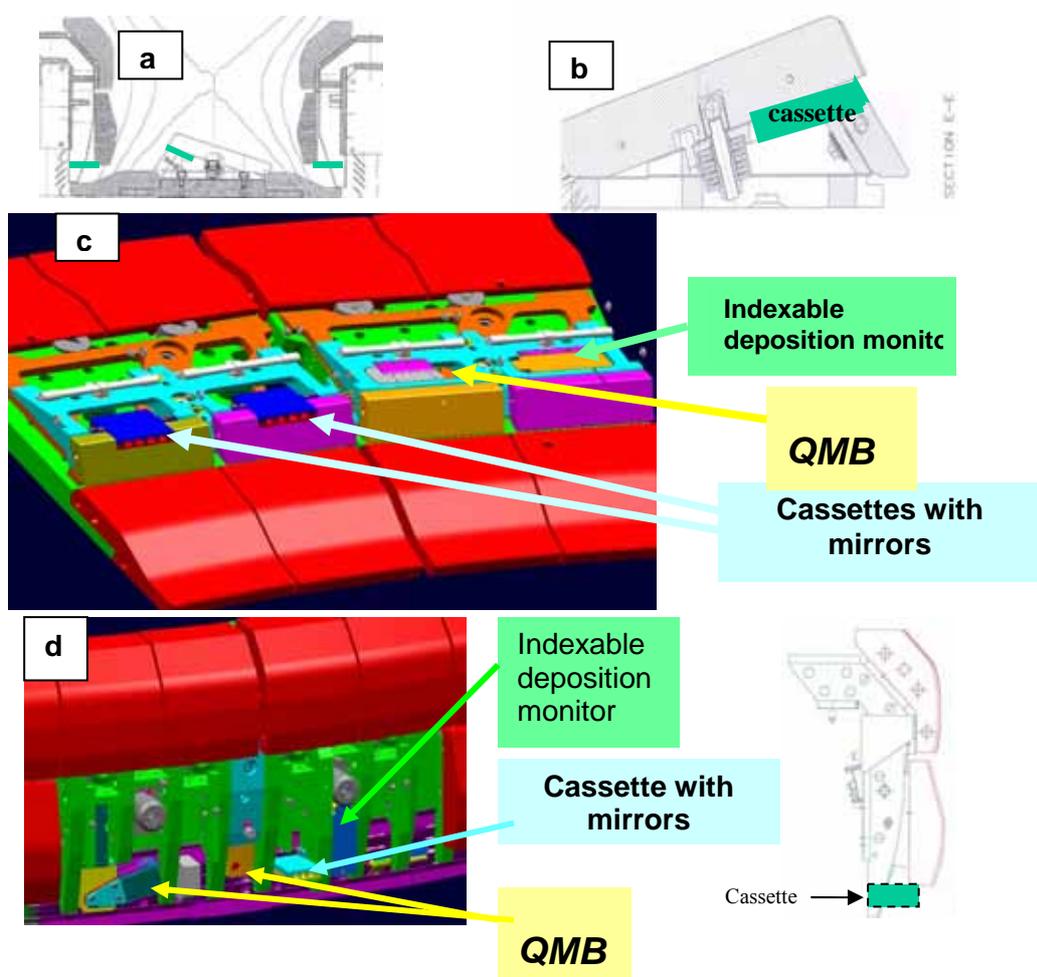
Fig. 16. (a) Divertor cross-section with a mirror cassettes (green boxes) in the inner, the outer carrier and below the load bearing plate (LBP made of carbon fibre composite); (b) base divertor module with a cassette; (c) location of several devices for monitoring the deposition mounted in the base divertor modules [Load Bearing Plate is removed]; (d) location of tested mirror and other deposition monitors in the inner divertor.

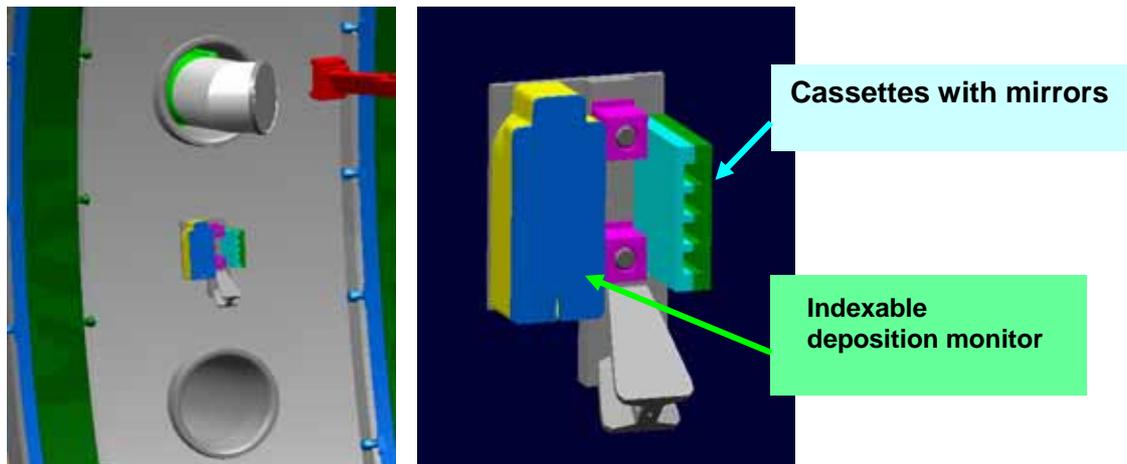
Fig. 17. Tested mirror and other deposition monitors in the main chamber wall mounted a clip (wall bracket) compatible with remote handling.
