Accessibility for persons with mobility impairments within an informal trading site: A case study on the markets of Warwick, South Africa

Objectives: This case study aimed at exploring accessibility within the markets of Warwick for persons with mobility impairments by an ergonomic assessment, augmented by voices of participants within the market.

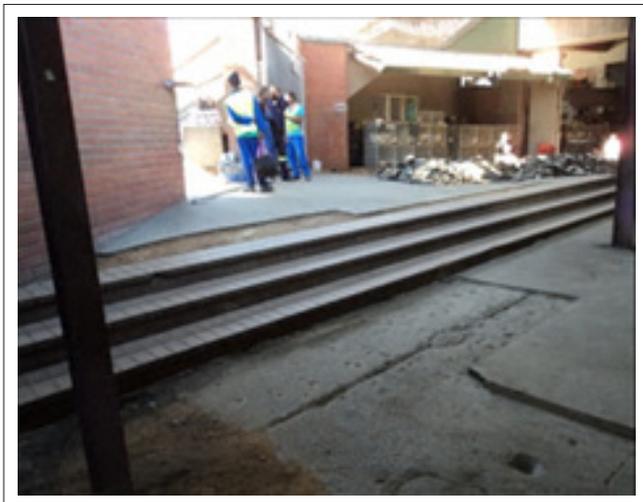
FIGURE 3: Entrance with no handrails on either side of the staircase.

The environmental survey raised various issues related to access points (such as roads, staircases, bridges, ramps and sidewalks) to the nine markets. These included the quality of the ramps and stairs (including handrails), sidewalks and road surfaces leading to these access points. Ramps and certain stairs failed to meet the standard safety requirements (Figure 3).

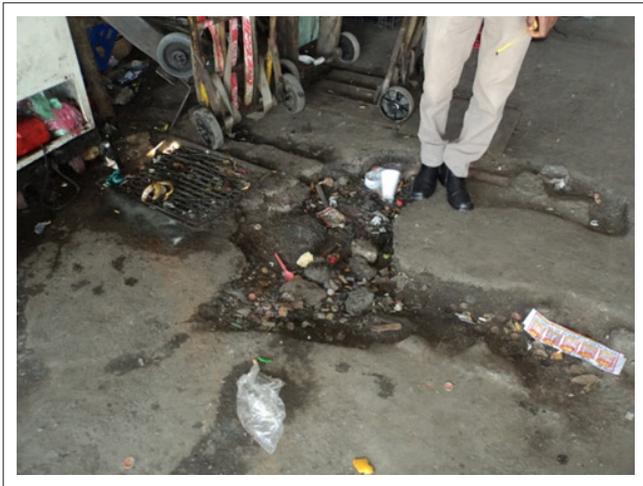
Doorways exceed the standard requirement, namely 750 mm width (SANS 10400-S 2011: section 4.6) and participants, therefore, reported no difficulties moving through the doorways and entrances to the markets. Surrounding sidewalks leading to access points were in a poor state, with many potholes and uneven floor surfaces being noted (Figure 4).

Potholes were often filled with litter and broken glass, posing health and safety risks for persons using wheelchairs. Whilst several sidewalks leading to access points met the design specification of 1500 mm in width, some traders occupied most of the sidewalk space to display their goods. This inevitably leaves limited space for persons with mobility impairments, especially those utilising wheelchairs, as there is no alternative accessible and safe route (SANS 10400-S 2011: section 4.4). These poorly conditioned sidewalk surfaces and limited spaces often result in wheelchair users mobilising on the road to access the markets and/or taxi services (Figure 5). 'The road

FIGURE 4: Pothole (120 mm deep and 530 mm wide).

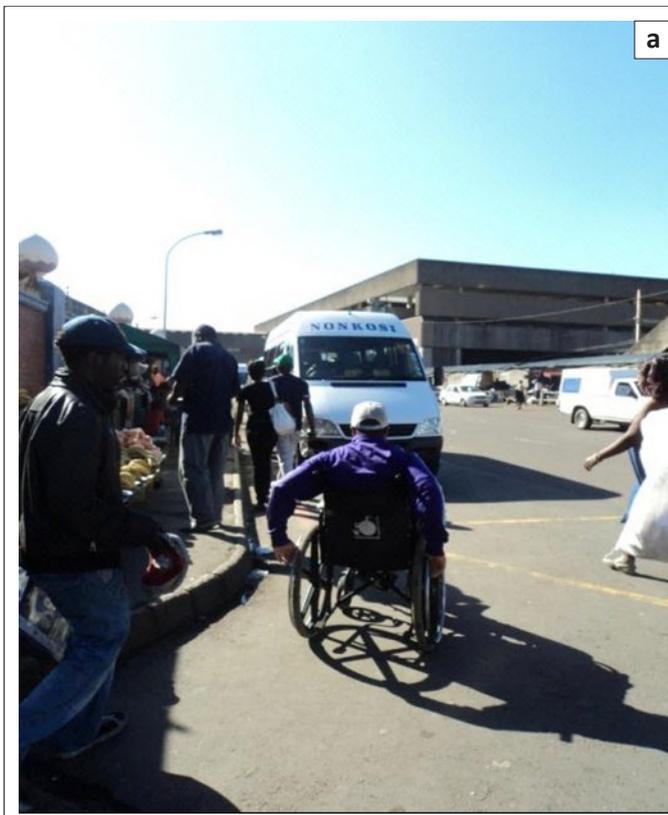
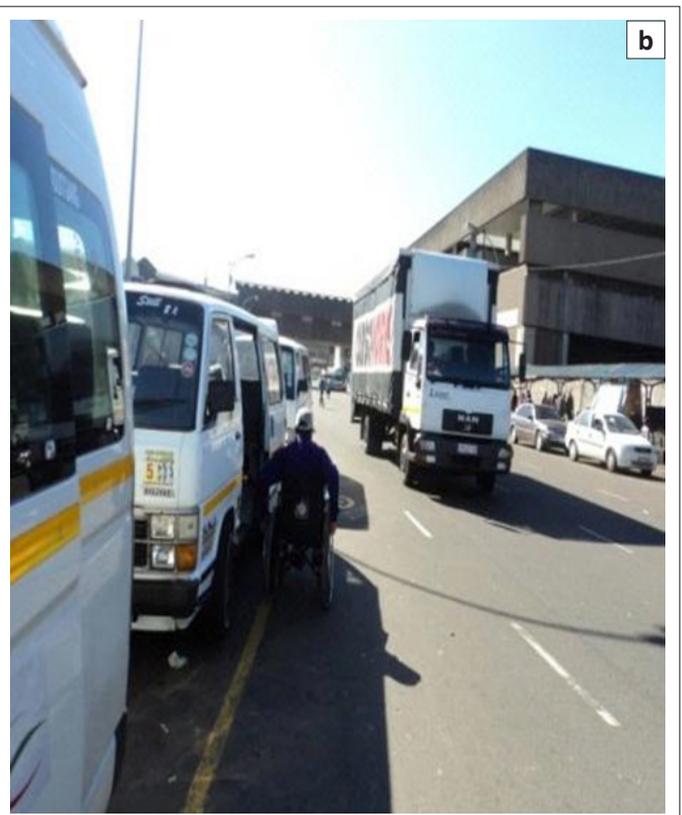
FIGURE 5: Wheelchair user accessing a taxi from the road.

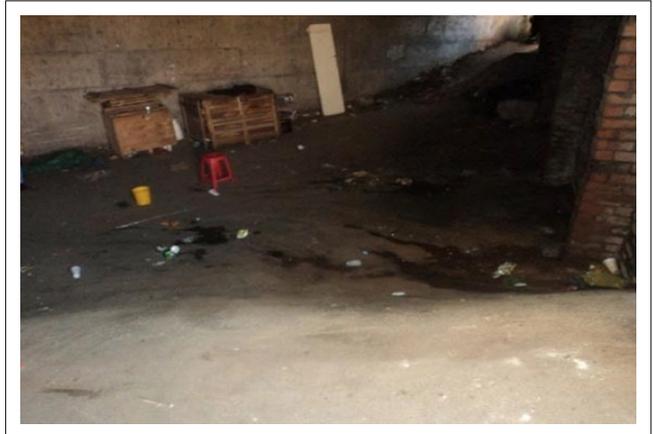
Subsequently, this storage facility has been abandoned, and is now used as an ablution facility, which poses a health risk to traders and consumers (Figure 6).

FIGURE 6: Abandoned storage facility located outside the bead market utilised as an ablution facility.

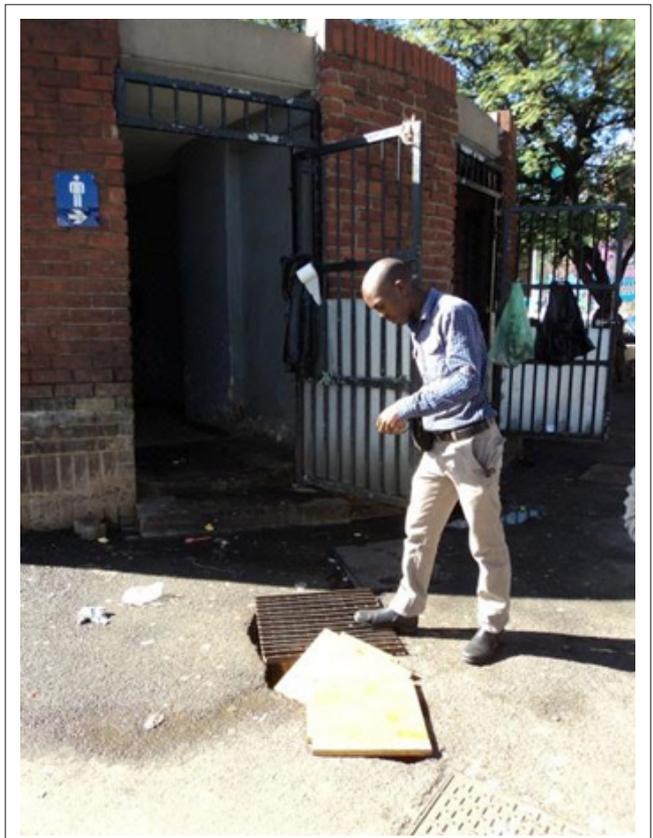
The environmental survey revealed poor terrain for mobilisation (for example, open manholes and large potholes), presenting difficulties and potential danger for those wanting to access the facilities (Figure 7).

The entrance to the ablution facility does not have a ramp; it, however, does have steps and therefore access for those persons with mobility impairments is hindered. Moreover, the ablution facilities surrounding the markets are not accessible to consumers after 16:00. Although this is considered 'rush hour' with many persons passing through the area (as a thoroughfare) after their working

FIGURE 7: Entrance of public ablution facility with large pothole covered with wood, and absence of ramp leading into ablution facility.

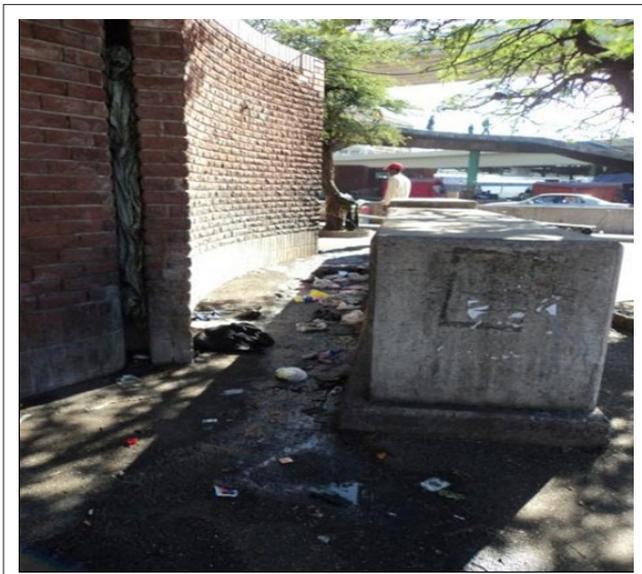
day, these facilities remain locked. As a consequence, persons needing to use the ablution facilities, utilise public stall areas as an 'ablution facility' (Figure 8).

The stall situated behind the ablution facilities in two of the markets has, hence, become a severe health risk because of urine and faeces on sidewalks which run into the surrounding drains.

FIGURE 8: Area used as ablution facility when public ablution facilities are closed after 16:00 daily.

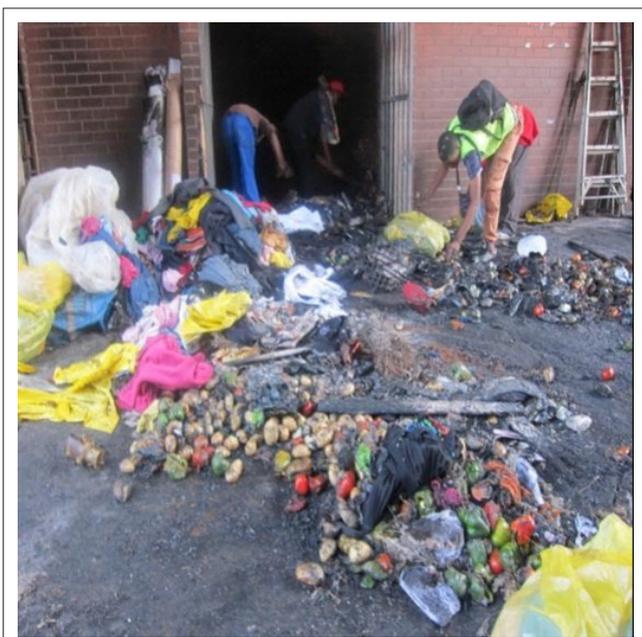
FIGURE 9: Recent fire damage resulting in loss of trader goods and damage to storage facilities.

in an emergency situation. Lastly, as already mentioned, severe health risks flow from utilising certain areas for ablution which were not designated for ablution use. In the extreme and unfortunate case of a fire or an emergency requiring fast exit from the markets, factors one to three will reduce the ability of persons with mobility impairments utilising the markets to exit buildings (Figure 9).

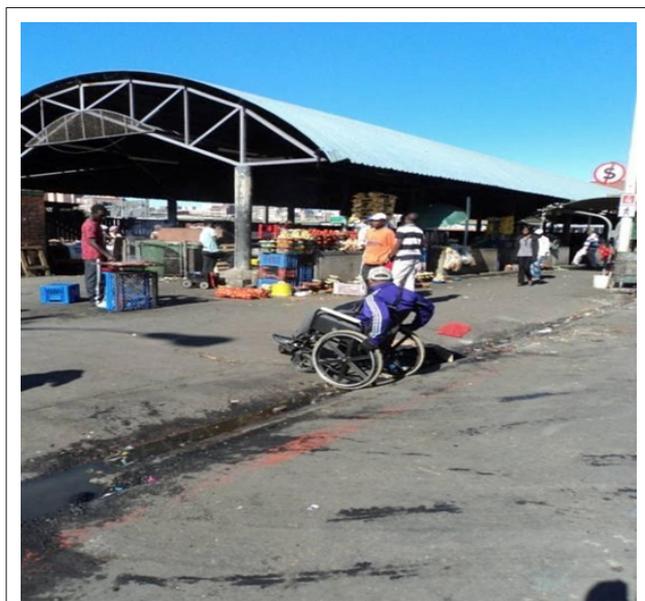
Participants also appeared to be unfamiliar with the context of designated disability parking bays within and surrounding the markets. The environmental survey revealed parking facilities available and accessible to only three of the nine markets, two of which have parking facilities available for both traders and consumers. There are a number of taxi pick-up zones which are located around the nine markets with each taxi zone servicing different geographical areas. According to the participants, they travel to the markets by public transport, more specifically taxis, and arrive and depart in close proximity to the market area (Figure 10).

FIGURE 10: Wheelchair user observed crossing Market Avenue from pick-up zone located on opposite side of the road.
