# Slope stability and rockfall assessment of volcanic tuffs using RPAS with 2-D FEM slope modelling

**Abstract.** Steep, hardly accessible cliffs of rhyolite tuff in NE Hungary are prone to rockfalls, endangering visitors of a castle. Remote sensing techniques were employed to obtain data on terrain morphology and to provide slope geometry for assessing the stability of these rock walls. A RPAS (Remotely Piloted Aircraft System) was used to collect images which were processed by Pix4D mapper (structure from motion technology) to generate a point cloud and mesh. The georeferencing was made by Global Navigation Satellite System (GNSS) with the use of seven ground control points. The obtained digital surface model (DSM) was processed (vegetation removal) and the derived digital terrain model (DTM) allowed cross sections to be drawn and a joint system to be detected. Joint and discontinuity system was also verified by field measurements. On-site tests as well as laboratory tests provided additional engineering geological data for slope modelling. Stability of cliffs was assessed by 2-D FEM (finite element method). Global analyses of cross sections show that weak intercalating tuff lay

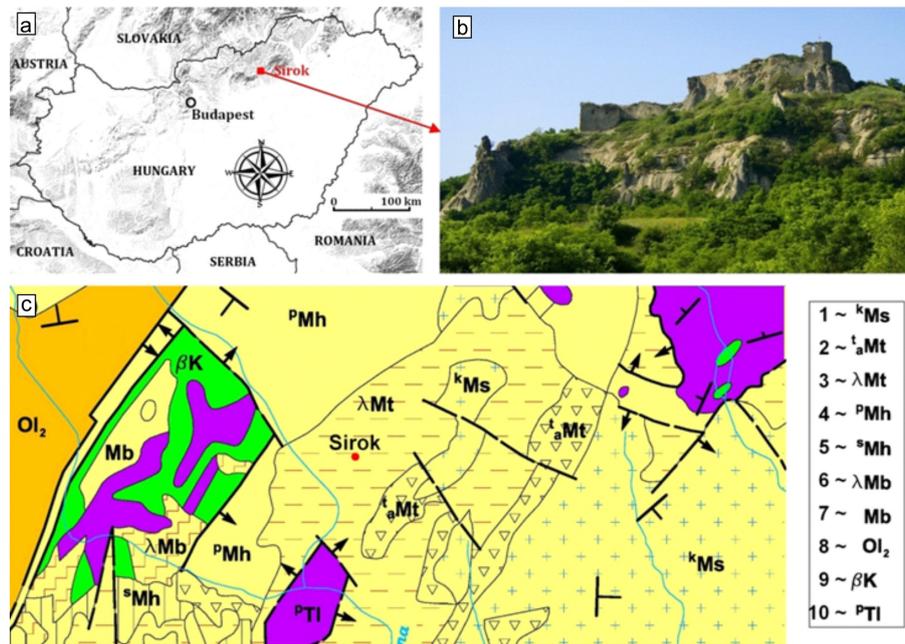
**Figure 1.** Location of studied cliff faces and an image of the rocky slope at Sirok Castle, NE Hungary (a, b) and the geological map of the area (redrawn after Balogh, 1964) (c). Legend for the geological map: Miocene (1–7), Oligocene (8), Cretaceous (9), Triassic (10). 1: gravel and conglomerate, 2: clay, 3: rhyolite tuff, 4: sand and sandstone, 5: siltstone, 6: rhyodacite tuff, 7: fine sand, 8: clay, 9: basalt, 10: radiolarite.

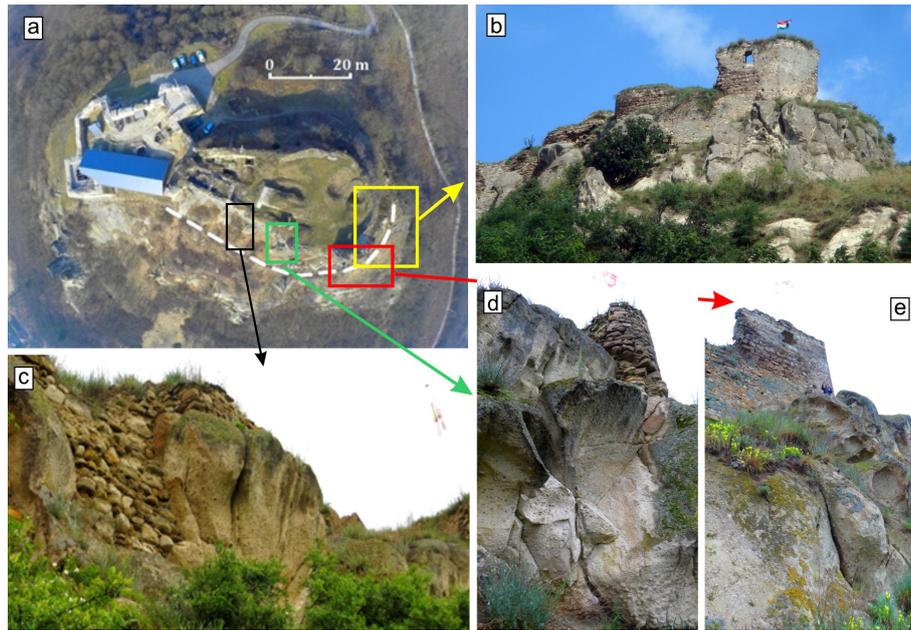
**Figure 2.** Studied southern cliff faces: (a) image of the castle obtained by RPAS with marked details, (b) distant view of the eastern part of the cliff section, (c) steep cliffs dissected by joints, (d) vertical to subvertical cliff face with steep joints and traces of rockfall and (e) weathered rounded cliff with larger tafoni.

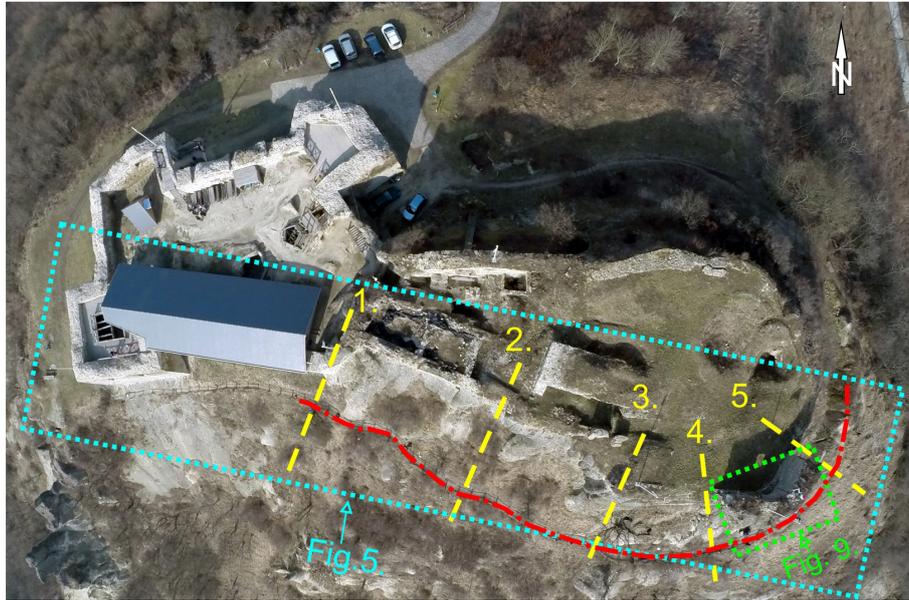
**Figure 3.** Location of the illustrations in the paper and the rockfall-affected area. Red dotted and dashed line represents zones affected by rockfall. Yellow dashed lines 1 to 5 mark the sections where slope stability was calculated by using 2-D FEM model (Fig. 8). Dotted lines indicate the areas shown in Figs. 5 and 9.

The results of RS2 FEM analyses suggest that the global factor of safety is SRF = 1.27–1.71 in the studied sections (some of the selected sections are shown in Fig. 3). The aim of the analysis is to determine the critical strength reduction factor (SRF) that can be considered the safety factor of the slope (Fig. 10). The SRF factor is influenced by the weak tuff layer (marked by B–D in Fig. 8), which has very low shear strength compared to the lapilli tuff. Colours in Fig. 10. represent the total displacements as a result of the shear strength reduction analysis. Thus these are not real displacements of the hillslope. The figure demonstrates only how the failure of

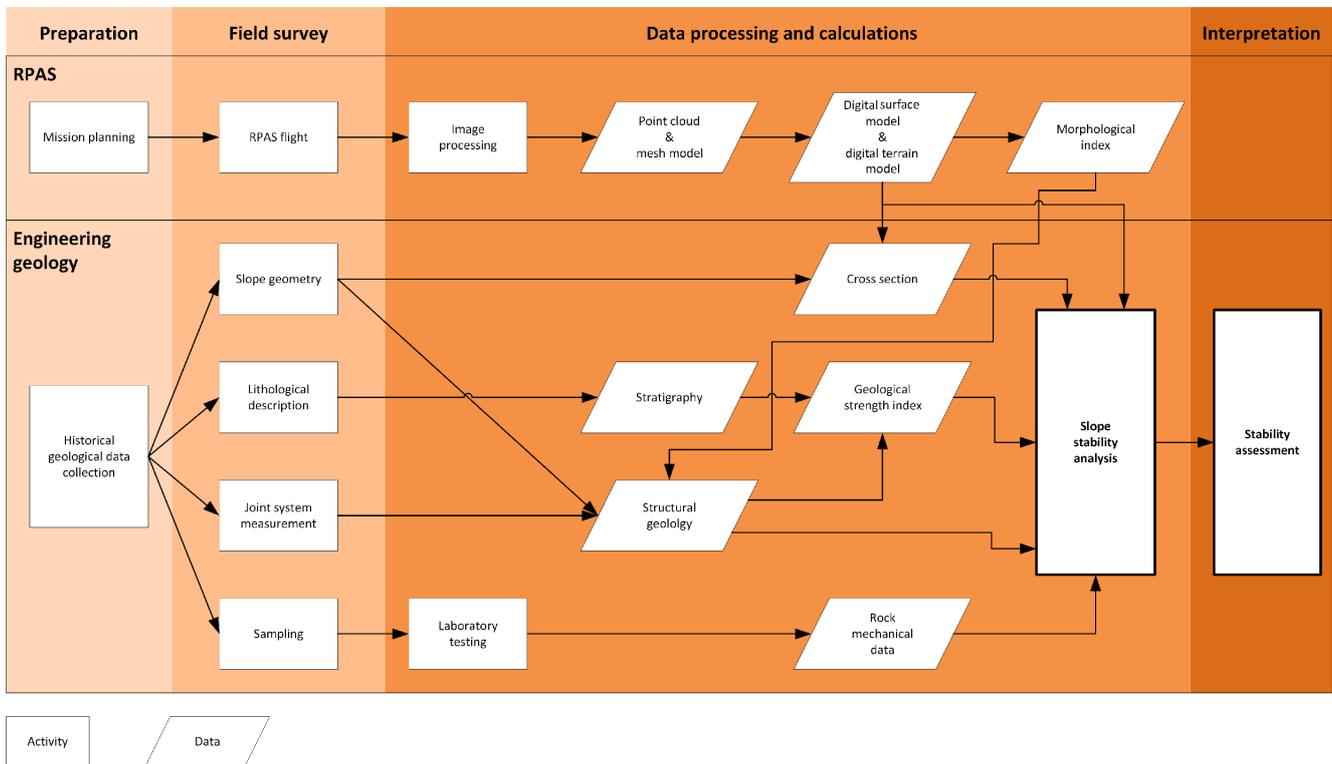
**Figure 4.** Flow chart showing the methods and obtained data set of this paper indicating the interrelationship between RPAS and slope stability assessment (see details in the text).

The research uses two major methods: (i) RPAS and (ii) engineering geology. The applied methods are summarized in a flow diagram displaying the combination and links between the two methods (Fig. 4). The flow chart has four major realms that have both RPAS and engineering geological units: (i) preparation, (ii) field survey, (iii) data processing and calculation and (iv) interpretation. The RPAS line is described in detail in the next part of the paper, but is also linked to previous publications providing overview of image acquisition, image processing and interpretation (Civera et al., 2012; Westoby et al., 2012; Remondino et al., 2014). The engineering geological part of the flow chart is also explained below and has strong links to publications describing the application of RPAS to landslide characterization and rock

Samples for laboratory analyses were collected on-site (Fig. 4). Major rock mechanical parameters were measured under laboratory conditions on cylindrical specimens. These were drilled from blocks and cut into appropriate sizes using cutting disc. The sizes of the tested specimen were made according to EN (European Norm) on air-dried and water-saturated samples. The specimens were grouped according to their bulk density and the propagation speed of the ultrasonic pulse wave. Strength parameters such as uniaxial compressive strength and indirect tensile strength (Brazilian) were measured according to relevant EN standards and ISRM-suggested methods (International Association of Rock Mechanics). Modulus of elasticity was also calculated (Table 2).

were obtained from DSM model-based morphological analyses with the use of catchment area tool. It assumes that major flow paths are related to joints; i.e. the fracture system controls the drainage pattern (Costa-Cabral et al., 1994). At accessible areas joints and fractures were also measured on-site on the southern and south-eastern parts of the hillslope. Additional control field measurements were also made in the underground cellar system of the castle, where the tuff is also exposed. The Dips software was used for the kinematic analysis. The direction of the hillslopes and the direction of the discontinuities were compared to determine the location of the potential hazardous failure zones on the hillside. Stereographic plots were generated showing the possible failure planes for all slope directions, and the safety factor of the possible planar failure was calculated by RockPlane software. Wedge failure was modelled by Swedge software. Toppling failure due to geological and geomorphological conditions cannot occur. Slope stability calculations and stability assessment formed the last part of the engineering geological analyses (Fig. 4).

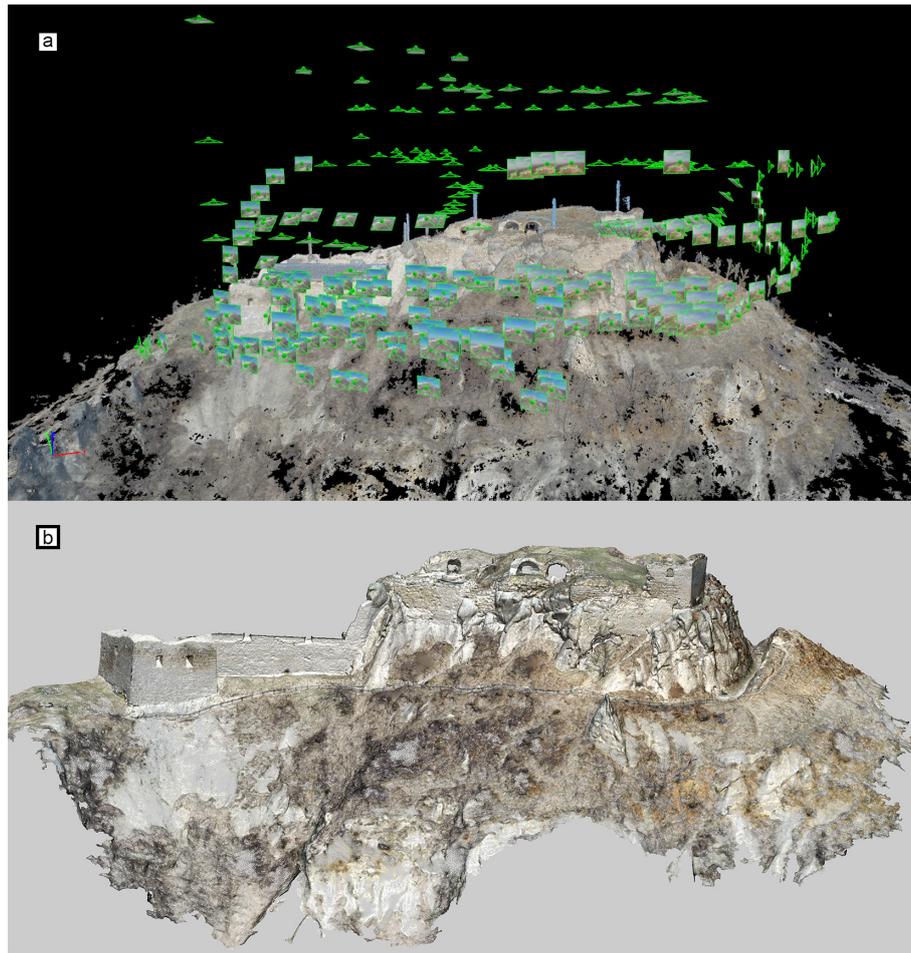
**Figure 5.** The captured image positions around the reconstructed castle hill (a) and the point clouds obtained by RPAS technology (b) (see top view in Fig. 3.)

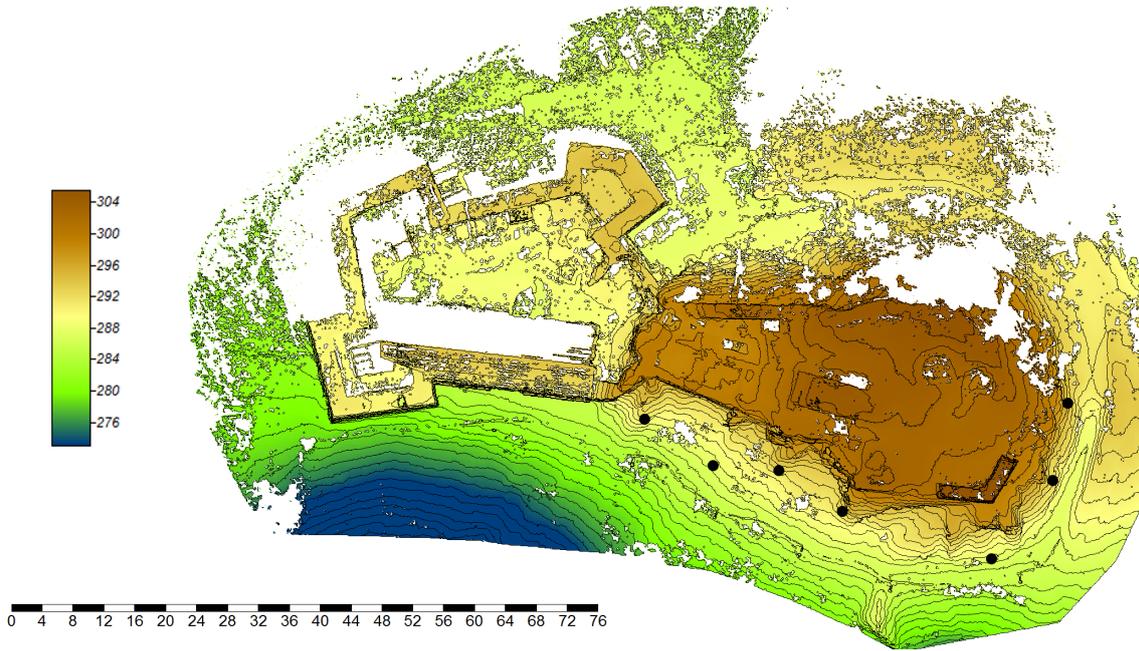
**Figure 6.** Colour digital surface model with 1 m contour line interval of the study area. The solid black dots show the ground control points, while the red dotted and dashed line represents zones affected by rockfall.

The rhyolite tuff faces consist of moderately bedded ignimbritic horizons and also brecciated lapilli tuffs according to our field observations (Fig. 6). The topmost 10 m of the cliff face, which was modelled from slope stability, com-

By combining and comparing all measured data of discontinuities and joints using DSM and its derivative (Fig. 6.) and morphological index (Fig. 9), the joint orientation was outlined. The field survey validated the obtained structural geological conditions, and six main joint sets (with dip angle/dip directions of 85/156, 88/312, 79/110, 81/089, 82/064, 61/299) were identified with prevailing a NE–SW direction.

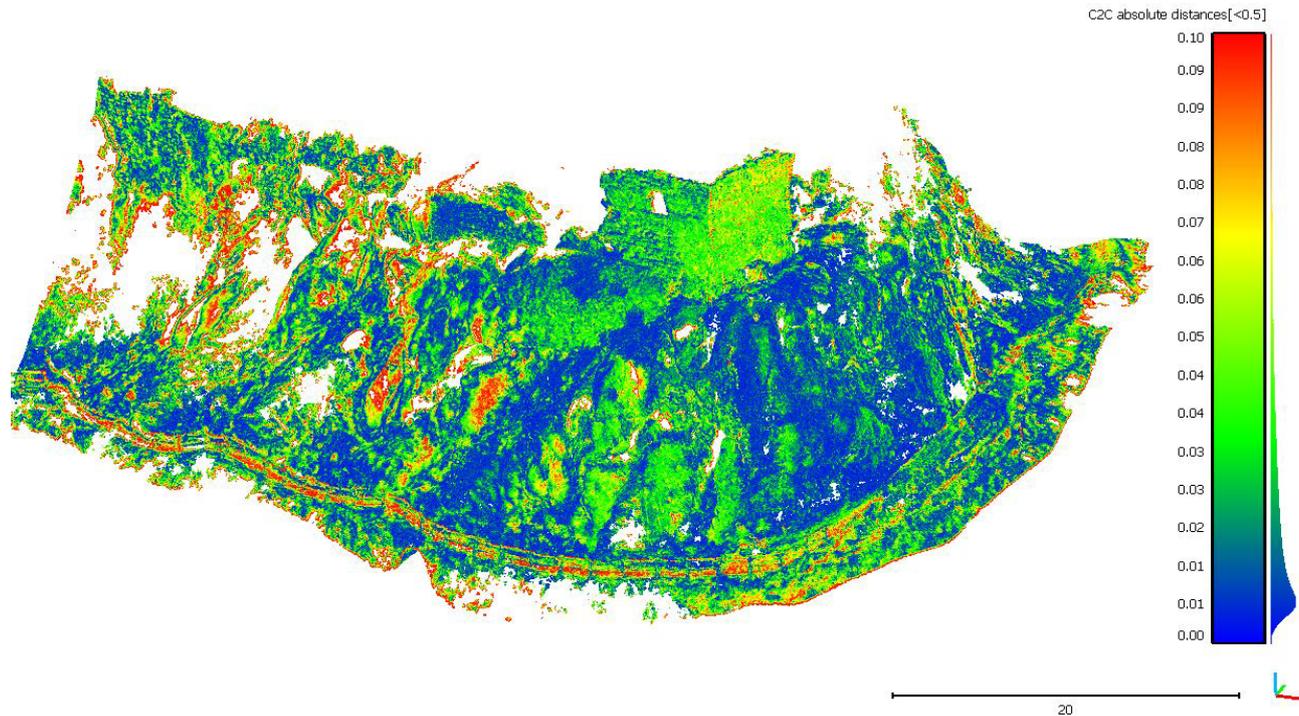
**Figure 7.** Differences between RPAS and TLS point clouds by CloudCompare shown in metres (modus of differences is at about 0.01 m).

The RPAS data collection was validated by the use of terrestrial laser scanning. The necessary data were captured by two scanners: a Faro Focus S 120 3D (Faro, 2016) and a Z+F Imager 5010C (Z+F, 2014). The terrestrial laser scanning was executed on the same day as the RPAS mission. The raw point cloud measured by the Faro scanner contained 1.9 billion points, while the Z+F point cloud had 0.8 billion points. Both point clouds included X, Y and Z coordinates, intensity and RGB colour values. RPAS- and TLS-based point clouds were compared with CloudCompare software (CloudCompare, 2014) (Fig. 7).

As can be noted in Fig. 7, the largest difference between the two sources is almost less than 10 cm and the majority of the differences are about 1 cm. The point cloud was then imported into Geomagic Studio 2013 (GeomagicStudio, 2013) and meshed. The triangle side length was 5–7 cm. To support the engineering geological survey, several horizontal and vertical sections were derived in Geomagic DesignX 2016 (Ge-

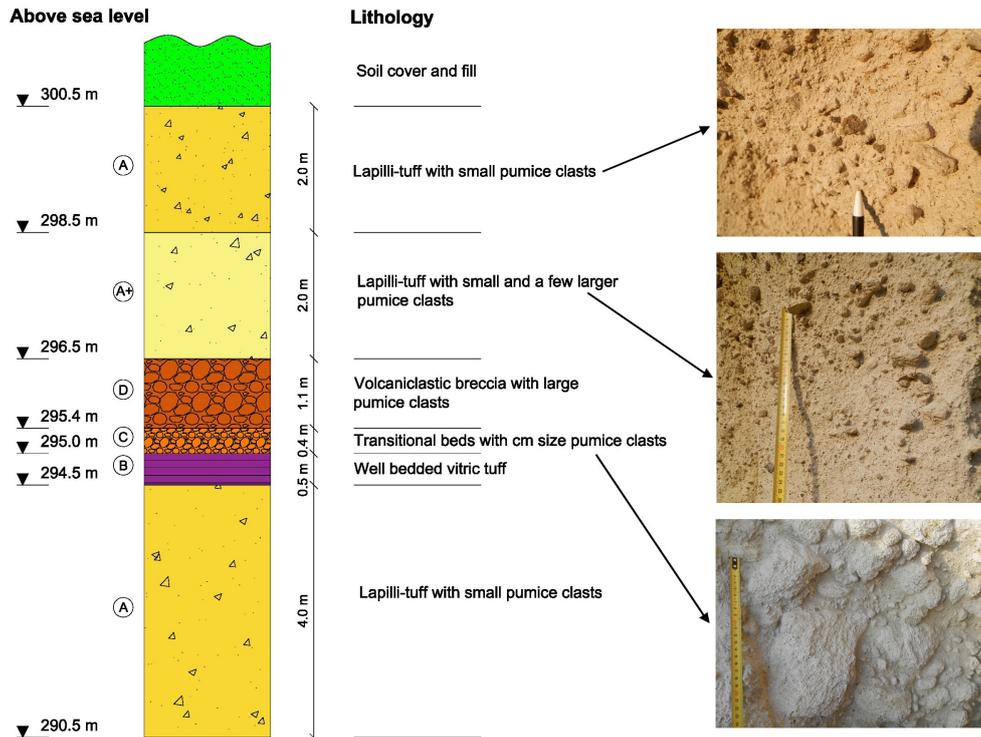
**Figure 8.** Lithologic column of Sirok Várhegy showing the modelled topmost 10 m section of the hill (letters refer to lithologic units).

prises three main horizons and can be modelled as a “sandwich structure”. The lower and the upper parts are formed by thick pumice containing lapilli tuffs. These beds enclose nearly 2 m of well-bedded less welded fine tuff and brecciated horizons (Fig. 8).

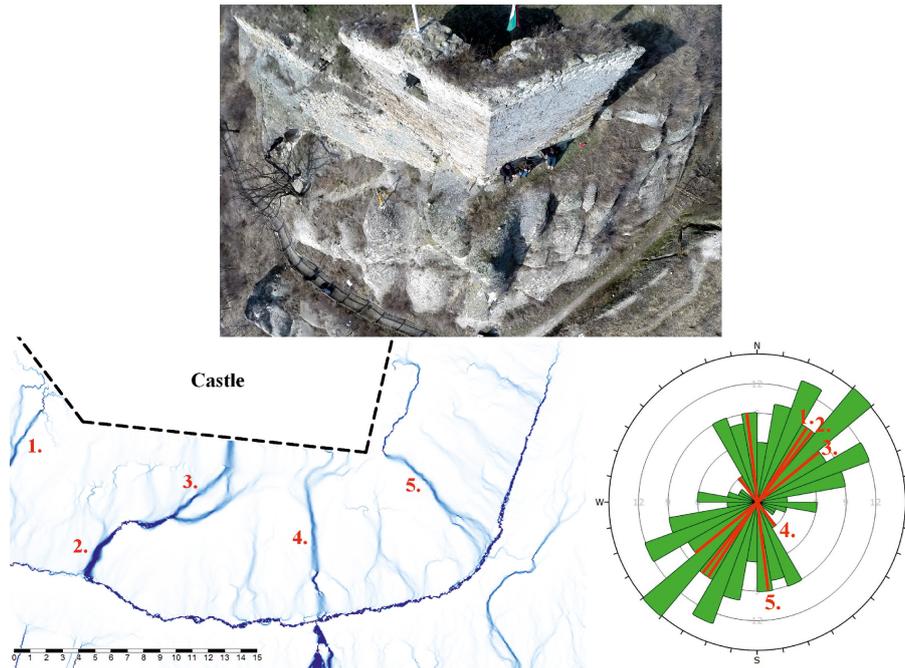
**Figure 9.** Top view of the cliff (see the location in Fig. 3) obtained with RPAS and the catchment area diagram obtained from DSM analysis by using a catchment area module (Costa-Cabral et al., 1994). The latter was used for joint pattern recognition. Numbers refer to major joint systems marked on the catchment area map and on rose diagram of the field measurements and DSM data set.

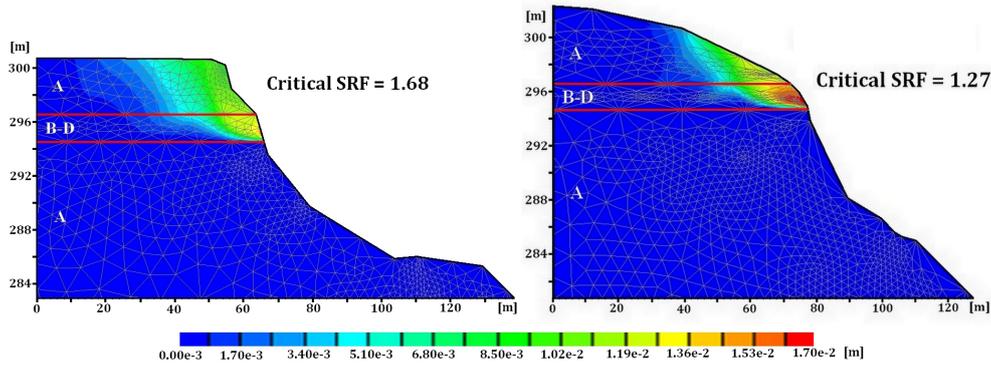
**Figure 10.** The results of the global stability analysis of the slopes (sections 3 and 4 in Fig. 3). Total displacements are marked from blue to red (lithology is indicated by letters A–D; note the weak zone marked by B–D; description of lithologies is given in Fig. 8.)

the slope would occur with reduced shear strength parameters. Our failure analyses have proved that the bottom of the slip surface would be in this weaker layer and could lead to a larger mass movement.

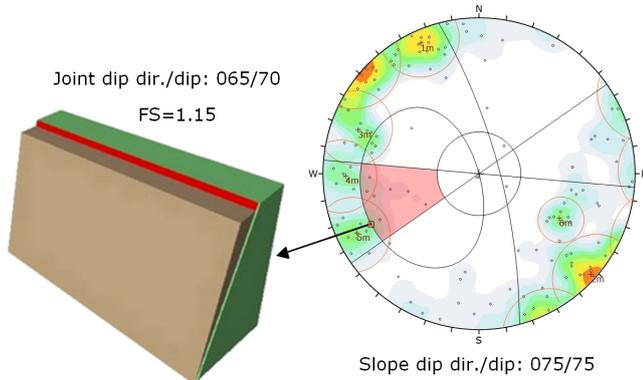
**Figure 11.** Kinematic analysis of planar failure by RockPlane (main joint sets are marked by red circles 1–6 m).

Other failure modes that were studied are planar failure and wedge failure, which are often controlled by joints and discontinuities. According to data obtained from remote sensing and according to field measurements there was no uniform spacing of the discontinuities. Stereographic plots with possible failure planes for all slope directions (Fig. 11) indicate that the most hazardous part of the slope is the one where the plane orientation is 75/75. The calculated factor of safety ( $FS = 1.15$ ) implies a high probability of planar failure.

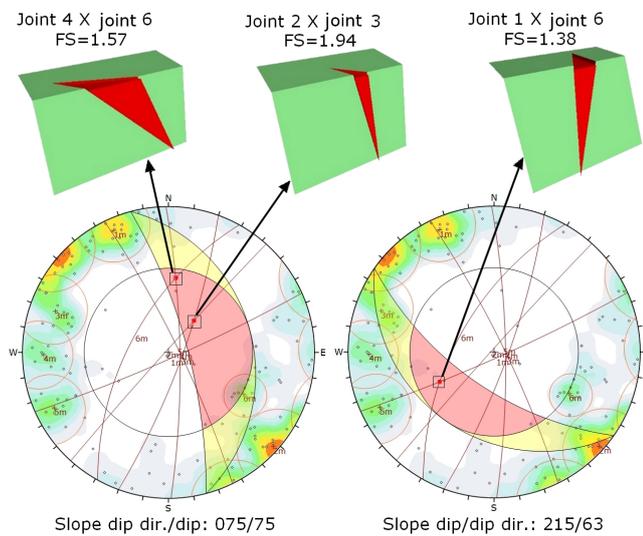
**Figure 12.** Examples for the kinematic analysis of wedge failures (main joint sets are marked by red circles 1–6 m).

Three possible wedge failure modes were identified as being the most hazardous according to our calculations by Swedge software (Fig. 12). In these three cases the factor of

safety was in the range of 1.38–1.94, representing the hazards of rockfalls along wedges delineated by different joint systems.
