What is the contrast-filled structure seen during right ventriculography?

Answer: A

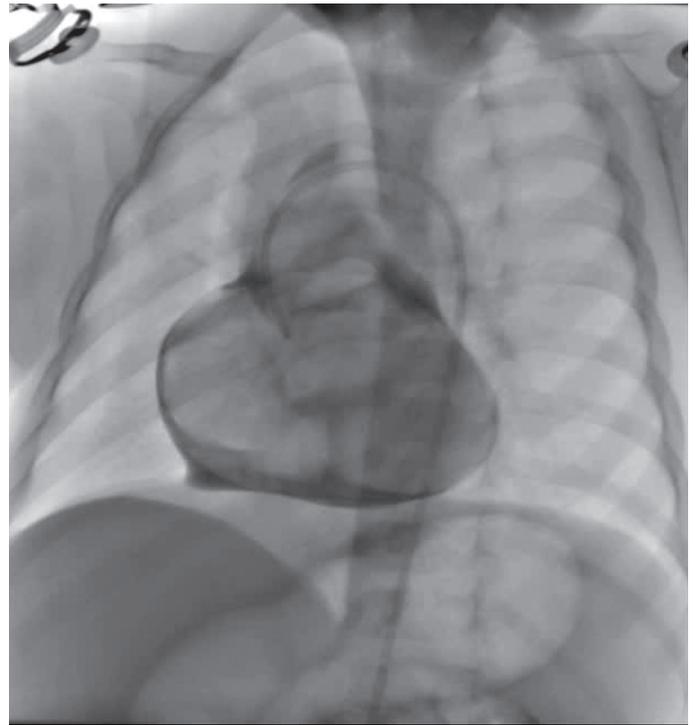
Figure 2. A still image immediately after right ventriculography showing contrast agent drained into pericardial space

During right ventriculography (Fig. 1, Video 1), it was noted that the contrast agent injected through the catheter did not fill the right ventricular (RV) cavity very well. Instead, it initially stained the RV myocardium and gradually formed a pouch within the RV wall. It appears that the catheter was inadvertently engaged into a thebesian vein and the contrast agent, which was injected with high pressure (600 psi), first opacified the thebesian venous system (thin arrows) and eventually formed a venous lake within the RV wall (thick arrow). Ventricular tachycardia was also noted during the formation of intramyocardial pouch. Immediately after the first recorded image, contrast agent was found to have drained into the pericardial space, and there was no persistent staining of myocardium (Fig. 2, Video 2). Hemodynamics of the patient did not deteriorate. Echocardiographic imaging in a cath lab revealed small pericardial effusion without signs of tamponade (Fig. 3, Video 3). Procedure was completed with left heart catheterization and aortography as planned. The patient remained stable, and pericardial effusion did not increase during post-procedural hospital stay of 2 days.

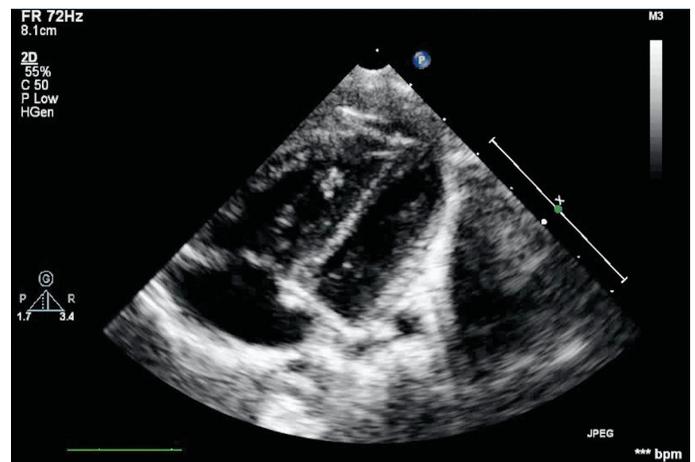
Figure 3. Echocardiographic image showing minimal pericardial effusion
