# Migrant Common Eider, *Somateria mollissima*, Collisions with Power Transmission Lines and Shortwave Communication Towers on the Tantramar Marsh in Southeastern New Brunswick

MacKinnon, Colin M., and Andrew C. Kennedy. 2011. Migrant Common Eider, *Somateria mollissima*, collisions with power transmission lines and shortwave communication towers on the Tantramar Marsh in southeastern New Brunswick. *Canadian Field-Naturalist* 125(1): 41–46.

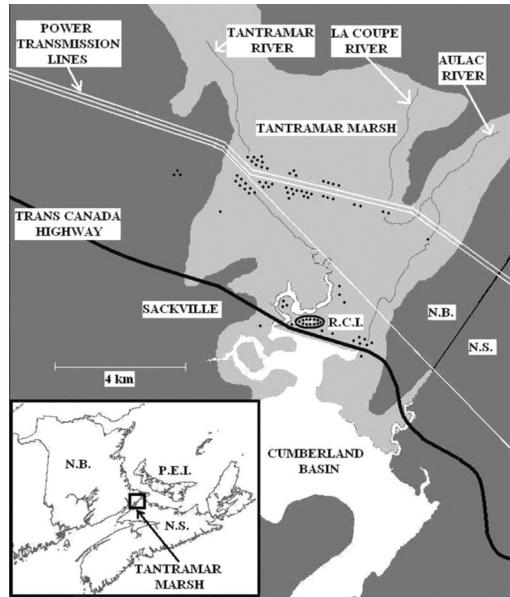
FIGURE 2. Locations of salient features of the Tantramar Marsh, New Brunswick. Note the locations of the power transmission lines as well as the Radio Canada International (RCI) facility immediately east of the Tantramar River. Baie Verte is situated 14 km to the northeast of the map. The "High Marsh Road" runs parallel and immediately south of the double row of power transmission lines. Approximate locations of downed Common Eiders are represented by black dots ( $n = 82$ ).

The Tantramar Marsh (67 km<sup>2</sup>), including the Tantramar River and Aulac River drainages, is situated in south-eastern New Brunswick, near the town of Sackville, and immediately west-northwest of the Missaguash Marsh which separates New Brunswick from Nova Scotia (45°55'N, 64°18'W). Located at the head of Cumberland Basin, which is at the northeastern extremity of the Bay of Fundy, the Tantramar Marsh consist predominantly of agricultural lands that have been reclaimed from the sea by a series of dykes, a tide control gate, and an *aboiteau* (a wooden sluice underneath a dyke used to maintain drainage) (Figure 2).

Of the 82 detailed location records, 53 (65%) Common Eiders were found along the 6.0-km-long section of road and adjacent power transmission corridor that cross the upper part of the Tantramar Marsh (generally from the covered bridge over the Tantramar River to the bridge over the La Coupe River). An additional 21 (26%) were recovered under, or in close proximity to, the Radio Canada International towers at Coles Island, while the remaining 8 (10%) were recovered from other locations within the study area (Figure 1).

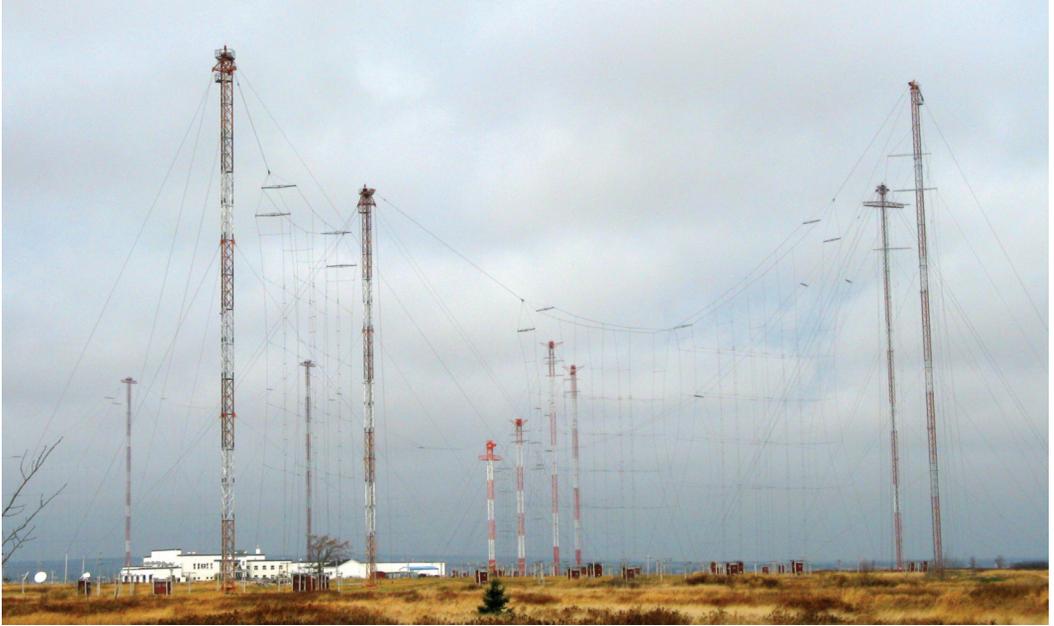
FIGURE 3. Radio Canada International station situated on Coles Island within the Tantramar Marsh near Sackville, New Brunswick. There is a complex matrix of wires/guy lines between the towers. The tallest feature is 131 m. Photo: C. MacKinnon.

Immediately north of the Trans-Canada Highway and centered within the Tantramar Marsh, is a small (~50 ha) area of elevated land known as Coles Island, site of the Radio Canada International station. This communications facility began operation in 1943; shortwave service followed in 1945 (Figure 3). The Radio Canada International operation is predominantly a large "curtain array" consisting of numerous support cables with a grid of wires strung between 13 metal-framed towers. These towers are arranged in a semicircle extending horizontally for approximately 1200 m. The tallest towers in the middle of the array reach a maximum height of 131 m. With a broadcast power reaching 500 000 watts, the Radio Canada International station can broadcast shortwave communications to all corners of the globe.

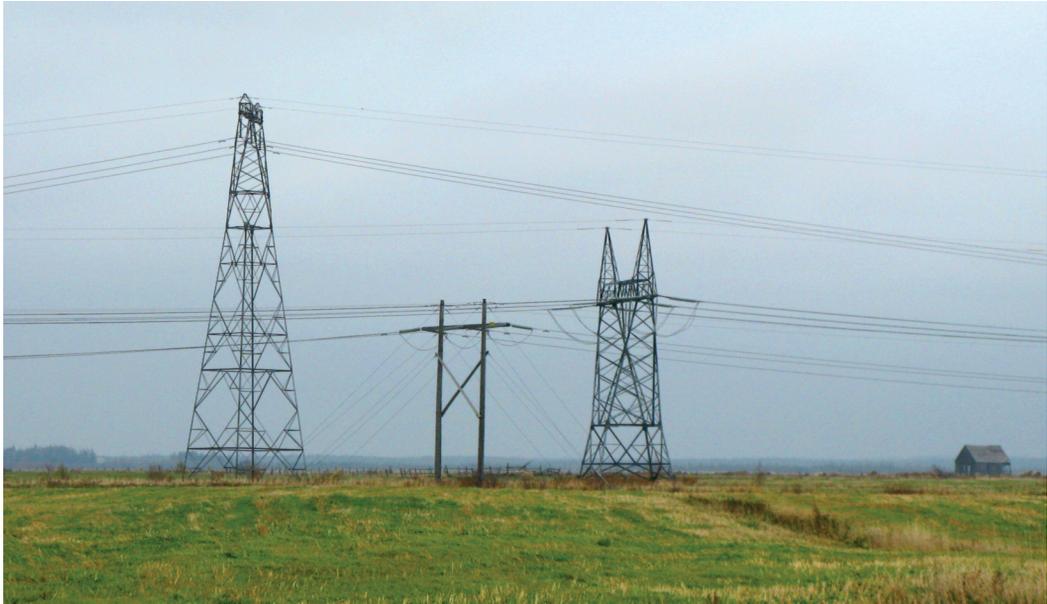
FIGURE 4. Intersection of three transmission lines north of the covered bridge on the High Marsh Road (Jolicure Road), Tantramar Marsh, New Brunswick, the site of numerous Common Eider collisions. Photo: A. Kennedy.

Tantramar, about 1 km northwest of the High Marsh Road. At a point 200 m north of the covered bridge that crosses the Tantramar River, these lines split (Figure 4). Two sets of parallel lines (one with metal lattice support towers and one with wooden poles) run across the marsh, west to east, just north of the High Marsh Road. The third set of lines, supported by both metal and wooden towers, runs diagonally across the marsh from the northwest to the southeast.
