# Guidewire Breakage during Neurointerventional Procedures: a Report of Two Cases

We report on two cases of microguidewire breakage that occurred during endovascular treatment of intracranial aneurysms. The microguidewire can be broken when a part of the wire is stuck due to vascular tortuosity, and, subsequently, application of excessive rotational movement. The mechanical and physical properties of a microguidewire are also important factors in microguidewire breakage. We also suggest technical tips for avoidance of this problem.

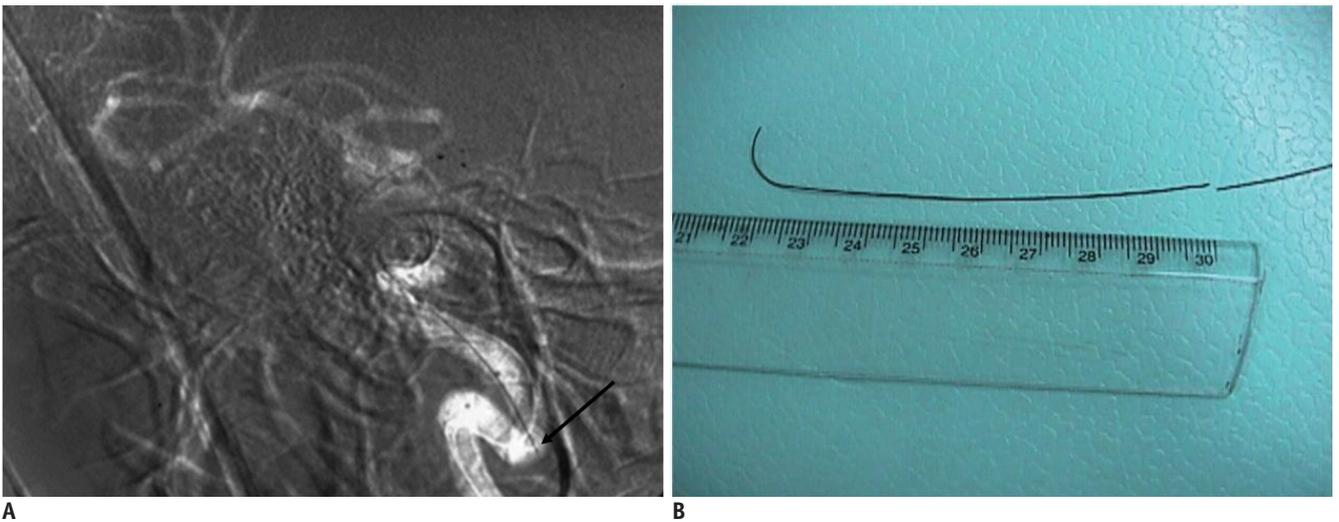
**Fig. 1. Guidewire breakage during neurointerventional procedures in 47-year-old woman.**

**A.** Fractured guidewire within internal carotid artery lumen. Proximal part of fractured guidewire can be seen at abrupt turning point of cervical to petrous internal carotid artery (arrow). **B.** Retrieved fractured guidewire. Fractured distal segment approximately 9 cm long can be seen.

was treated with endovascular coiling under general anesthesia. The aneurysm measured 5 mm in size and was superomedially directed. Conjoined with a guiding catheter (Envoy 6 Fr, Codman, MA), a microcatheter (Prowler 14, Codman, MA; 0.4 mm inner diameter) with a microguidewire (Transend 014, Boston Scientific, MA; 0.37 mm outer diameter) was used in selection of the aneurismal sac. Initially, several attempts were made to select the aneurysm using the steam-shaped microcatheter and microguidewire. However, due to the tortuosity of the ICA, entry into the aneurysm sac was very difficult. During this process, the wire was rotated many times in a clockwise and counterclockwise direction. At one point, we noticed that the tip no longer moved with the rotation of the guidewire. The distal part of the wire was fractured (Fig. 1A). Using a microsnares (Microvena, Boston Scientific, MA), it was successfully removed without complication (Fig. 1B). The aneurysm was then selected using a new guidewire and successfully coiled without further problems.

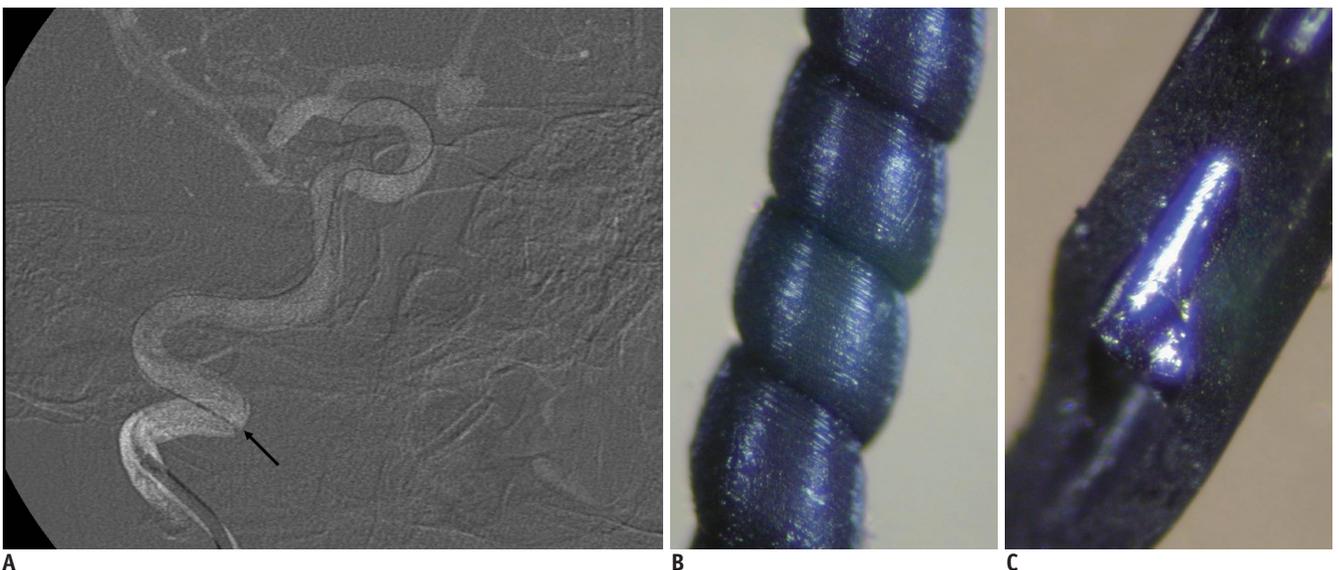
**Fig. 2. Guidewire breakage during neurointerventional procedures in 65-year-old woman.**

guidewire remained within the ICA lumen. The fractured end appeared to be stuck in the ICA wall (Fig. 2A). Microsnare (Microvena, Boston Scientific, MA) were used for removal of the broken guidewire, but failed to capture it. The procedure was ended after confirming that there was no flow disturbance or any complications associated with the remaining wire part in the ICA. The patient was sent to the operating room and surgical aneurysm clipping was successfully carried out. Surgical removal of the broken guidewire was not attempted.

**A.** Fractured guidewire within internal carotid artery lumen. Fractured proximal tip of guidewire (arrow) appears to be stuck in wall of tortuous internal carotid artery. **B, C.** Experimental magnification view showing twisted (**B**) and fractured (**C**) guidewire (Transend 014, Boston Scientific, MA; 0.37 mm outer diameter) using stereoscope. In **C**, outer sheath has been partially removed to show inner metal core.

Microguidewires for neurointervention are commonly used for complex and intricate intracranial vascular pathology; therefore, they must meet a high standard of quality. These guidewires are frequently subject to multiple strong axial and lateral stresses that can cause bending and kinks. Repeated overextension or excessive rotational movement can also cause failure of guidewire components. The mechanical and physical properties of an optimal microguidewire are important facets of their quality. Using torsion-testing equipment, Ceschinski et al. (4) measured the torsional rigidity of various guidewires on the market. They found significant variation in torsional rigidity, depending on materials and design characteristics. The fractured guidewire in our series was the Transend EX 014 (Boston Scientific, MA). The basic structure of this microguidewire consists of a scitanium alloy core metal, which is covered with polyurethane. As an experiment, the authors rotated the Transend microguidewire many times in one direction within a microcatheter, which is placed on a table with simulation of the tortuosity of the carotid artery and cerebral arteries (Fig. 2B, C). We found that the outer polyurethane sheath at the middle or distal part of the wire became twisted segmentally with manual rotation of the proximal wire part (Fig. 2B). After 20-30 rotations in one direction, the inner metal core was often fractured too. This twisting and fracturing occurred only when the microcatheter was placed as if in simulation of vascular tortuosity. In this situation, a part or parts of the guidewire became relatively fixed to part of the microcatheter lumen. As a result, rotational force can be transmitted unevenly through the microwire. Consequently, the fixed part does not rotate while the proximal part does. This discrepancy in rotational motion causes the two components (the core metal and the outer polyurethane cover) to move separately. The outer part is twisted more than the inner metal core. Soon, the inner metal core begins to become twisted;

if excessive, it can be fractured (Fig. 2C). As the same guidewire has been fractured in several neurointerventional cases, we suspect that the Transend guidewire is more brittle than guidewires produced by other companies.

Technical errors committed by the operator are another important cause of guidewire fracture. In the cases reported here, excessive torsional rotatory manipulation or handling, especially in one direction, was the apparent cause of the wire fracture. To avoid this complication, operators need to make note of or recognize how they manipulate microwires during the procedure. If vessels are particularly tortuous, they should be more careful. Excessive rotation of the microguidewire may cause its fracture.
