JAMUNA RIVER EROSIONAL HAZARDS, ACCRETION & ANNUAL WATER DISCHARGE—A REMOTE SENSING & GIS APPROACH

E.U.Pahlowan^{a,*}, A.T.M. S. Hossain^b

KEY WORDS: Jamuna River, Hazard, Remote Sensing, NDWI, Erosion, Accretion

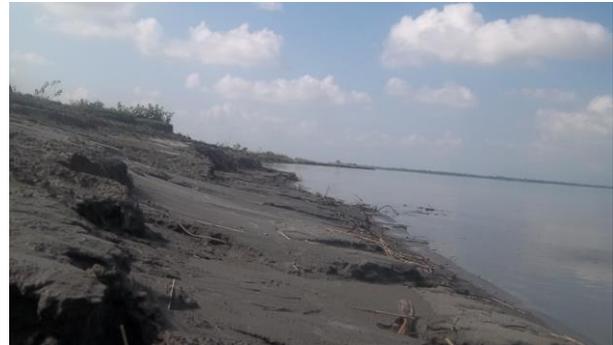
Figure 7. Unvegetated bar erosion at Char Maina Jamuna River, Jamalpur.

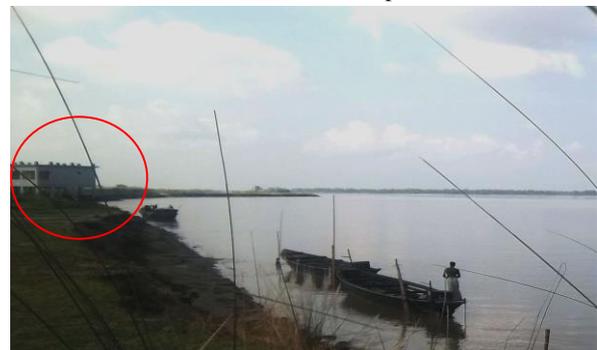
Figure 8. Govt. Primary School at Belgacha facing serious threat of bank erosion .

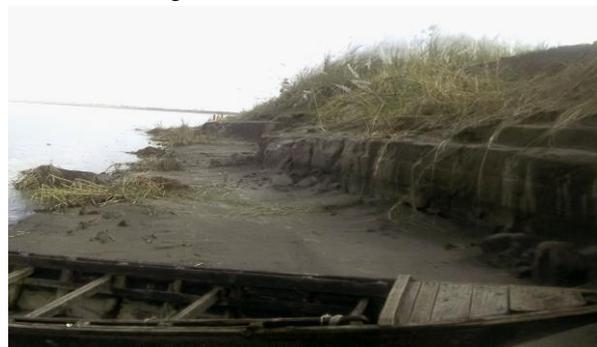
Figure 9. Vegetated bar erosion at Char Barul, Jamuna River, Jamalpur.

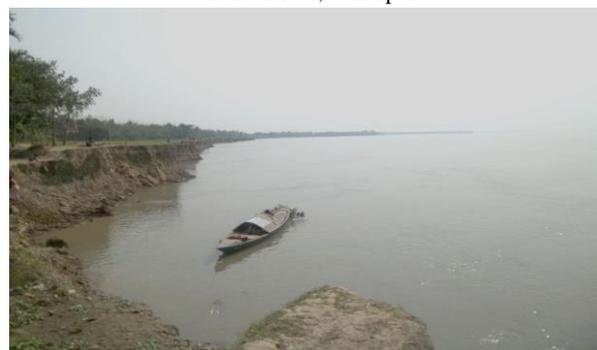
Figure 10. Bank erosion 6 km south from Bahadurabad.
