## POST-OCCUPANCY EVALUATION STUDY OF A UNIVERSITY PREMISES IN CAIRO, EGYPT

This study introduces a post-occupancy evaluation to assess the performance of one of the buildings at MSA University (a pioneer private university) in Cairo, Egypt, from the users' perspective. The main objective of this study is to understand the relationship between the built environment demonstrated in the Faculty of Engineering indoor spaces and the needs of the college community comprising the students and staff. This will underpin the strengths and shortcomings of the present design to facilitate future improvements. The adopted methodology utilizes a number of assessment techniques, including observation, walk-through, questionnaires and interviews. The study culminates with a number of recommended actions to improve the building's performance from the users' (students and staff) perspective, which have a strong impact on the learning experience. These are classified into immediate, intermediate-term and long-term actions.

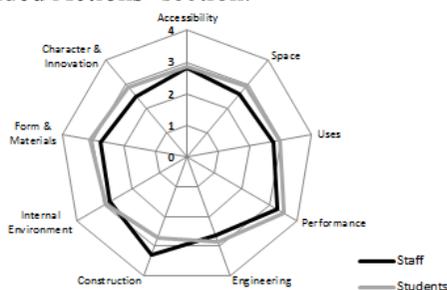
Fig. 3. Radar diagram shows average satisfaction level for user groups with design quality indicators (Source: Authors).

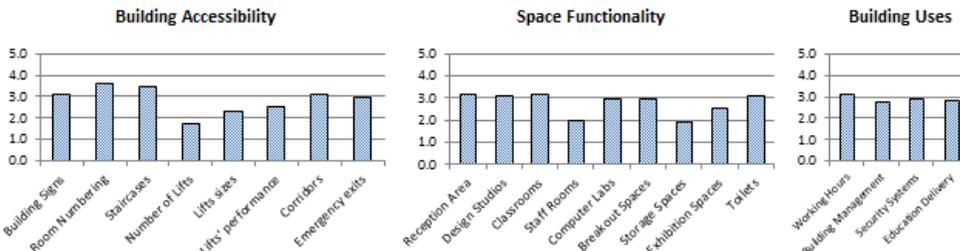
Functionality is concerned with the arrangement of spaces and how they are designed to be useful. Occupants were asked to rate their satisfaction of the building performance regarding building accessibility, space functionality, building uses and management. The survey reveals that the mean degree of user’s satisfaction regarding building functionality is the least among other building quality indicators with an average score of (2.82).

**Fig. 4.** Average satisfaction score on 5-points Likert scale for the functional performance of the building in terms of building accessibility, space functionality and building uses (Source: Authors).

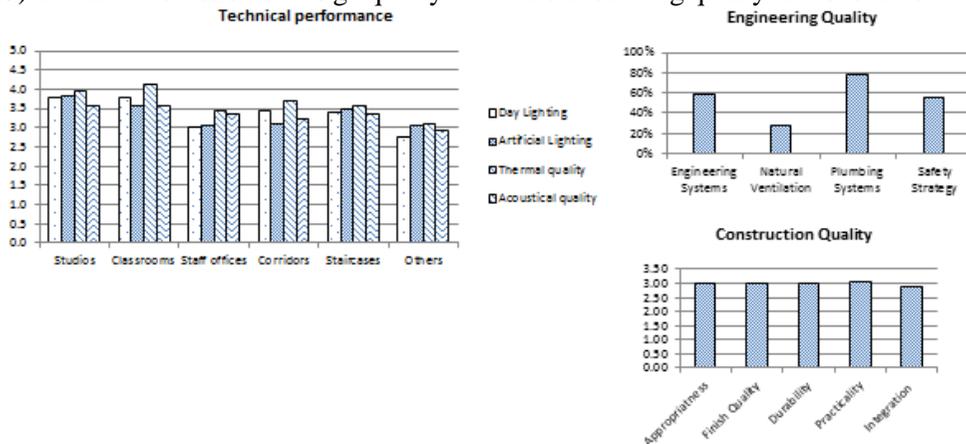
**Fig. 10.** Average satisfaction score for the building quality in terms of technical performance, engineering quality, and construction quality (Source: Authors).

As shown in figure (10), thermal quality scored an average degree of satisfaction of (3.65). The following discussion sheds light on the thermal considerations of the subject building to clarify the reasons for this level of satisfaction. The Köppen-Geiger climate classification system classifies the climate of 6th of October City as hot desert where there is largely unbroken sunshine for the whole year due to the stable descending air and high pressure [19]. Accordingly, shading studies had to be well considered. This explains why the authors and their assistants paid special attention to this particular aspect in the walkthrough journeys. It is also because this issue did not have the needed focus and was dealt with as a subset of 'thermal quality' throughout the previous two phases. Hence, when an observer looks at the building externally, it becomes clear that the form of the building achieves this to a good extent. On the other hand, when the observer is distant from the immediate proximity of the building, it becomes noticeable that the designers did not pay the same attention to landscaping, and there is an apparent lack of plants and vegetation around the building. This affects the users around the building and the building itself, because it leaves the structure totally exposed to the severe solar radiation of 6th of

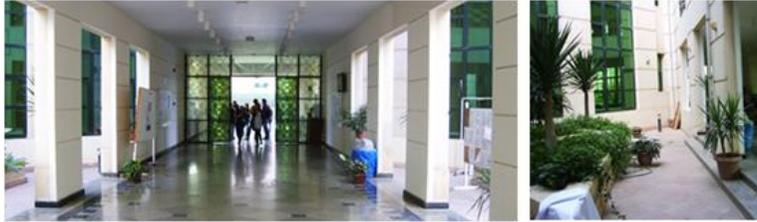
This section is concerned with how well the building is put together. The structure of the building depends on concrete columns and slabs. The windows are made of green glass panels supported by aluminium frames. The entry doors are made of aluminium sections, while the main entrance is composed of a curtain wall that spans over a double-height entrance lobby.

**Fig. 11.** Panoramic views for the promenade leading to secondary entrance with courtyards on both sides (Source: Authors).

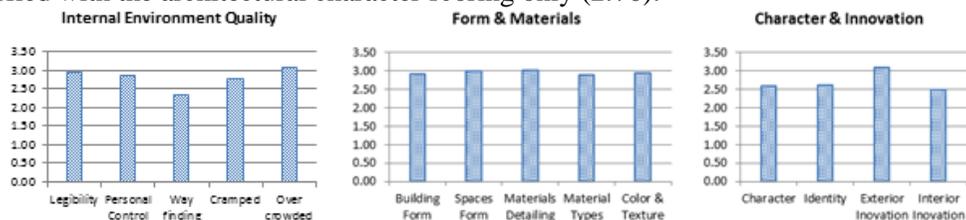
In general, this includes the building's ability to delight, to create a sense of place, and to uplift the local community and environment. Thus, and as mentioned earlier, it mainly entails a twofold study. It starts by focusing on the building's impact on its internal environment. Then, the study examines the impact of the building on the surrounding context. The survey discloses that respondents are moderately satisfied with internal environment quality, as well as form and materials of the building with an average score of (2.89) and (2.94) respectively. On the other hand, the study shows that users are less satisfied with the architectural character scoring only (2.70).

**Fig. 12.** Average satisfaction score for the impact of the building in terms of internal environment quality; form& materials; and character & innovation (Source: Authors).

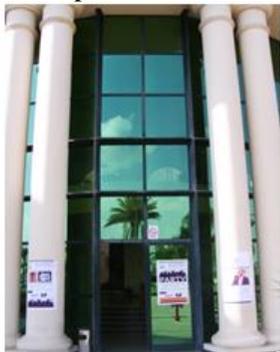
The building has a regular form that depends on a hierarchy of courtyards to form the way it looks. Materials used for external finishes are typical paint on plaster in addition to green-tinted curtain walls. In average respondents reported that they consider the building's form and shape appropriate to its use and environment, and that the form of different inner spaces is reasonably pleasing with an average satisfaction score of (2.94).

Fig. 13. Main entrance of the building within the curtain wall (Source: Authors).

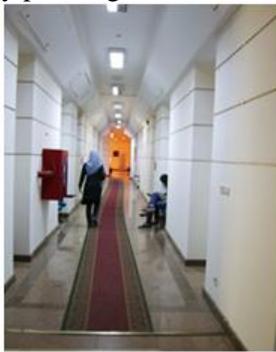
Along the same lines, there are comments regarding circulation and the way finding of spaces with an average satisfaction score of only (2.34). It is known that way finding is, to a certain extent, based on signage system, sign designs and their legibility are very important factors that affect the way finding system, in addition to room numbering. Those two aspects were mentioned earlier under the sub-title 'A-1 Building Accessibility'. Building signs scored an average of (3.09), while room numbering system recorded (3.62). Yet, almost half of the study sample stated that they face difficulty and feel lost when moving inside the building, to an extent that sometimes they have trouble orienting themselves within the building and in relation to their destinations. Students who have experienced such difficulties illustrated their confusion with comments such as 'all corridors look similar'; 'although the number of signs are reasonably good throughout the building, but they need to be increased in number and better distributed' and 'signs are not clear enough, they may need to be redesigned'. These quotes clarify the conflict between being satisfied of the signs and room numbering system from one side and facing difficulty in reaching destinations within the building from the other side.

Fig. 14. Typical corridor inside the building, showing absence of identity & architectural character (Source: Authors).

Although partially resolved by having some of the architectural students' projects hung up in the corridors of the architectural department, it is not enough to entirely resolve neither the identity nor the way finding issues. It is highly recommended that a new plan for signage system be adopted to distinguish between different departments within the building. This plan may include adding new signs, sign design, sign legibility, and sign distribution throughout different areas. It is also suggested to make strong variations in colours through corridors, add more 'you are here' maps, put signs for names of departments and main spaces (e.g., dean's office, head of department), and not only by room number.

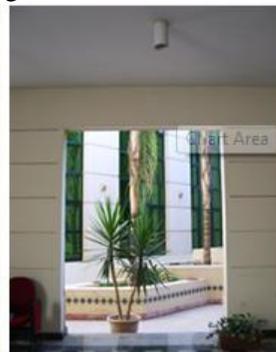
Fig. 15. One of the courtyards in the ground floor (Source: Authors).
