Performance Assessment of Installed Solar PV System: A Case Study of Oke-Agunla in Nigeria

ABSTRACT

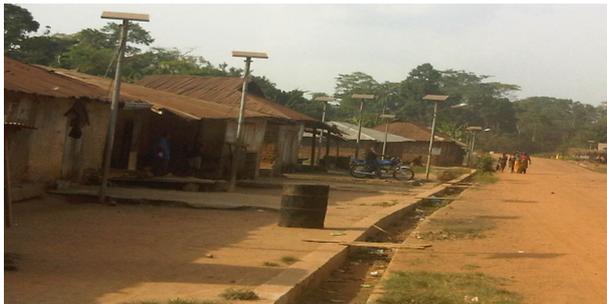
Figure 2. Installed solar street lights in Oke-Agunla, Ondo State, Nigeria.

The solar street lights numbering 10 are all off-grid solutions. They are AC powered with top-of-pole mounted solar modules. In the first few months of installation, the beneficiaries enjoyed night lighting from dusk to dawn every night and the photocell intelligence worked as installed. However, the system performance began to deteriorate at about 28 months. The deficiencies noticed in the SSL infrastructure are twofolds. Due to the short length of the light poles, the distance between light poles were short, and this means there are more poles being used. From design perspective, the higher the poles, the fewer the number to be used because of the wider area of illumination coverage. Paint coating on the poles are peeling off. The silver paint coating on the lighting poles has been peeled off, leaving a rusty surface. Use of none galvanized metal poles. The metal poles used for the lighting system were not galvanized. Galvanized metal poles have higher corrosion resistance than non-galvanized materials. Poor Aesthetics was noticed where good design and finish were not given a priority on the SSL job. The battery box height was rather low, making it easily accessible to unauthorized people. Earth wires in some installed were hanging which has exposed a substantial number of the earthen wires to abuse by passer. The SSL lamps were AC powered hence, each unit has an inverter embedded to invert the DC. This led to some power losses.

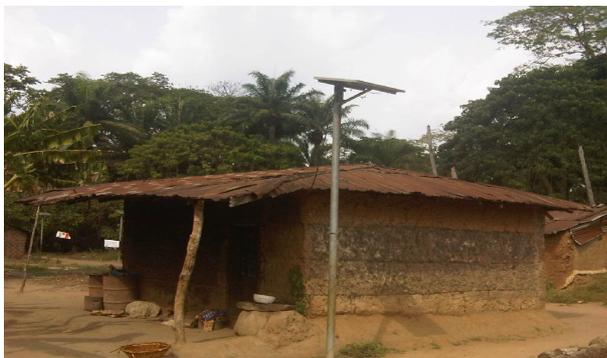
Figure 3. Installed home solar lights.

All the fourty stand alone systems are off-grid solutions. Each unit consists of two components; outdoor unit and indoor unit. The outdoor unit is a top-of-pole mounted single 70W solar module, working at 5.5 peak sun hours per day, the module has the capacity to generate 385 Watt-Hrs per day baring system losses. Performances were quite good at installation. However, due to system inadequacies bothering on maintenance, the effectiveness was short lived. A large number of the systems stopped

working thirty months after installation. Deficiencies in terms of delivered energy inadequacy are enormous. While the SHS passed the proof of concept as a viable source of electricity for rural dwellers, this particular deployment (Oke-Agunla solution) failed to go beyond meeting the need for just 2 lighting points (Lighting) in the homes. A typical home (urban or rural) conforms to the lighting, ventilation, entertainment, refrigeration, Air Conditioning, Heating and Cooking. LIVERAHC, a residential energy requirement model, whereby lighting L is the most basic electricity need. Almost all electrical household appliances in Nigeria are AC powered. However, the deployed SHS pumps out only DC power to run the lights and provide a single power outlet for DC appliances. Therefore, except a householder invests a converter; almost no other appliance in the house may run off the provided electricity. Lack of spares for component replacement and mishandling of cables by unauthorized persons also constituted the deficiencies.
