## Prognosis and evaluation of tooth damage caused by implant fixtures

**Abstract** (J Korean Assoc Oral Maxillofac Surg 2013;39:144-147)

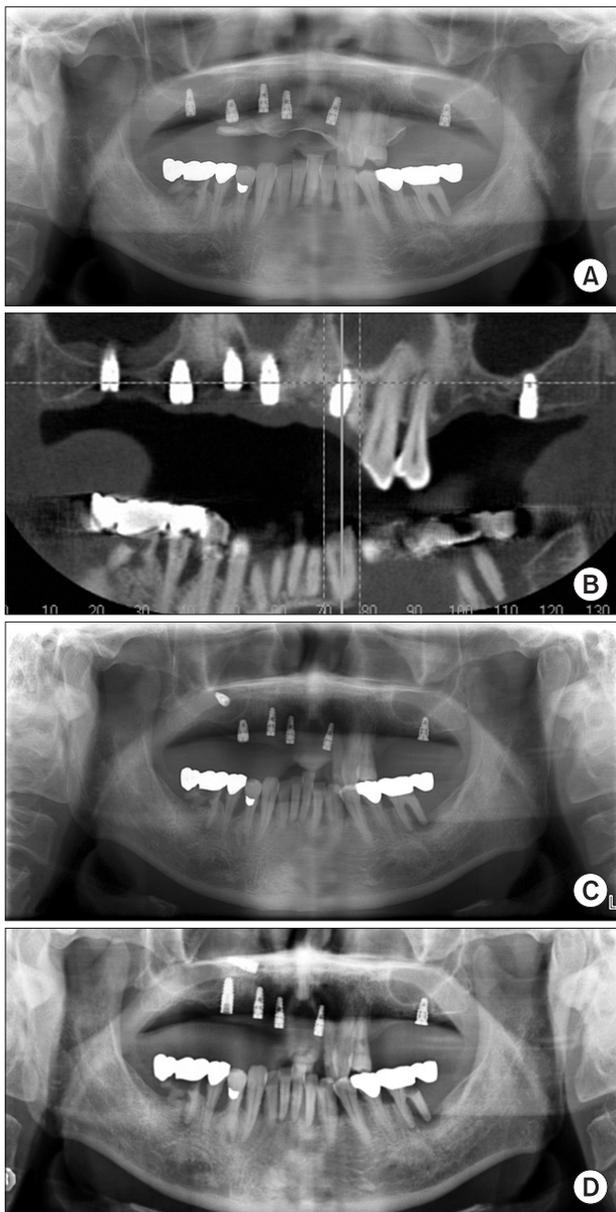
closely to the adjacent #22.(Figs. 1. A, 1. B) The fixture did not affect the adjacent periodontal ligament space, however. The implant stability quotient (ISQ) using Osstell Mentor (Integration Diagnostics AB, Göteborg, Sweden) was 67. #22 did not show specific clinical and radiological findings.

The follow-up radiographs taken 6 and 18 months after surgery showed no extraordinary findings in the periradicular area of the natural adjacent tooth.(Figs. 1. C, 1. D)

**Fig. 1.** Radiographic findings. A, B. Immediately after installation. C. After 6 months. D. After 18 months.

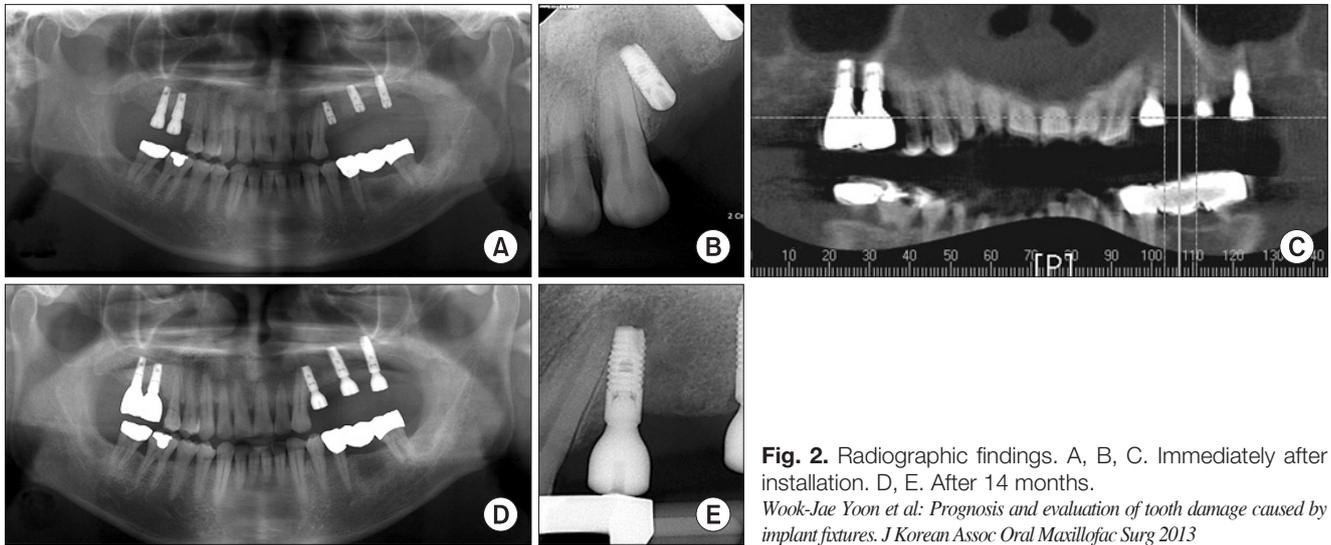
A 55-year-old male patient visited our hospital primarily requiring repair of the implant placed in the missing maxillary molar area. According to his medical history, he had diabetes, which was controlled with medication. Clinical and radiological tests revealed the loss of several maxillary molars (#16, 17, 25, 26, and 27). The left maxillary first premolar (#24) showed a residual root with periradicular inflammation. On the day of the visit, the root was extracted. Because of the patient's personal situation, 18 months passed before an implant was placed in the corresponding area (Astra, 3.5×9.0 mm; OsseoSpeed TX, Astra Tech AB, Mölndal, Sweden), and allogenic bone graft (Allomatrix; Wright Medical Technology Inc., Arlington, TN, USA) was performed simultaneously. ISQ using Osstell Mentor was 72. Nonetheless, the fixture was observed to be located very close to the adjacent tooth (#23).(Figs. 2. A-2. C) In addition, radiolucency was noted in the periradicular area of the fixture. The radiographs taken 14 months later showed that its size was not changed.(Figs. 2. D, 2. E) There were no specific clinical findings in the adjacent natural teeth. After 1 year, the Periotest value (PTV) using PerioTest C (Medizintechnik Gulden, Hessen, Germany) was -4.

**Fig. 2.** Radiographic findings. A, B, C. Immediately after installation. D, E. After 14 months.  
 Wook-Jae Yoon et al: Prognosis and evaluation of tooth damage caused by implant fixtures. J Korean Assoc Oral Maxillofac Surg 2013

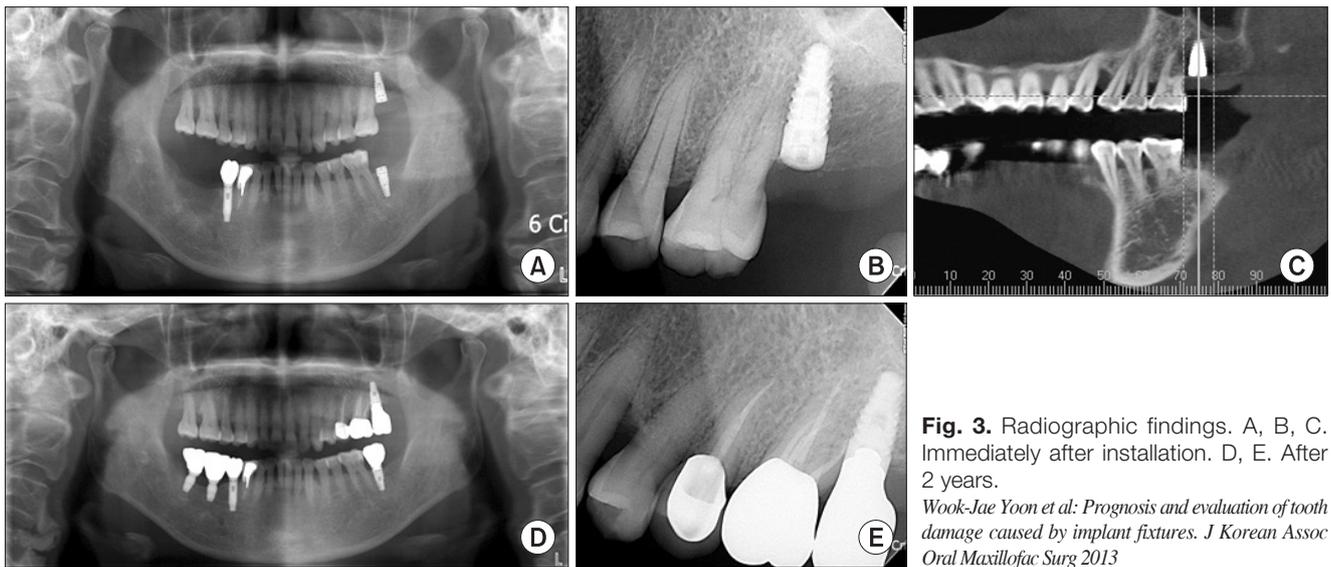
An implant was placed in a 62-year-old female patient due to the loss of the left maxillary second molar (#27) (Biohorizon, 4.6×10.5 mm; Biohorizons Implant Systems Inc., Birmingham, AL, USA). PTV was 7, which was slightly low. In addition, the postsurgical radiographs showed that, due to the dilaceration of the adjacent natural tooth, the fixture was located near the left maxillary first molar.(Figs. 3. A-3. C) A second surgery was performed after 9 months. PTV was -6 (PerioTest C), and ISQ was 84, which were good levels. One year after surgery, endodontic treatments were performed to resolve hypersensitivity symptoms caused by the fall-out of the prosthesis in the mesial area of the adjacent natural tooth (#26) but were not associated with a fixture placed nearby. The follow-up radiographs did not show special findings.(Figs. 3. D, 3. E)

**Fig. 3.** Radiographic findings. A, B, C. Immediately after installation. D, E. After 2 years.  
 Wook-Jae Yoon et al: Prognosis and evaluation of tooth damage caused by implant fixtures. J Korean Assoc Oral Maxillofac Surg 2013
