Application of Comprehensive Landing Method During the Rectification for the Brick-concrete Buildings in Soft Soil Area

Abstract: This paper first analyzes the tilting reasons of a brick-concrete building in Yunnan province in China. Then, a comprehensive rectification method which combines the stress release method and the excavation of stress release trench was put forward. This method uses the anchor static pile in order to guarantee the safety of the building in the process of rectifying. The practice case showed that the inclination rate of the building returned to 3 % from 14.4 %, which proved the efficiency of the proposed method.

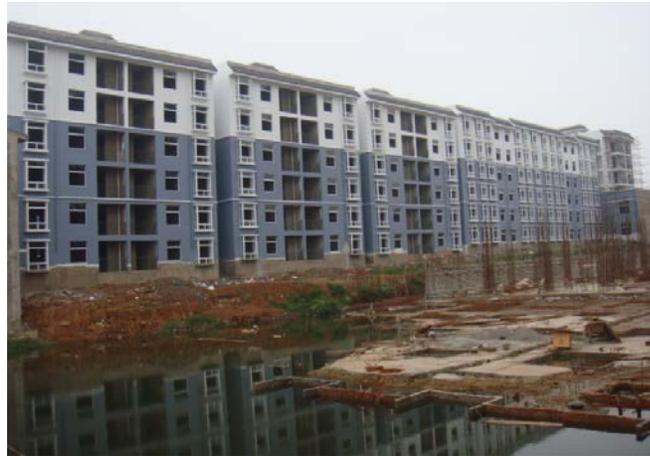
Fig. (1). Architecture elevation drawing.

were completed. When the main structure was totally completed in December 2011, the north side of the building obviously tilted. The maximum ramp rate was 16.9 ‰, and the average ramp rate was 14.4 ‰, which was much higher than the allowable rate of 4 ‰. The surrounding facade and layout of buildings are in Fig. (1), and Fig. (2).

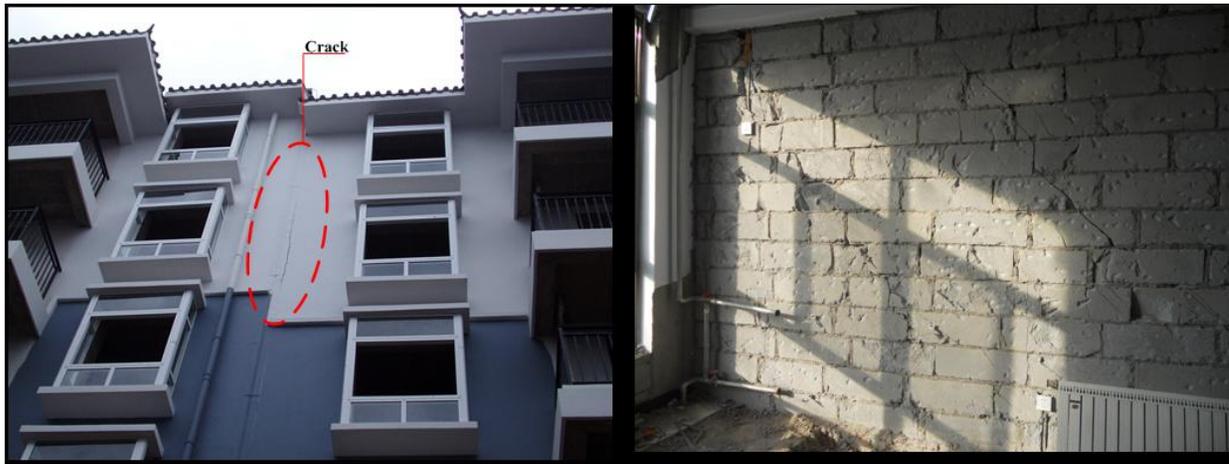
Fig. (2). Architecture layout around.

The rectification of the existing buildings should be carried out in harmously, smoothly and slowly. Because the structure is surrounded by a large number of buildings (Fig. 2), and the water level under it is shallow, if taking the methods of precipitation, the uneven consolidation settlement

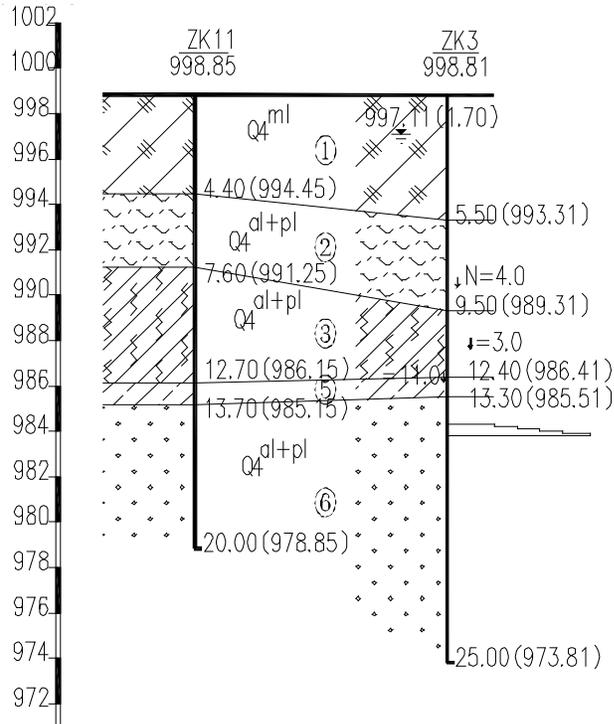
Fig. (3). Typical geological section.

the main kinds of the soil was plain fill, mucky soil, organic clay, silty clay, silt and circular-gravel (a typical geological section is shown in Fig. 3). The miscellaneous fill strata and the soft soil were thick. The underground water was 1.0m ~ 2.5m from the earth, and the components of the soil and the main physical indicators are listed in Table 1.

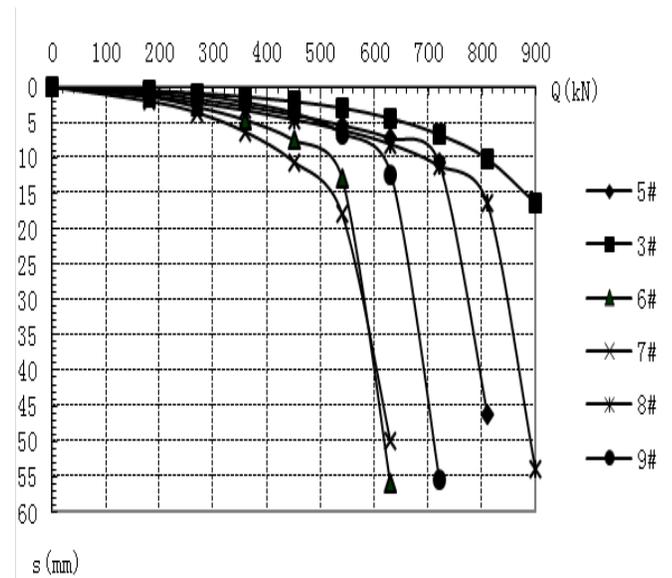
Fig. (4). Q-s curve.

In order to verify the actual carrying capacity of the stirring cored pile, under the foundation beams six piles are selected to have the static load test. The deformation curve is shown in Fig. (4). Obviously, the pile 3 # having the ultimate bearing capacity greater than the designed 900kN, the capacity of the pie 5 # and the 6 # pile reached 520kN, which is much smaller than the design value. So the bearing capacity of single pile did not meet the designed requirements, which was also one of the main reasons leading to the occurrence of uneven settlement building.

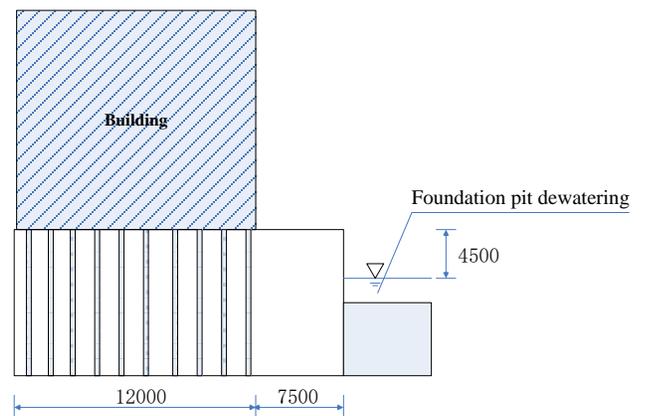
Fig. (5). The relative position.

There was a new building project to the north side of this case (the relative position is shown in Fig. 5). Because the groundwater level of the new building site was shallow, pitting dewatering was implemented.

lower water level of the latter one, which further leads to a greater consolidation settlement. Moreover, there were no support measures around the foundation pit of the north new building, giving the south building the stress relief effect. In other words, the building tended to tilt to the north.

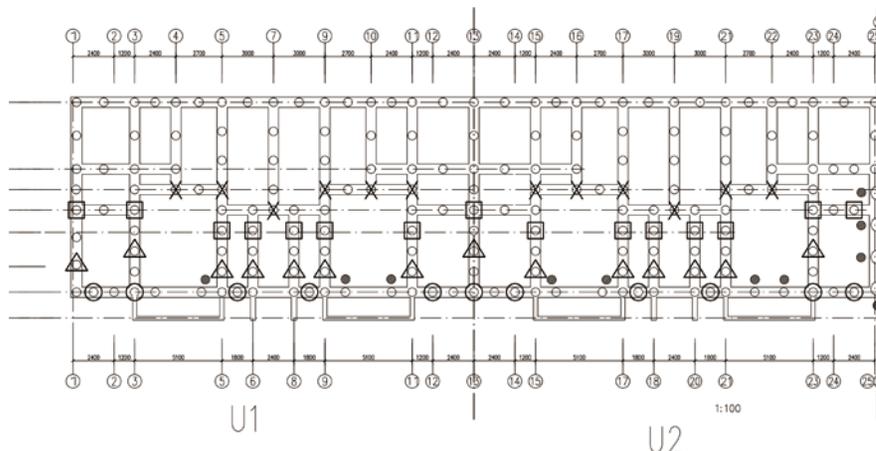
Fig. (6). Chopping pile schematic diagram.

(The batch(\circ , \triangle , \square)shows the order of pie cutting, the others were the same with unit1 and unit2)

In view that the settlement of the east side is smaller than that of the west side, the order of the pile cutting is from the east side to the west side in a gradual transition, and determined the new schedule and batch of the pile truncating are determined according to the settlement observations. The batches of the pile cutting make it possible to make the south of the building a gradually sinking due to its own weight, until the tilting rate of the building meets the regulatory requirements. The truncation order of the pile foundation is shown in Fig. (6), and the site of pile cutting is shown in Fig. (7).

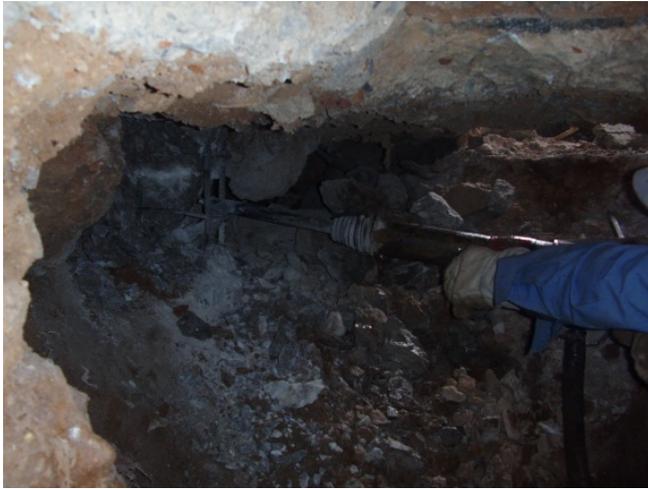
Fig. (7). The scene of cutting pile.

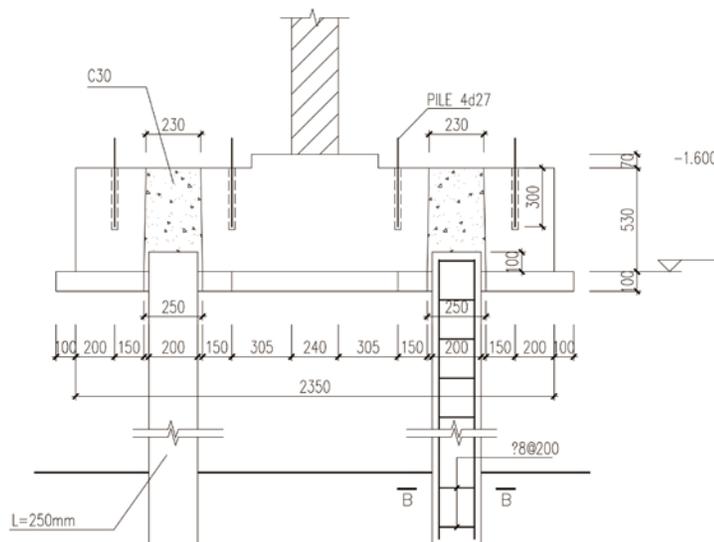
Fig. (8). Anchor jacked pile system.

In order to prevent the building from tilting back again after rectification, the anchor piles are added on both sides of the foundation beams of the building (shown in Fig. 8), and the number of the anchor pile is determined after the accounted foundation bearing capacity. The trapezoidal pile hole is reserved and size is big on top and small on bottom, so as to make the pile form an effective embedded solid force when the pouring of concrete is totally healed. The process of pressing piles is bidirectionally controlled by the depth and pressure piling force, with the guiding pile holes if necessary.

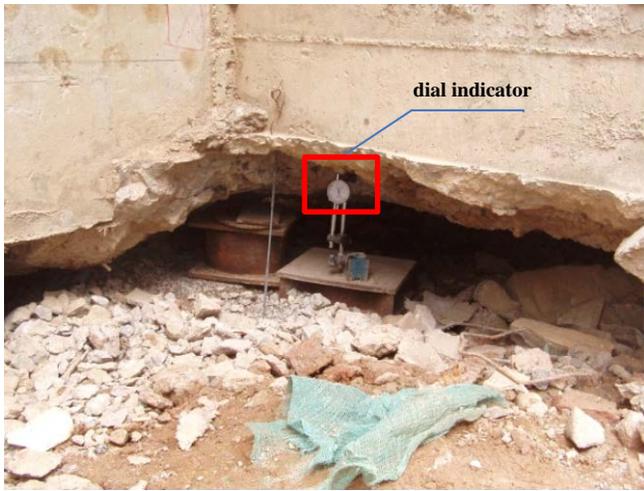
Fig. (9). The dial indicator in position.

The dial is selected at the featured parts of the building, and fixed on the hard base. Moreover, the contacting parts of the building and the ends of the dial are flatted, so as to prevent the external shocks from the data of dial. During the process of the rectification, the larger relatively stiff areas are chosen to set the dials, the monitoring points are observed frequently, the monitoring data are calculated, and the situation of tilting back is reported in time. The dials are shown in Fig. (9).

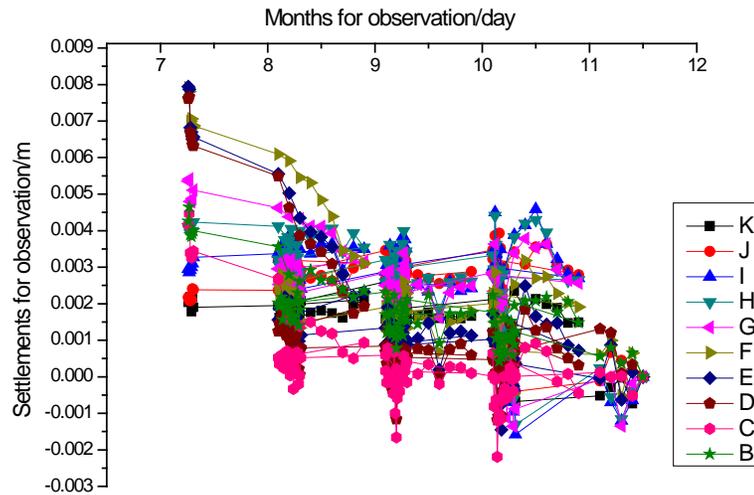
Fig. (10). The curve of the settlement observation on the north side.

(K—the north construction of the anchor static pile; B—the south construction of the anchor static pile; C,E—the order of pie cutting; D,F—upper load in the south grouting; G,J—the finish of pie cutting; H,I—the pile sealing)

The observations of settlement were conducted from the pie cutting to the pile sealing during the rectification of the building. Each monitoring points and the curves of the settlement were shown in Fig. (10) and Fig. (11).

Meanwhile, It could be seen from the curve of the settlement observation that after the completion of pile cutting on the stage of G, the settlement was gradually stabilized. Moreover, it is indicated that the settlement stopped if the results of the monitoring settlement are basically unchanged till the next week.

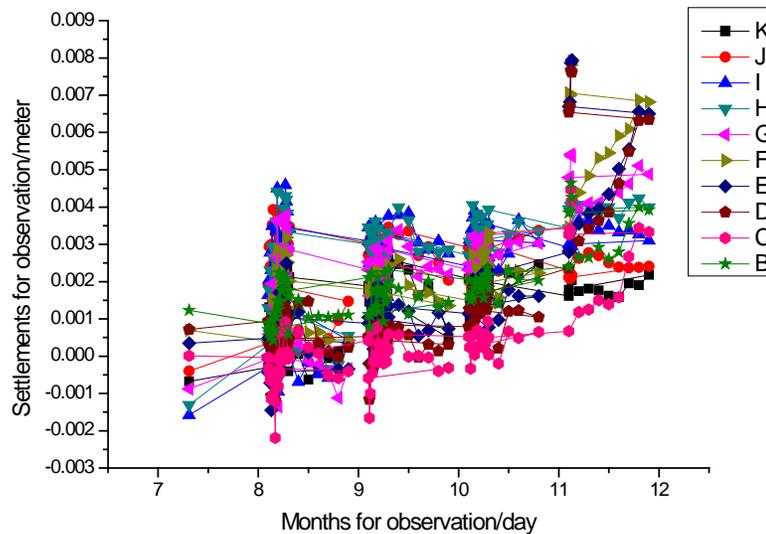
Fig. (11). The curve of the settlement observation on the south side.

(K—the north construction of the anchor static pile; B—the south construction of the anchor static pile; C,E—the order of pie cutting; D,F—upper load in the south grouting; G,J—the finish of pie cutting; H,I—the pile sealing)
