Delayed Knee Locking after Complicated Anterior Cruciate Ligament Reconstruction Despite Good Stability Using A Bio-Transfix

We describe a case of delayed cyst formation that presented as intermittent knee locking after complicated anterior cruciate ligament (ACL) reconstruction using a Bio-TransFix implant in a 21-year-old male patient. During femoral fixation, we could not pull out the guide wire that was temporarily used for the femoral fixation. However, stability was good, and the guide wire was not removed. This was shown to be a wrong type of fixation in a later study. During follow-up, the patient was satisfied and stability was relatively good until 18 months post-operatively. From the 2nd post-operative year, he experienced intermittent knee swelling and locking and pain around the lateral femoral condyle. Follow-up magnetic resonance imaging showed a large cyst around the broken wire tip, but the reconstructed ACL was fine.

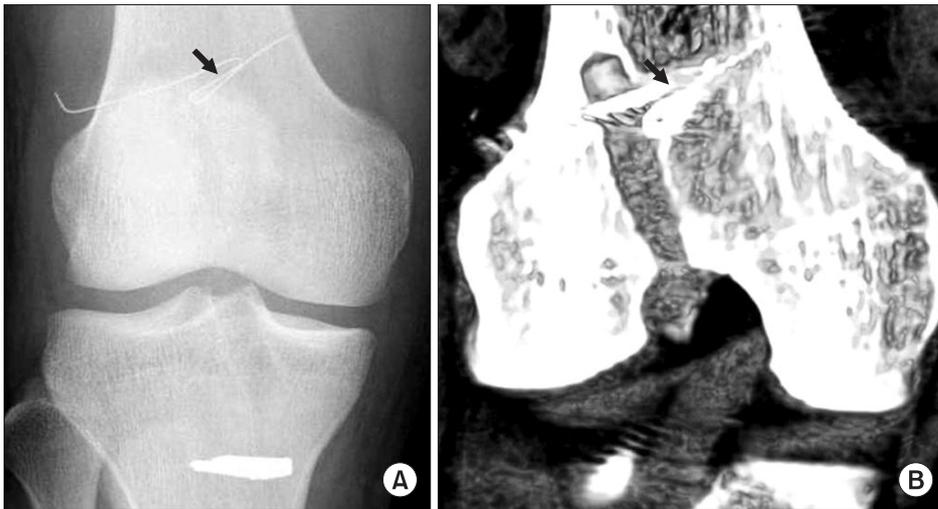
Fig. 1. Postoperative plain anterior posterior radiograph shows the remaining broken wire on the femoral side (A). The CT scan using the ligament setting to remove the metal artifact shows no graft on the Transfix implant but fixation only to the wire loop (B). Arrow: broken guide wire.

graft can not be fixed with any approach. The TransFix implant must be inserted between two strands. However, the implant in our case was inserted above the loop portion of the graft. A broken wire that exits medially is compressed by the forehead portion of the Bio-TransFix implant and the graft is hung on the wire loop because the Bio-TransFix implant and medial side two wire co-exist in the predrilled narrow space located on the medial side of the femoral tunnel (Fig. 1)³. During the operation, a 1 cm incision was used for the TransFix insertion. We maintained the guide wire because fixation failure could occur if the wire was pulled. Therefore, we cut the wire via a skin incision for the TransFix insertion as maximally as possible. The patient underwent routine post-operative rehabilitation and the early postoperative course was not eventful.

In the analysis of complications of ACL reconstruction using a Transfix implant, the mechanism of such good stability with incorrect fixation was considered to be broken wire loop fixation. The cause of this complication was examined, the surgical procedure was checked, and a tight femoral tunnel was suspected. The possibility of an incomplete full proximal insertion of the graft was suspected. The guide wire is relatively flexible compared with the Bio-TransFix implant. Therefore, unrestricted back and forth motion of the wire can occur even though the wire is mildly curved³. Hence, unrestricted back and forth motion of the wire does not confirm the full proximal insertion of the graft.

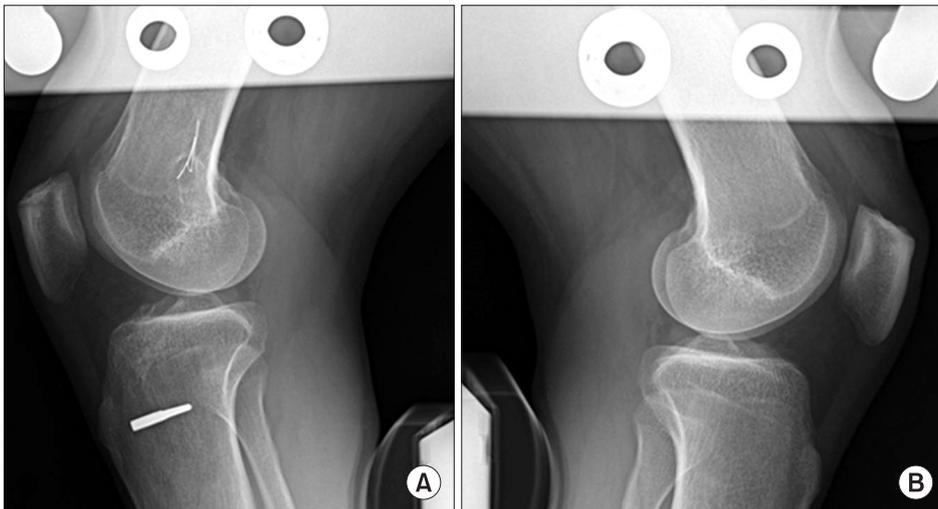
Fig. 2. Stress radiographs show a 1 mm difference between the reconstructed (A) and the normal knee (B).

During follow-up, the patient was satisfied and stability was luckily good until 18 months post-operatively. From the 2nd post-operative year, he experienced intermittent knee swelling, locking and pain around the lateral femoral condyle. Stability was also excellent at this time (Fig. 2) and a well-reconstructed ACL was visible (Fig. 3). However, an abnormal 3×3 cm cyst around the broken wire tip was observed in MRI (Fig. 4), which originated from the tip of the broken wire. It was thought that some irritation had occurred from the tip of the TransFix implant, and this was the cause of the locking symptom. The cyst was excised and the wire and TransFix were also removed. Tendon to bone healing was achieved because stability was also good after removal.

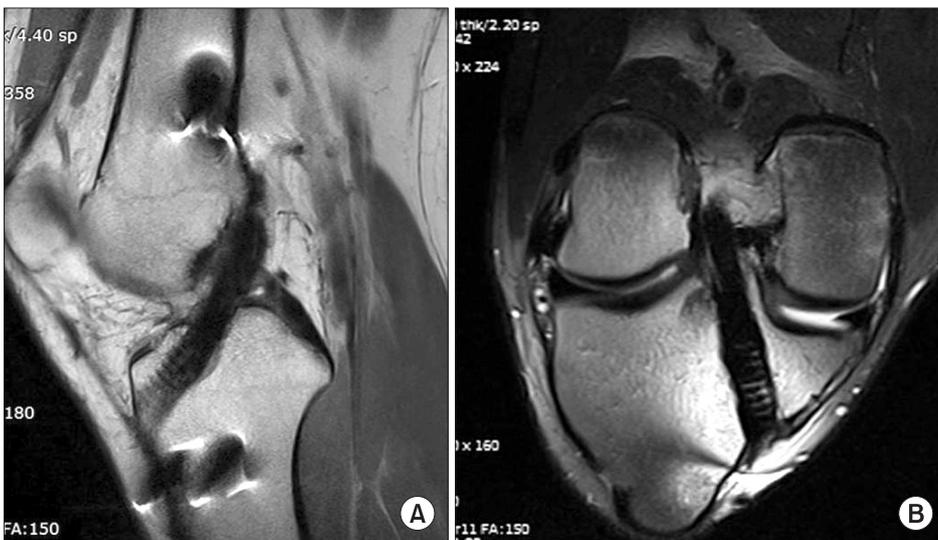
Fig. 3. MR images (A: sagittal, B: oblique coronal) show a dark and straight graft signal of the reconstructed anterior cruciate ligament.

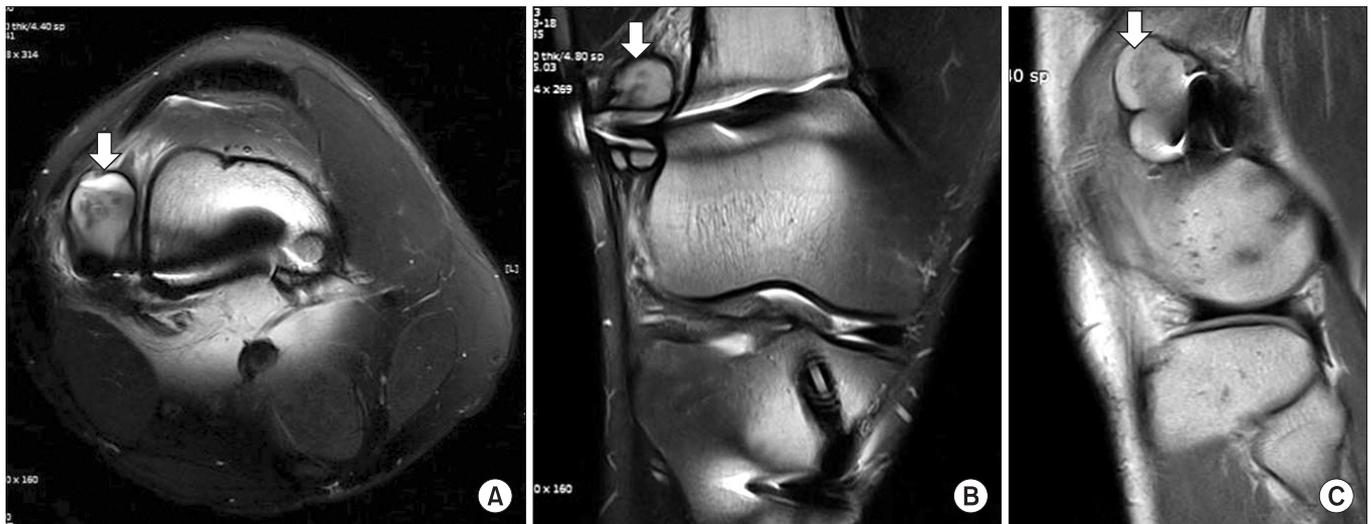
Fig. 4. MR images (A: axial, B: coronal, and C: sagittal) show a 3 × 3 cm cystic lesion at the lateral aspect of the right distal femur, just adjacent to the metal wire tip. Arrow: cyst around broken guide tip.
