WAVE OVERTOPPING SIMULATOR TESTS IN VIET NAM

Le Hai Trung¹, Jentsje van der Meer², Gerrit Jan Schiereck³, Vu Minh Cat⁴, Gerben van der Meer⁵.

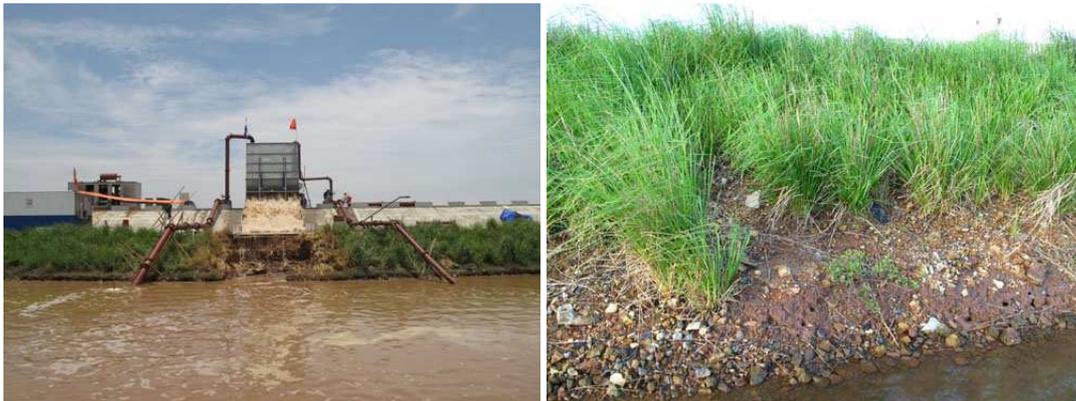
Figure 2. Left: Simulator on dike crest in Hai Phong. Right: lower part of the landward slope was covered with vetiver grass.

In three years 2008, 2009 and 2010 several fieldtrips were carried out along the coastline of Hai Phong and Nam Dinh in order to select suitable test locations. Dike route No.1 in Do Son – Hai Phong was chosen to perform the pilot test in May 2009. The dike is reinforced with concrete on three parts: seaward slope, dike crest, upper part of the landward slope and the inner berm. Only the lower part of the landward slope was covered with vetiver grass (*Vetiveria Zizanioides*). The dike crest level is at $+5.2 \text{ m}$ above MSL and the crest width is 7.5 m . The inner berm is at $+3.5 \text{ m}$ above MSL and 5.0 m wide. The inner slope inclination is $1:2$. Next to the dike toe is a canal supplying water to aquaculture ponds of the local residents. Water was pumped from this canal to fill the Simulator during testing. The test location with the vetiver grass slope in Hai Phong is denoted as DS_01.

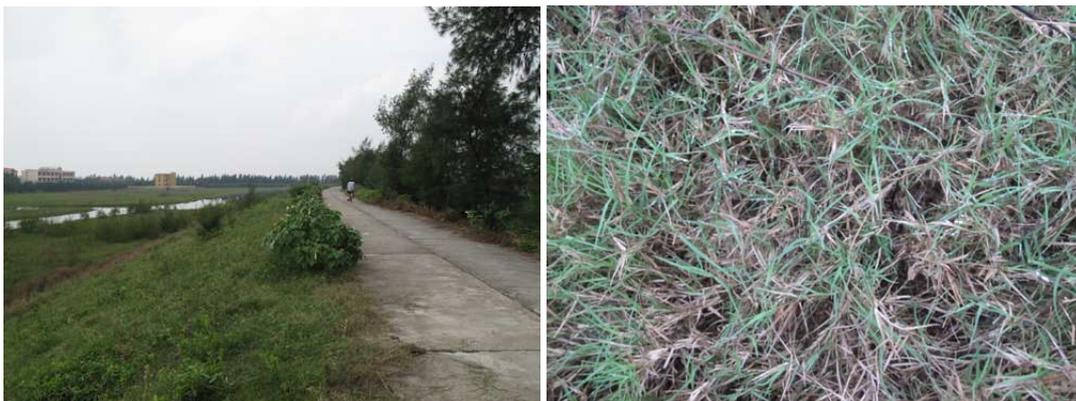
Figure 3. Left: concrete dike crest and tested slope in Nam Dinh. Right: Bermuda grass.

Destructive tests were also performed on a dike slope covered with Bermuda grass (*Cynodon Dactylon*) at the sea dike in Hai Hau – Nam Dinh in Jan 2010. The dike crest level is at +5 m above MSL and 4.5 m wide, paved with concrete of 20 cm thick. The tested slope is 10 m in length from crest to toe and the inclination is 1:3. The dike toe is about 10 m in width and is covered with Torpedo grass (*Panicum Repens*). Parallel to the dike toe is a brackish water canal which could supply water for the pumps. Within 50 m, three sections each 4 m in width with various slope qualities were tested. These locations are denoted as TL_01, TL_02 and TL_03, respectively.

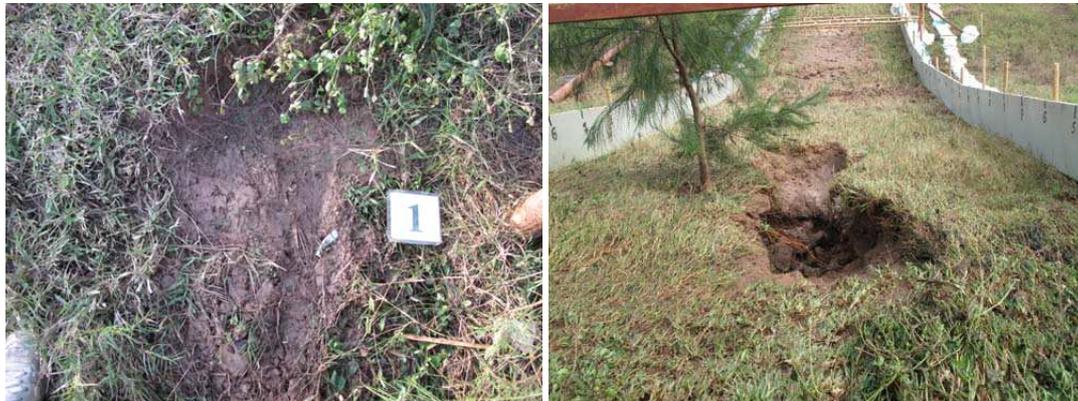
Figure 6. Formation and development of damage on Bermuda grass slope. Left: initial situation. Right: damage was extending to the casuarina root.

At test location TL_02, damage was first formed at an existing hole, see Figure 6. After 2 hours testing with a discharge of 10 l/s per m, this damage hole became a deep gully with one side reaching

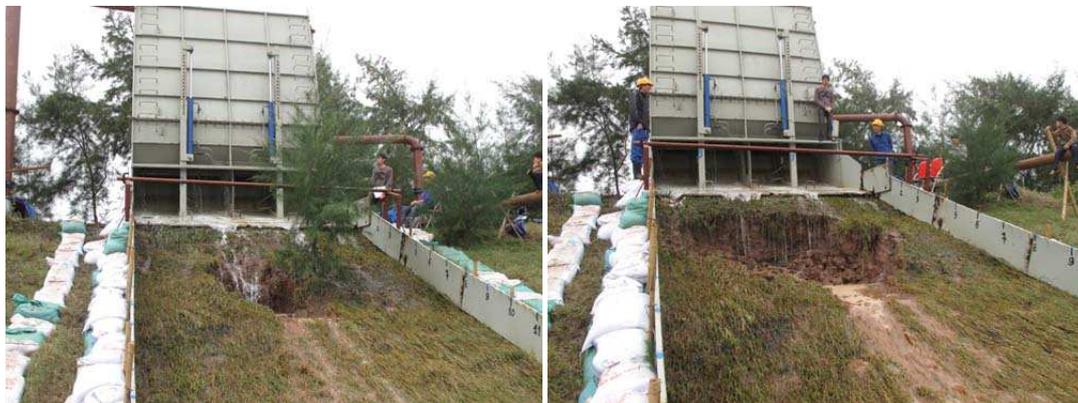
Figure 7. Dike slope after 4 hours of 10 l/s per m (left) and after that 30 minutes of 20 l/s per m, the 7-cm-diameter casuarina collapsed (right).

the small casuarina which was 7 cm in diameter. After that, the damage developed rapidly resulting in the collapse of the casuarina and a large hole on the dike slope, see Figure 7.

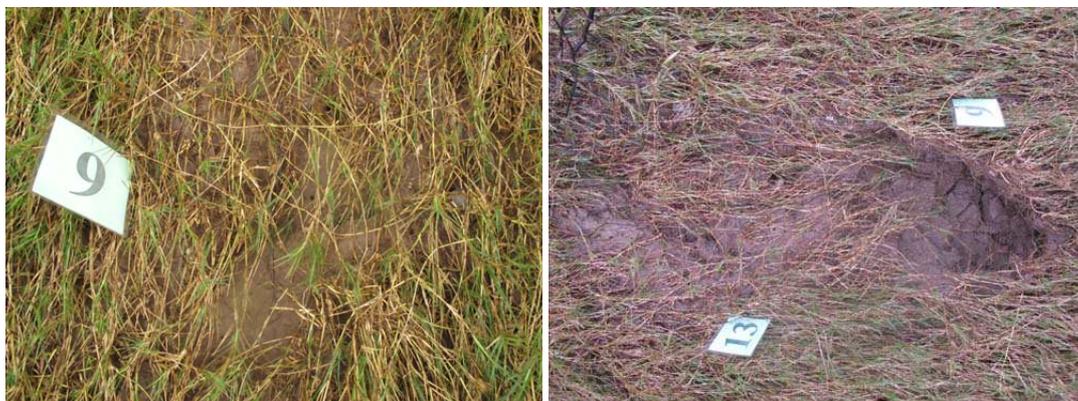
Figure 8. Left: single damage hole after 4 hours of 10 l/s per m and 2 hours of 20 l/s per m. Right: 2 hours extra of 20 l/s per m, tendency of combining two separate holes close to each other.

Under attack of overtopping flows, separate damages could extend to merge into a larger one. Figure 8 shows the situation of a single damage hole and the tendency in which this hole was extending to reach another hole nearby. Later on, the newly formed damage was developing significantly downward in the flow direction. Figure 9 illustrates the damage with rectangular shape after 4 hours of 10 l/s per m, 4 hours of 20 l/s per m and 1 hour of 40 l/s per m.

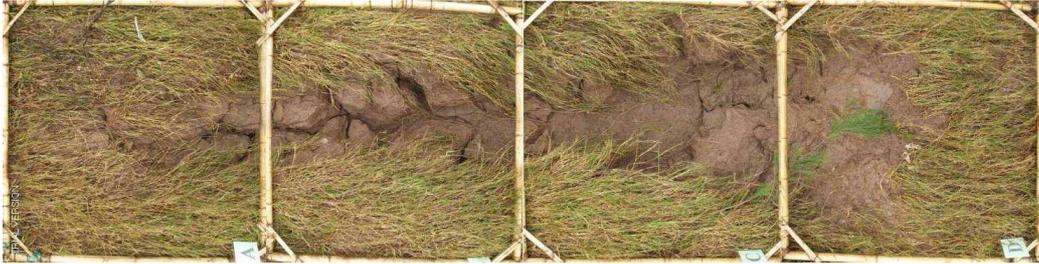
Figure 9. Damage on the Bermuda grass slope with rectangular shape.

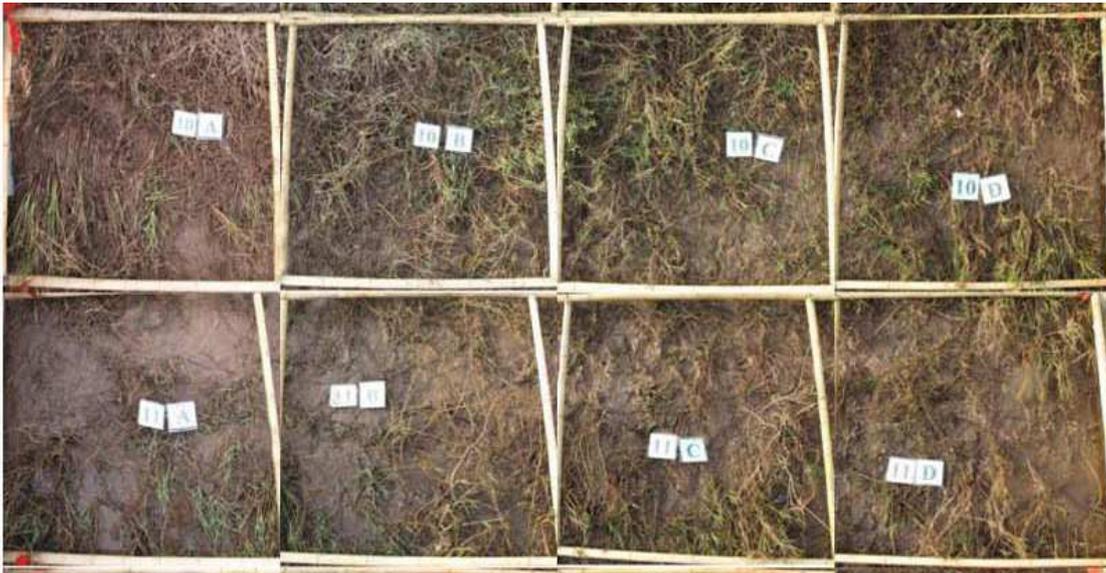
Figure 10. Poor coverage of grass at the transition between the dike slope and the dike foreland.

At test location TL_01, damages occurred at the transition between the dike slope and the dike toe. The slope was covered with Bermuda grass while the foreland was covered with Torpedo grass. Around the transition, the density of either Bermuda grass or Torpedo grass was lighter compared to the higher part of the slope or further away from the dike toe, see Figure 10. It was covered with a thin mat of grass and the soil at the transition was exposed directly to the attack of wave overtopping flows. Moreover, overtopping flows had to turn direction at the transition to attack the foreland under an angle of $\beta \neq 0$ resulting in a much stronger effective force compared to the situation when flows are parallel to the slope. Damages around the transition had square shapes with similar length and width in the entire duration of testing, see Figure 11. It was recognised that when the damage holes got a certain depth, an amount of water was trapped to act as a buffer against the flow impact.

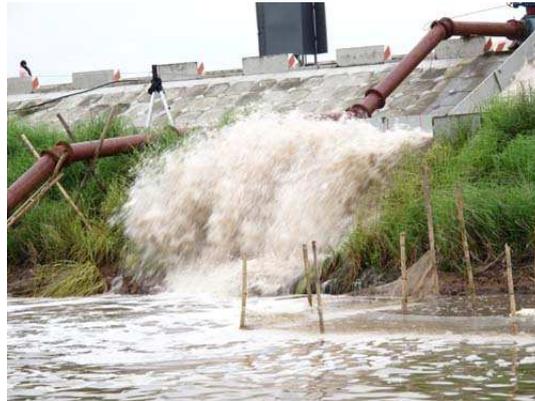
Figure 12. Flow flying from the inner berm attacked the dike toe.

The situation at test location DS_01 was very different due to the vetiver grass and the existence of the inner berm. The berm and the upper part of the inner slope reinforced with concrete were considered to remain intact during testing. Overtopping flow released from the simulator could only affect the lower slope covered with vetiver grass. Figure 12 gives an impression of the water flow flying into the air from the inner berm, and then attacking the dike toe more or less vertically from above. The first row of vetiver clumps next to the concrete berm were first hit by the overtopping flows however these clumps were only forced to lie down and remained intact till the end of the test, see Figure 13. When moving on the slope through separate clumps of vetiver, flow energy and flow velocity were reduced steadily resulting weak flows at the end of the slope. Therefore it is hypothesized that the flying flows from the inner slope caused damage at the dike toe first. Damage developed upward in a trapezoidal shape with large bottom and narrow top as illustrated in Figure 18.

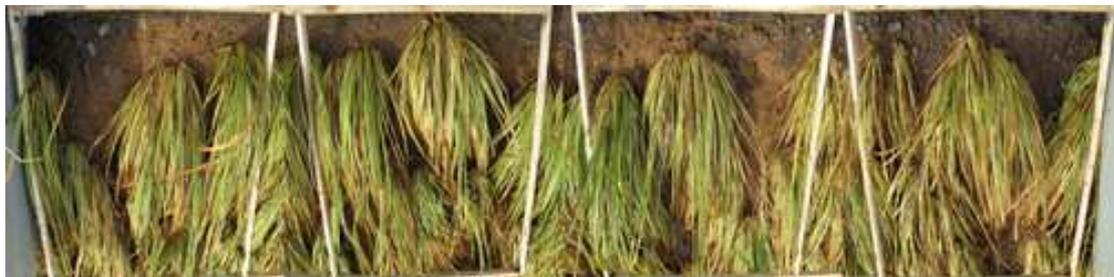
Figure 13. Clumps of Vetiver grass remained intact during testing.

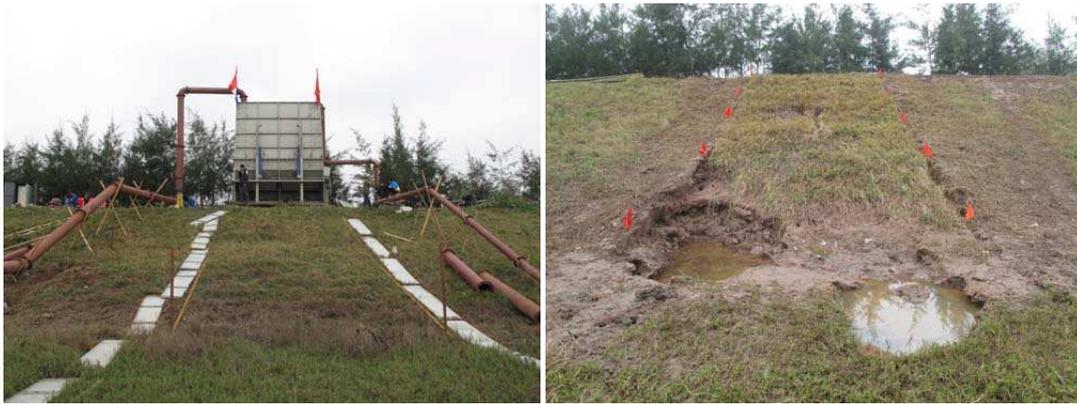
Figure 14. Grass slopes at test location TL_01: initial situation (left) and final result (right).

At test location TL_01, the slope surface was regular and evenly covered with Bermuda grass. No visible damage was found before testing. The test was completed after 15 hours of testing with increasing mean wave overtopping discharge from 10 to 70 l/s per m. Figure 14 compares the grass slope at initial situation and at the end of testing. Significant changes can be recognised such as slope profile and grass quality expressed by the coverage and the colour. Damages occurred on the slope and around the transition between the slope and the horizontal toe, the sand core was however not yet reached.

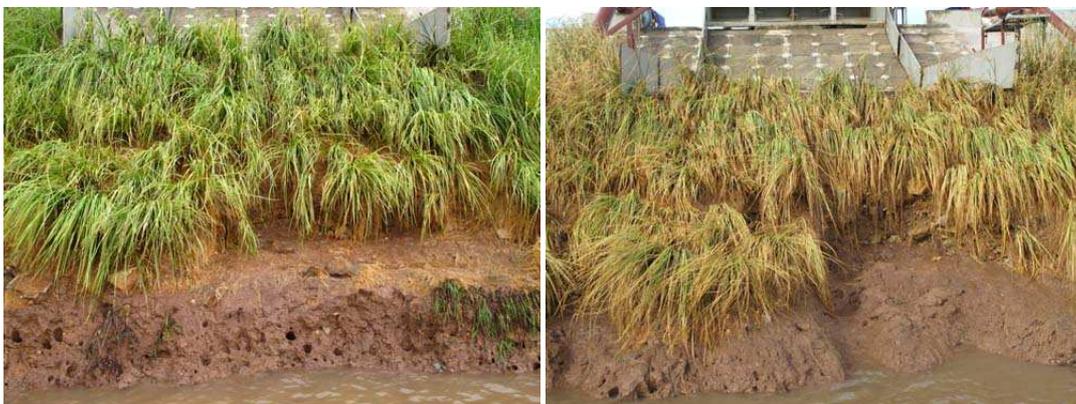
Figure 18. Vetiver grass slope at location DS_01. Left: after 4 hours of 20 l/s per m and 1 hour of 40 l/s per s. Right: final situation.

Damages were first recognised between closing clumps near the dike toe after 3 hours testing with a mean discharge of 20 l/s per m. After 4 hours of 20 l/s per m and 1 hour of 40 l/s per m, some vetiver clumps were eroded away from the dike slope, see Figure 18, left panel. After 12 hours testing with increasing discharge, no considerable development in the upward direction of the damage was found but the dike toe was steadily eroded. The experiment was finished after 18 hours in total, in which 2 hours of 20 l/s per m, 4 hours of 40 l/s per m, 4 hours of 70 l/s per m, 4 hours of 100 l/s per m and 2 hours of 120 l/s per m. As can be seen in Figure 18, the lower part covered with vetiver grass remained stable, however, the clay underneath was severely eroded.

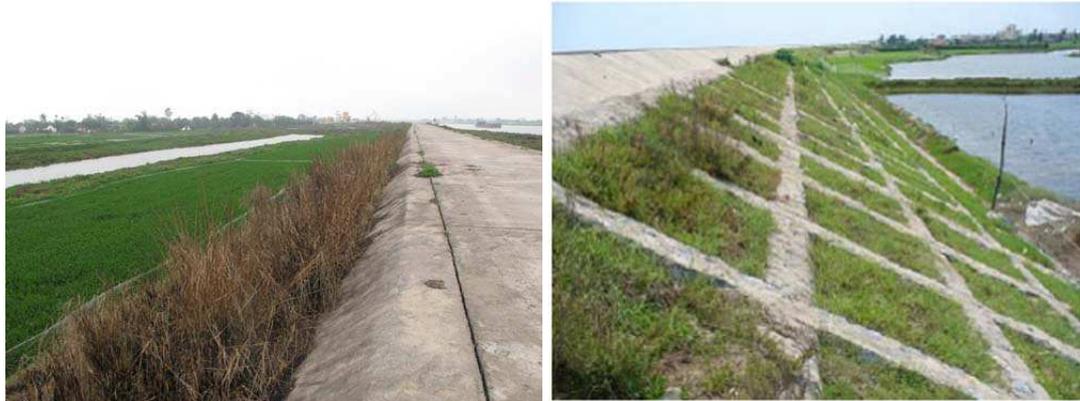
Figure 20. Left: sea dike in Thai Binh with vetiver grass on inner slopes. Right: local grass in concrete frames on Nam Dinh .

To understand more about the strength and the weakness of the present sea dikes in Viet Nam and to gain more experience and knowledge to improve the design guideline, more destructive tests are encouraged on different grass slopes. For instance, two typical landward slopes are shown in Figure 20: the first which is steep and short is protected with vetiver grass in Thai Binh; while local grass is planted within concrete frames on the later in Nam Dinh province. For each selected dike section,
