Archeological and Historical Database on the Medieval Earthquakes of the Central Himalaya: Ambiguities and Inferences

by C. P. Rajendran, Kusala Rajendran, Jaishri Sanwal, and Mike Sandiford

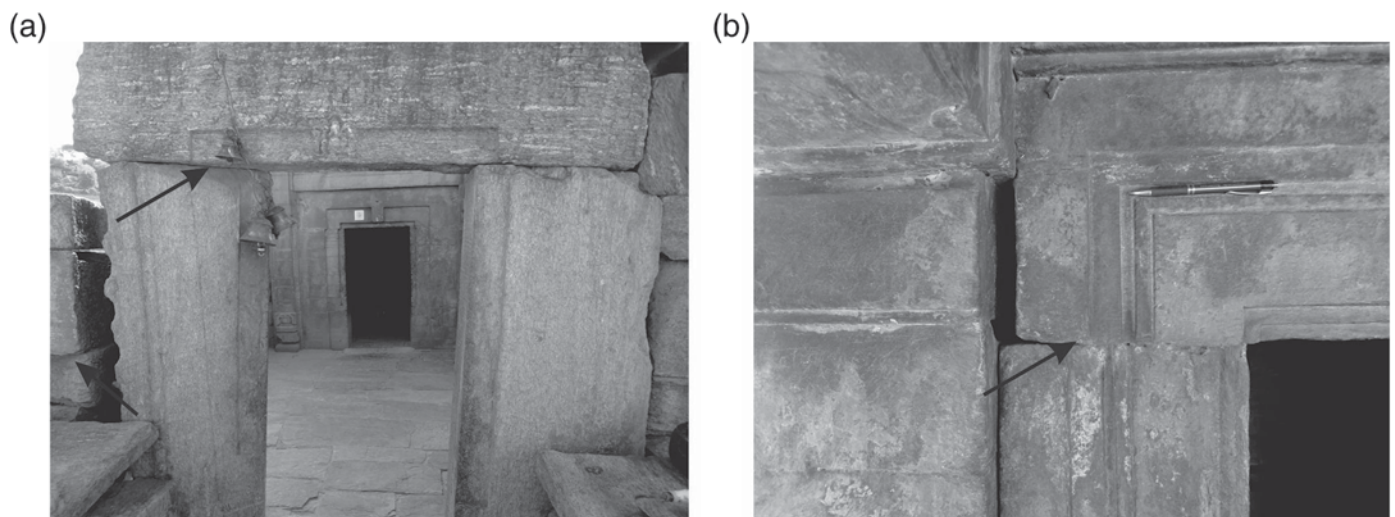
15 ▲ **Figure 4.** View of Baijnath temple showing (a) rotation of a pillar and (b) block displacement.

Baijanath was the capital city of the Katyuri kings, the earliest ruling dynasty of the central Himalayan region, and the Baijanath temple complex was built during the tenth to twelfth centuries A.D. (~A.D. 1150) (Nautiyal, 1969). The top part of the main temple was destroyed in the year of A.D. 1743–1744 by an insurgent army, thus the main temple lacks its original tower. The construction style is typical of contemporary architecture wherein large blocks are arranged on top of each other without any cementing material. The blocks are anchored using iron brackets. The temple complex as a whole shows tilting toward the south and pillars of some of the smaller structures show rotation and displacement of the building stones (Fig. 4).

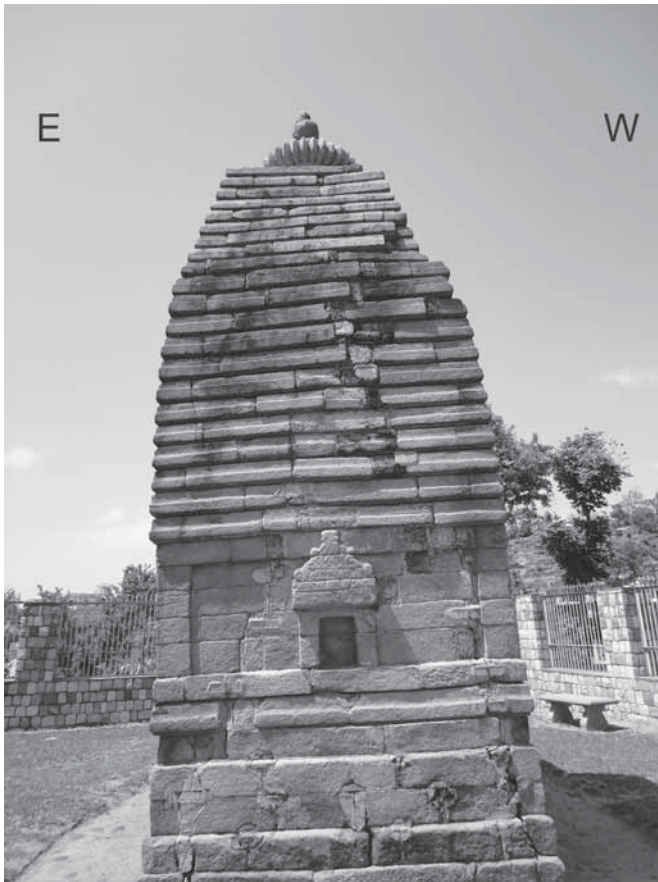
▲ **Figure 5.** View of Vandev temple at Dwarahat, twisted about its axis.

Vandev Temple. Vandev (eleventh to twelfth century A.D.) is a south facing temple situated ~ 150 m east of the Badarinath group (Fig. 3). Standing in the midst of cultivated fields on the bank of a small river, this pyramidal shrine is rectangular in plan and is presently without any idol. The whole structure appears to have been rotated about its axis in the clockwise direction (Fig. 5). Significant gaps at its corners are taken as evidence for tilting and shearing.

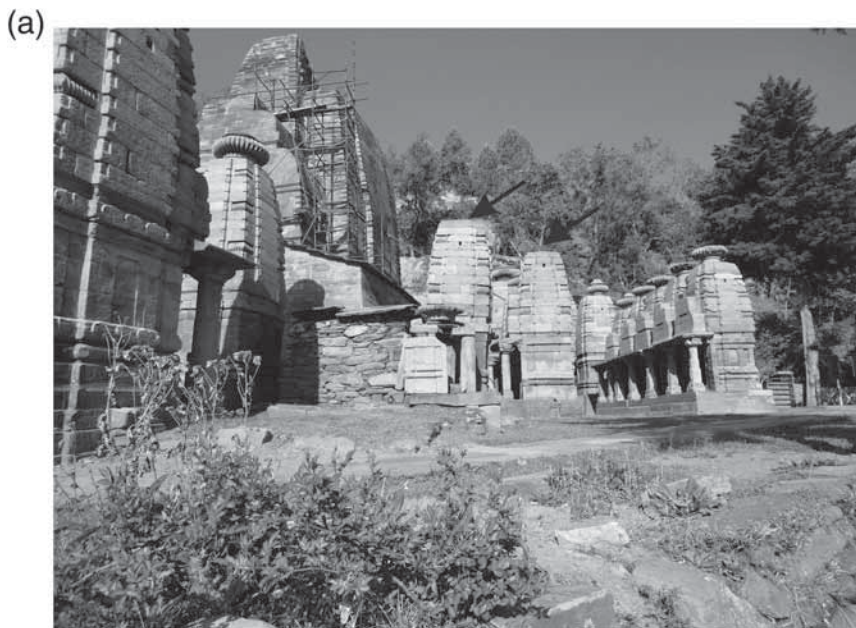
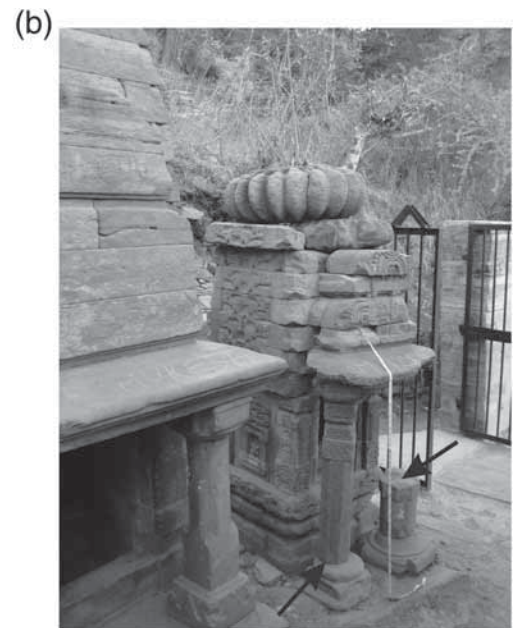
▲ **Figure 6.** (a) View of Katarmal temple and (b) a rotated and damaged pillar of one of the subsidiary smaller temples.

The Katarmal Sun Temple. The Katarmal Sun temple complex (eleventh and thirteenth century A.D.; Nautiyal, 1969) consists of a main temple and an assortment of 45 variously sized miniature structures. Located about 14 km from Almora on a hilltop, the temple is presently in ruins. During the canon firing by British forces in 1815 to evacuate Gorkha troops, the top of the main temple was destroyed (Fig. 6). Located toward the southern end of the complex, one of the pillars of the main temple carries an obscure inscription, dating to the thirteenth century A.D. (Goetz, 1955). The smaller temple units are believed to be older, probably dating to mid-twelfth century (Handa and Jain, 2008). However, our observations on the subsidiary smaller temples indicate evidence for clockwise rotation of pillars ($\sim 15^\circ\text{--}20^\circ$).

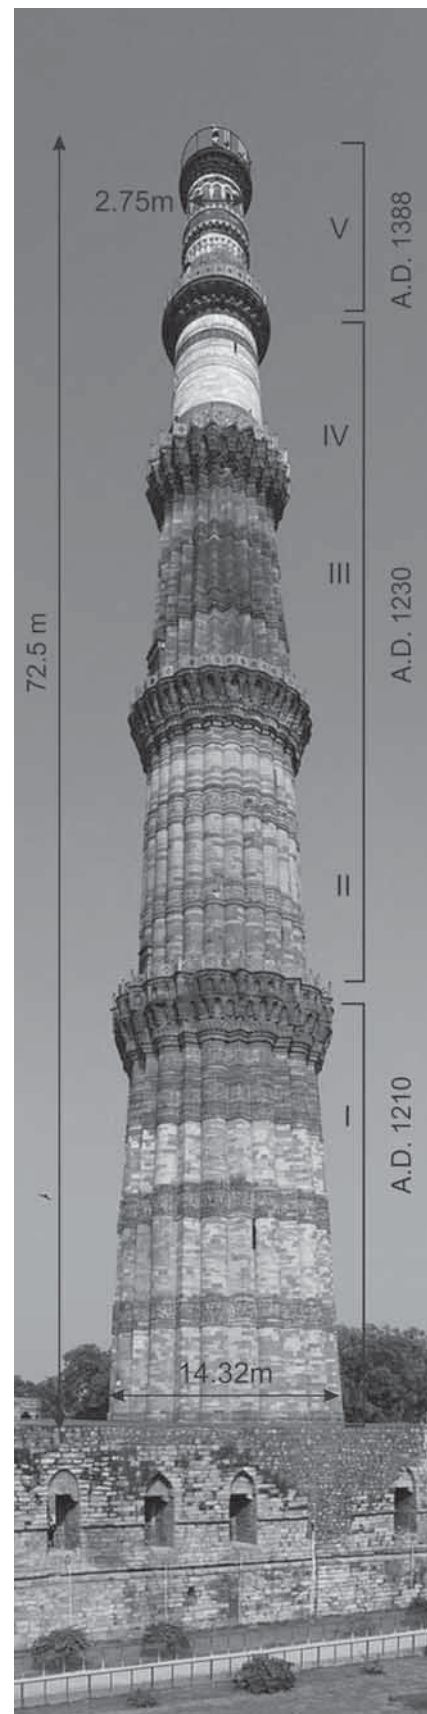
▲ **Figure 7.** View of Qutb Minar (Delhi), showing dimensions of the different stories and their respective years of construction.

Delhi, the capital of India during the medieval period, features several monuments dating to ~ 700 years. The only known case of earthquake-related damage is that of Qutb Minar, a long-standing tall structure located in the heart of the capital city of Delhi (Fig. 7). This 72.5 m high, whose history is quite well documented, is a landmark of Delhi. Built in stages, the first story was completed in A.D. 1210 and the second, third, and fourth stories by A.D. 1230. Lightning damaged its tower in A.D. 1368, and the construction was resumed with the completion of the topmost (fifth) story in A.D. 1388 (Munshi, 1911). There is an inscriptional evidence to suggest that lightning damaged Qutb Minar again in A.D. 1503 (Hijri year AH 909; Munshi, 1911).

The next report of damage to Qutb Minar was from the A.D. 1803 earthquake, affecting the balustrades, balconies, and the entrance. The cupola (i.e., a plain square top on four stone

pillars) is reported to have toppled (Archaeological Survey, 1864; Sharma, 2001). A remodeled cupola replaced it but was brought down in 1847, and the pillar has been without a cupola since then (Munshi, 1911). Damage due to the 1803 earthquake in the Gangetic plain was widespread and coseismic liquefaction was reported from locations as far as Mathura, ~150 km south of Delhi (Oldham, 1883).
