LOCALIZED CORROSION OF CAST ZR 702

By Thomas C. Spence &
D. Scott Reed

ABSTRACT

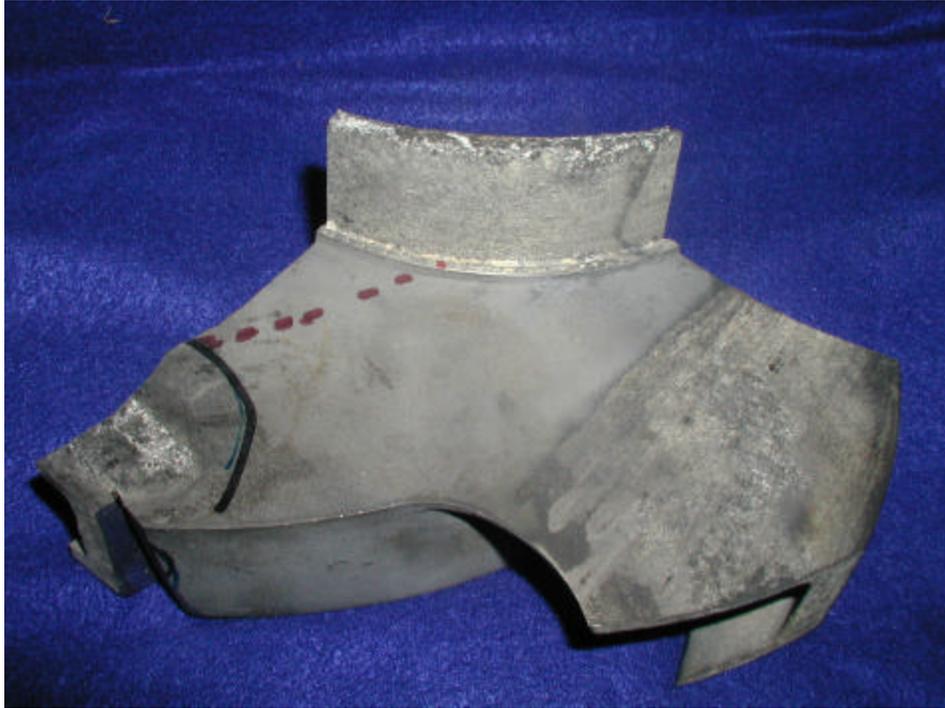
FIGURE 3
Portion of Returned Impeller

Figure 3 shows a portion of a corroded impeller that has undergone failure analysis thus the reason for the missing sections. Notice that the ground area on the left

side is heavily corroded and black in appearance as is the machined seal ring, particularly its edge. The as-cast surfaces appear to be unaffected. While it is recognized that zirconium experiences localized corrosion in acid-chloride solutions that contain oxidizing species, it is also the authors' experience that localized or breakaway corrosion can also appear in non-chloride containing services like sulfuric and concentrated nitric acids. In addition to oxidizing contaminants, it appears that surface condition by itself may also influence this type of corrosion. Some previous work by Yau and Maguire³ on the effect of surface condition on zirconium in hydrochloric acid with oxidizers showed that surface contamination could be a factor.

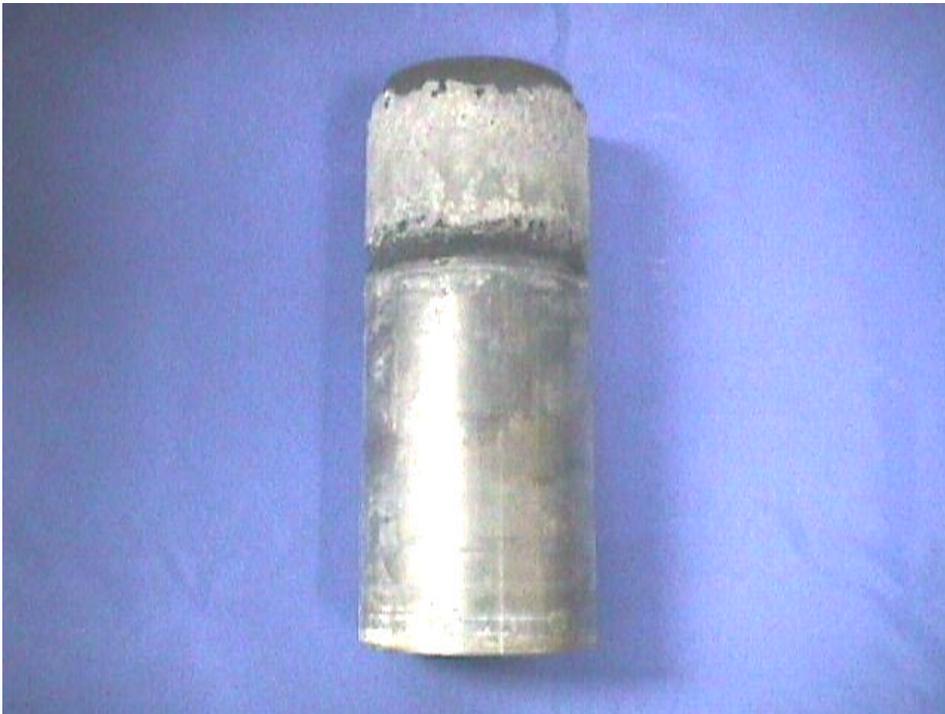
FIGURE 4
Zirconium Shaft Sleeve

Figure 4 shows another example of breakaway corrosion on a pump shaft sleeve. Shaft sleeves are made from wrought 702 material and simply machined; there is no need for grinding. However, for whatever reason the customer in this case felt a need to sand the surfaces of the sleeve and as a result severe localized corrosion is evident on the wetted end of this shaft sleeve. This sleeve was in a service of 62%+ sulfuric acid at 260°F.

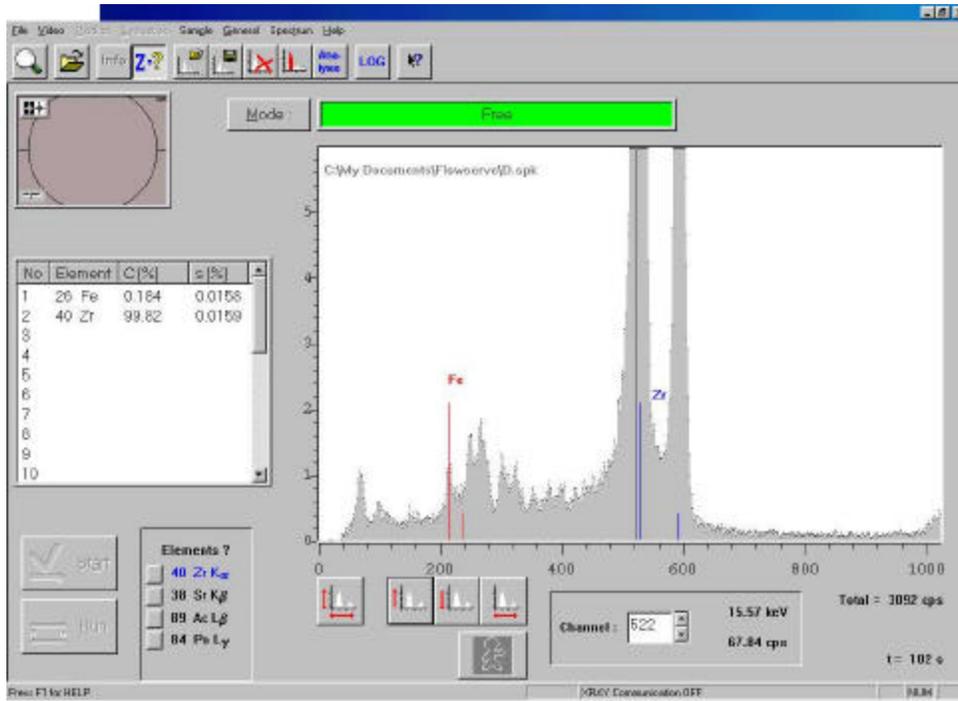
FIGURE 5
Scan of Contaminated Surface

Obviously something is being changed on the surface of ground zirconium samples to cause accelerated corrosion in these areas. To further investigate this another zirconium 702 sample was ground with a contaminated wheel and cut into three pieces. One piece was left as ground, one was pickled for 2 minutes and one pickled for 4 minutes. The samples were then submitted for scanning electron microscopy (SEM) to analyze the ground areas for surface contamination. The scans can be seen in figures 5, 6 and 7, respectively.

SEM examination of the sample ground with a contaminated wheel did not reveal any visual evidence of chromium or iron particles on the surface. There were patches of organic material that contained carbon, oxygen, nitrogen, sodium and potassium. These elements appeared less prevalent on the two pickled samples. There were changes in the trace iron level which could be related to the organics or a very thin iron layer. The trace iron levels on the two pickled samples were about one-third the level of the as contaminated sample which confirms the expected beneficial effect of pickling. There was not any significant difference in iron level of the sample pickled for 2 minutes versus 4 minutes.
