# Application of Remote Sensing for Tsunami Disaster

Anawat Suppasri<sup>1</sup>, Shunichi Koshimura<sup>1</sup>, Masashi Matsuoka<sup>2</sup>,  
Hideomi Gokon<sup>1</sup> and Daroonwan Kamthonkiat<sup>3</sup>

<sup>1</sup>*Tsunami Engineering Laboratory, Disaster Control Research Centre,  
Graduate School of Engineering, Tohoku University*

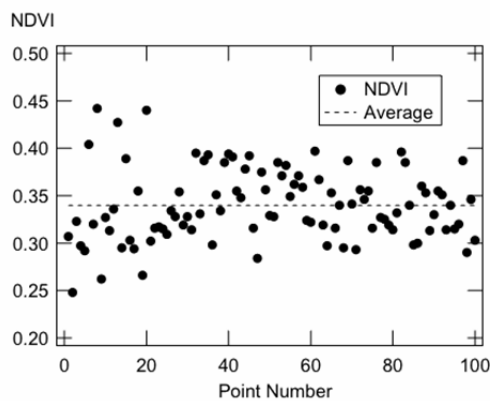
Fig. 1. Threshold value of NDVI within the tsunami inundation zone obtained from the analysis of the post-tsunami satellite imagery.

where  $R$  and  $NIR$  stand for the spectral reflectance or radiance in the visible (red) and near-infrared bands, respectively. Focusing on the existence of tsunami debris, 100 points were sampled to identify the NDVI threshold to classify the tsunami inundation zone. As shown in Fig. 1, the NDVI values are calculated within a range  $0.34 \pm 0.05$ . As a result, the extent of the tsunami inundation zone is determined by the supervised classification based on the NDVI threshold. As shown in Figure 2 (a), the QuickBird imagery clearly detects the vegetation change between pre- and post-tsunami. Tsunami debris can be seen along the edge of the tsunami inundation zone. Figure 2 (b) shows the result of the detection of the tsunami inundation zone by applying the threshold value of NDVI, and the result is consistent with the field survey.

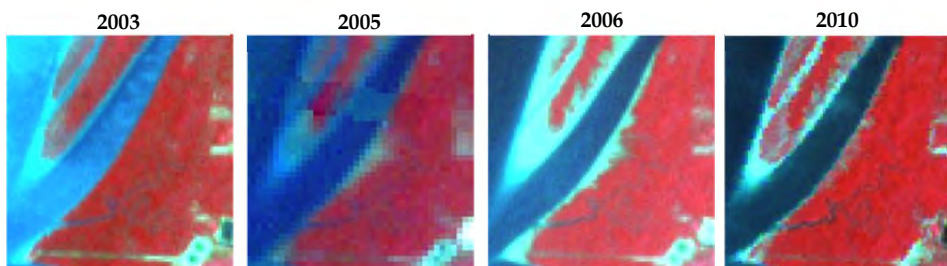
Fig. 3. Damage and recovery process due to the 2004 tsunami in Takuapa, Thailand

Because mitigation and protection against the 2004 Indian Ocean Tsunami was one of the important services that mangrove ecosystems provided in the affected areas, a six-year program to conserve and rehabilitate mangrove forests in the tsunami-impacted areas was implemented by the Thai Government after the tsunami. However, information on mangrove restoration and reforestation is limited to field surveys. Monitoring proposals were applied for a damaged mangrove area. Kamthonkiat et al. (2011) used ASTER images acquired in 2003, 2005 (two months after the 2004 Indian Ocean tsunami), 2006 and 2010 and the analysis using NDVI to monitor the mangrove recovery in tsunami-impacted areas in the southern part of Thailand. Figure 3 depicts the area of mangroves in 2003 in red and the area impacted by the tsunami in 2005 in dark blue and white for the same location. After the mangrove trees were uniformly or homogeneously replanted in the same location in the last quarter of 2005 in Takuapa District, the areas marked in red increased in 2006 and increased still further in 2010, as shown in Fig. 3 (*Note: red represents vegetation or mangroves, white represents bare soil/sand, and blue/dark blue represent water*). The recovery process can be detected, as some parts in light blue became red in 2006, and most became red in 2010 meaning the mangroves recovered to nearly the normal condition before the tsunami attack. These results show the abilities of geoinformatic technologies, especially regarding the time series analysis.

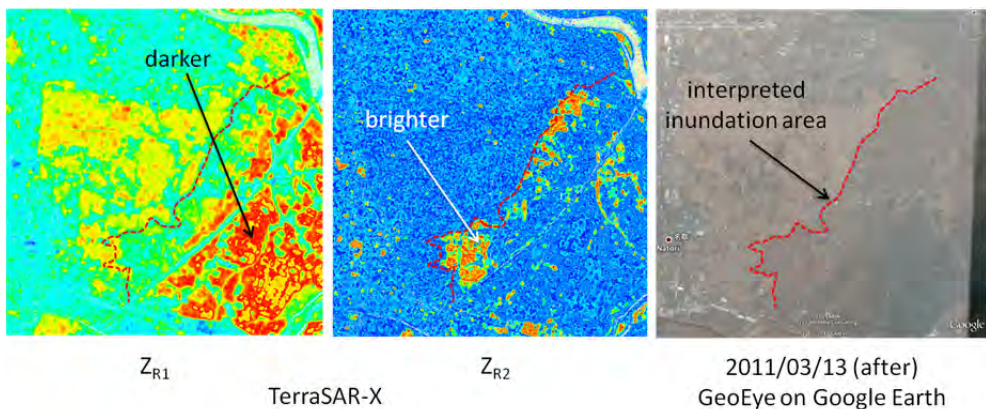
Fig. 5. Computed  $Z_{R1}$  and  $Z_{R2}$  from TerraSAR-X image to determine inundation area

Here,  $Z_{R1}$  represents the discriminant score from the SAR images where the values of parameter A and B are 1.21 and 4.36, respectively. The pixels whose  $Z_{R1}$  value is positive (red) are interpreted as suffering severe damage (Fig. 5 left). Because both coefficients are negative, higher and negative  $d$  or smaller  $r$  produce larger  $Z_{R1}$  values. A preliminary formula for the C-band dataset was used because that for the X-band was unavailable. For this reason, the backscattered echoes were stronger in the post-tsunami image. To detect such damaged areas using image analysis, cases where the reverse occurs need to be considered. Therefore, the following Equation (3) was also calculated based on a positive value for the difference in backscattering coefficient  $d$ .

Here,  $Z_{R2}$  represents another discriminant score where the values of parameters A and B are 1.21 and 4.36, respectively. Using this formula, the pixels whose  $Z_{R2}$  value is positive (red) might be assigned as damaged areas (Fig. 5 centre).

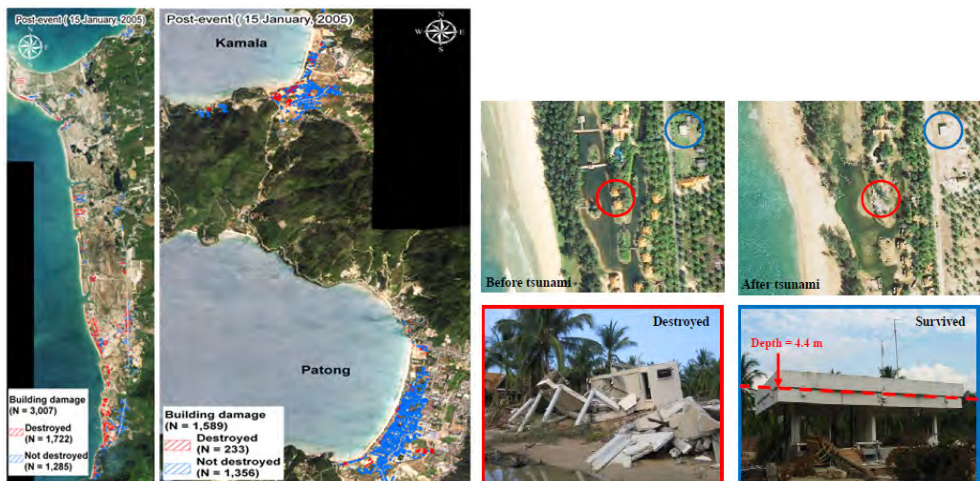
Fig. 10. Visual damage inspection results in Phang Nga and Phuket, Thailand

Phang Nga and Phuket were two of six southern Andaman coast provinces that were damaged by the tsunami. They provinces are famous for sightseeing areas such as Khao Lak and Patong. Therefore, reinforced concrete (RC) buildings are common in this area. Regarding structural damage, 4,806 houses were affected by the tsunami, of which 3,302 houses were destroyed completely, and as many as 1,504 were partly damaged. The maximum water level of approximately 15 m reported at Khao Lak in the Phang Nga province and of 7 m at Kamala and Patong Beach in Phuket gave these areas their respective distinction as the worst and second-worst areas, with structural damage to 2,508 and 1,033 houses, respectively. High-resolution satellite images (IKONOS) taken before and after the tsunami event were used for visual damage interpretation. The pre-event images were acquired on 13 January 2003 and 24 January 2004 for Phang Nga and Phuket; the post-event images were both acquired on 15 January 2005. In a recent study (Gokon et al., 2011), four damage levels were classified “Not collapsed” (moderate, slight or no damage), “Major damage”, “Collapsed” and “Washed away,” using a QuickBird satellite image with a  $0.6 \times 0.6 \text{ m}^2$  resolution. However, the  $1.0 \times 1.0 \text{ m}^2$  resolution of the IKONOS satellite image is not fine enough for a visual interpretation to differentiate the damage levels of buildings. Therefore, the classification of the building damage in this study was limited to “Not destroyed” and “Destroyed” (Koshimura et al., 2009c). The remaining roof buildings were interpreted as “Not destroyed” and those that had disappeared were classified as “Destroyed”. Note that the buildings classified as “Not destroyed” may have had some sort of Damage that could be identified by the satellite images. The results of the building damage inspection in residential areas are presented in Fig. 10 (Suppasri et al., 2011a), which shows damaged buildings in residential areas in Khao Lak, Phang Nga province (1,722 destroyed and 1,285 not destroyed) and the populated residential areas in Kamala and Patong, Phuket province (233 destroyed and 1,356 not destroyed). The visual interpretation data resulted in an accuracy of more than 90 per cent after being checked with the investigation data.

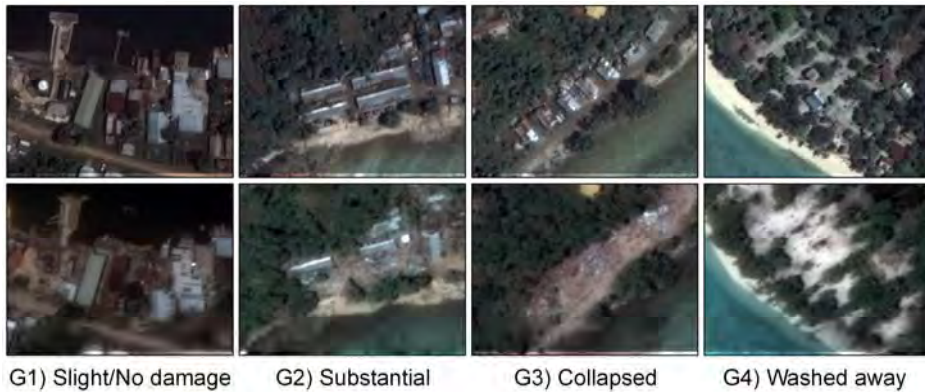
Fig. 11. The structural damage interpretation is divided into four classes: slight/no damage, substantial damage, collapsed and washed away

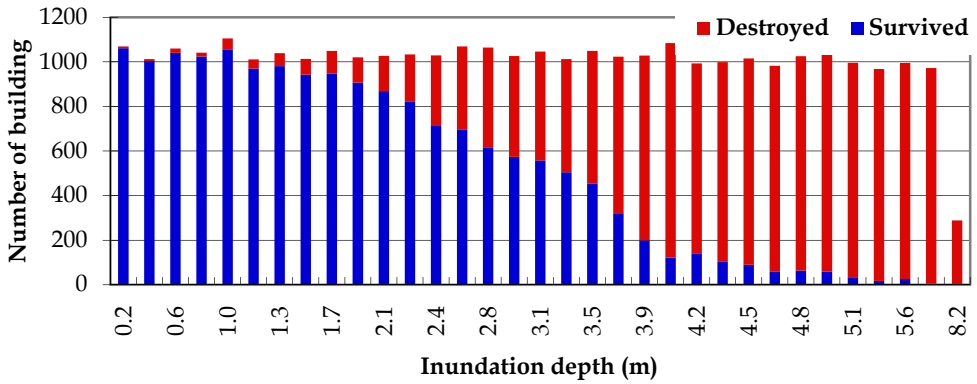
Fig. 18. Histogram of damaged and not-damaged houses to calculate the damage probability

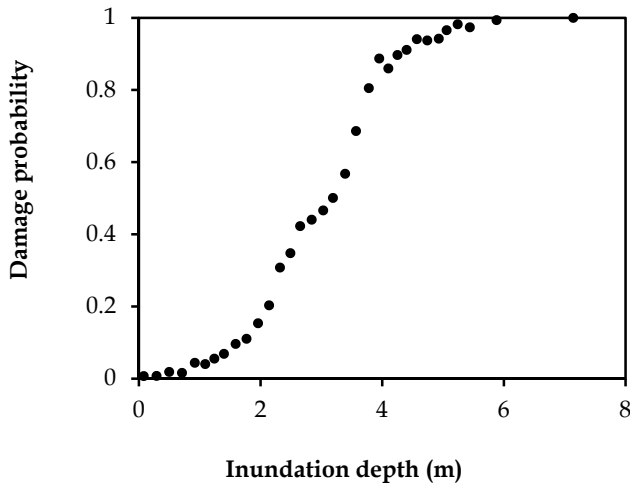
Fig. 19. The plot of damage probabilities and the median values of inundation depths that were compiled from sample data

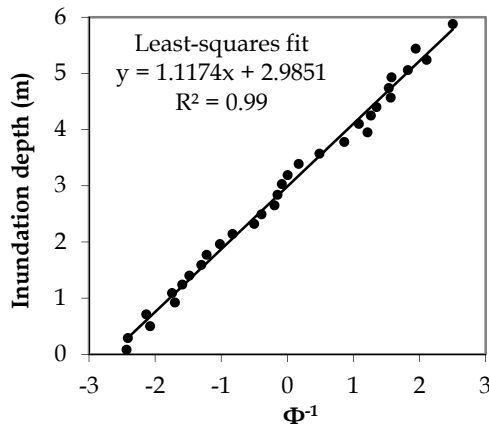
Fig. 20. An example of the plot on normal probability paper

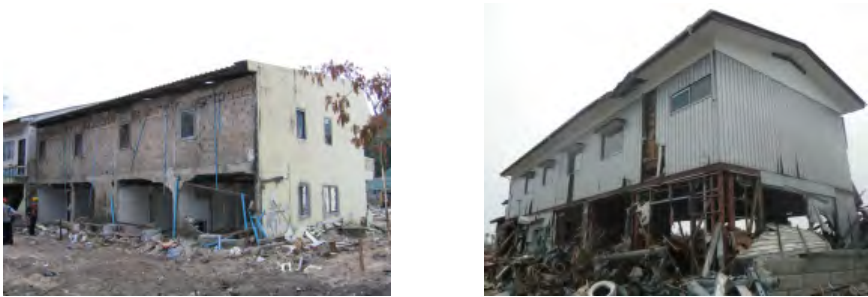
Fig. 25. Examples of building damage in the case of the 2004 Indian Ocean tsunami in Thailand and the 2011 Tohoku tsunami in Japan
