## Recovering the function and esthetics of fractured teeth using several restorative cosmetic approaches. Three clinical cases

### CASE REPORT

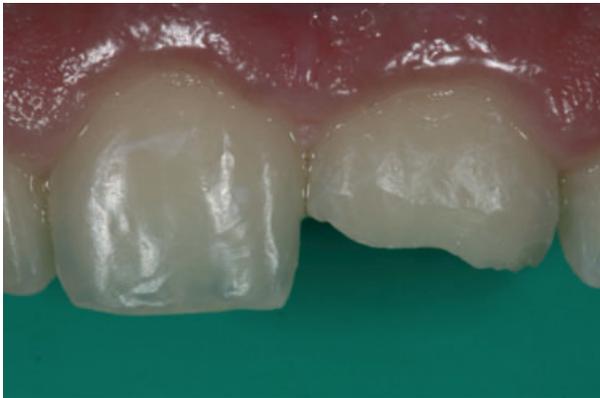
A male patient, RCG, 21 years old, sought care at the dental clinic after a fall while biking, complaining that one of his teeth was broken. Clinical examination revealed that the left central incisor was fractured in the middle-third of the crown, involving enamel and dentin without pulp exposure (Fig. 1) and without signs symptoms of concussion or contusion.

Fig. 1. Front view of fractured left central incisor.

Because there was a satisfactory amount of coronal tooth available, it was proposed to treat with a direct resin composite restoration to restore the fractured part. The patient chose to not have the diagnostic waxing of the left central incisor, and final restoration

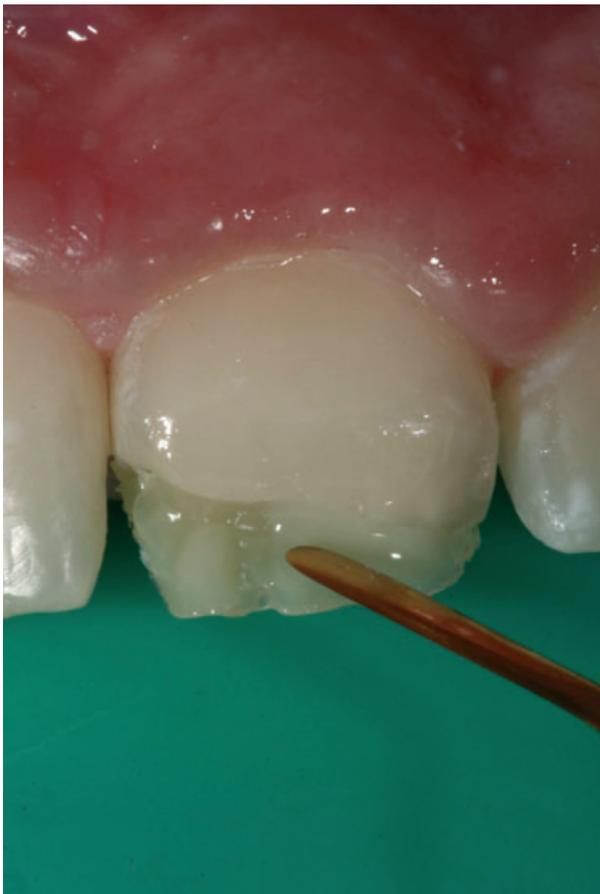
Fig. 2. Placement of the first and second layers of composite resin.

A multilayer technique with freehand sculpting was used to build up the restoration. The stratification began with an opaque dentin shade (A3D, Z350XT; 3M-ESPE)

(Fig. 2), followed by the use of a more translucent dentin shade (A3B, Z350XT) to build up the dentin body. A translucent shade (CT, Z350XT) was applied to fill the gaps between the dentin mamelons and to create an extension of the restoration to the proximal regions and incisal edge (Fig. 3). To create a match with the superficial enamel, an appropriate enamel shade (A2E, Z350XT) was used to cover all the restored buccal surface. Because of dehydration, it was impossible to confirm whether the shade of the restoration matched the adjacent teeth immediately after finishing the sculpture. Therefore, a rubber point (Enhance; Dentsply, Rio de Janeiro, Brazil) was used to minimize the surface roughness, and the patient was asked to make a follow-up appointment.

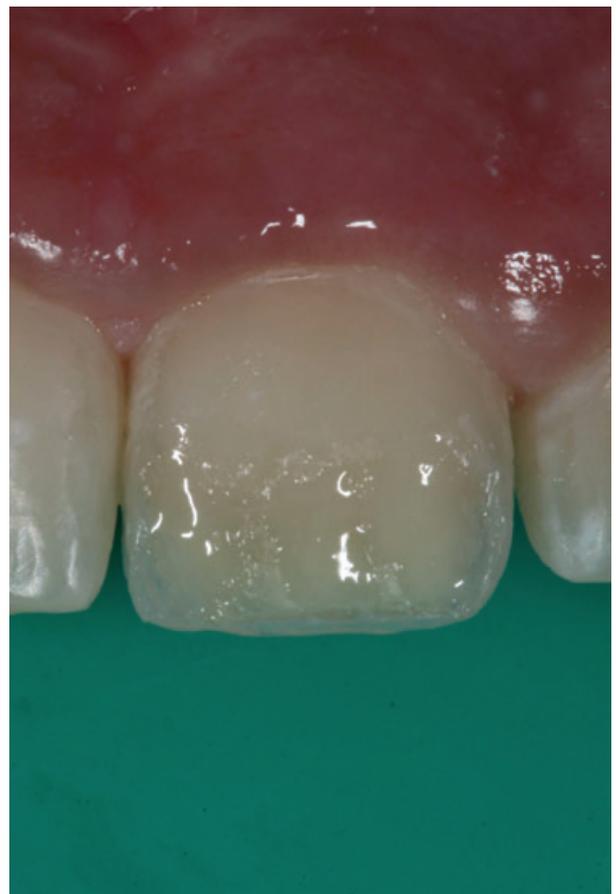
Fig. 3. Note that palatal face was completed. The third layer of composite resin filled the spaces in the incisal and marginal edges.

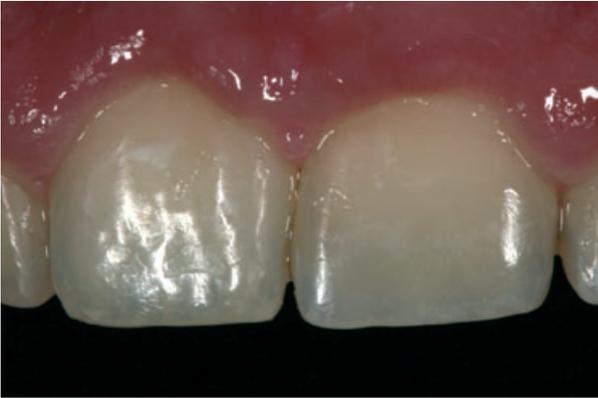
Fig. 4. Complete restoration before polishing.

Two days later, the final finishing and polishing were performed with a 12-blade taper carbide bur, contouring and polishing disks (Soft-Lex; 3M-ESPE) and two systems of rubber points (Astropol, Ivoclar Vivadent; PoGo, Dentsply) (Fig. 4).

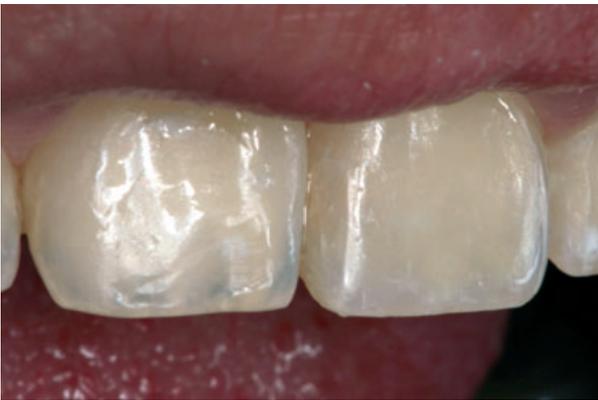
Fig. 5. Final restoration after polishing.

The final result was a natural look of the tooth restored (Fig. 5).

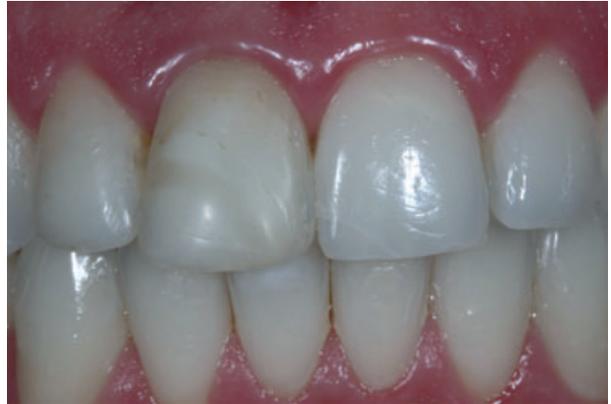
esthetics of his teeth. In the anamnesis, the patient stated that, as 22-year-old, he had suffered a fall because of an excess of alcohol, causing avulsion of the right central incisor, with a fracture of the tooth crown in the middle-third, with pulp involvement, crown fractures associated with the middle-third of right lateral incisor (enamel and dentin), and a crack of the left central incisor at the mesial incisal edge. The right central incisor was re-deployed immediately after the accident and was immobilized by a rigid restraint. After a few days, an endodontic treatment was made for 11, and the fragment of 12 was reattached. Later, composite restorations were made in teeth 11 and 12 (Figs 6 and 7).

Fig. 6. Right central and lateral incisors with large composite resin restorations.

Under these conditions, two indirect restorations of teeth 11 and 12 were proposed, with 21 being left intact at the wish of the patient. The type of indirect restoration would be decided after the dental preparations were completed.

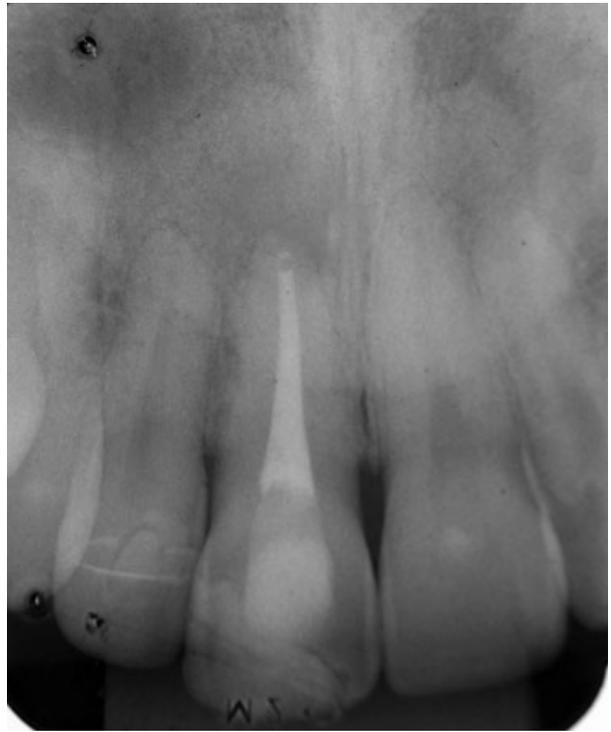
Fig. 7. X-ray of central incisor showing the treated canal root.

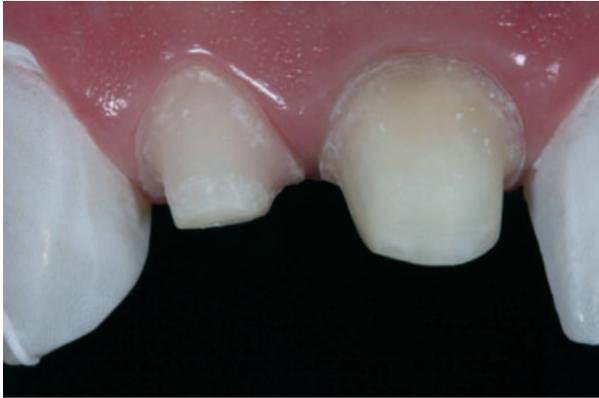
After removal of the entire composite resin that had teeth and preparation, the great loss of tooth structure in two teeth was evident, two all-ceramic crowns indirect having been chosen for esthetics and to maximize retention as the remaining tooth had great wear because of the large amount of resin composite that was present (Fig. 8).

Fig. 8. Remaining dental substrate after composite resin removal and dental reductions.

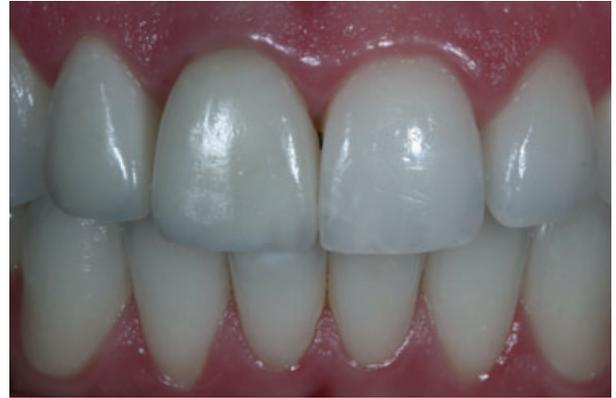
Fig. 11. Immediately after resin cementation.

The final crowns were fabricated with ceramic-based lithium disilicate (Fig. 10). After the crowns' proof, hydrofluoric acid etching (10%) was performed in the ceramics for 20 s, followed by silanization and adhesives procedures on enamel and dentin, and cementation of the restorations with resin cement (Variolink II, Ivoclar Vivadent, Schaan, Liechtenstein) (Fig. 11).

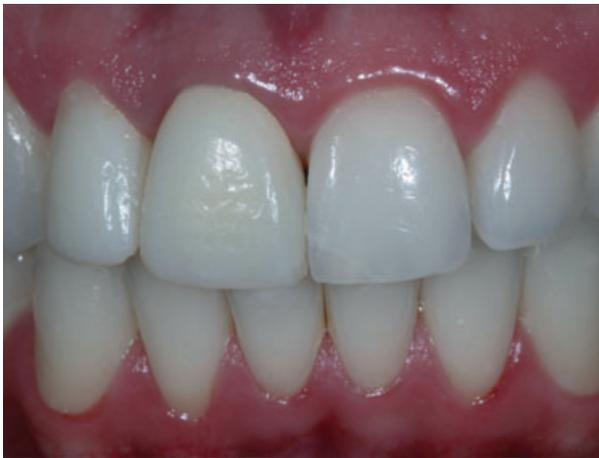
Fig. 9. Provisional crowns placed.

were made with a bis-acrylic composite (Protemp 4; 3M/ESPE, Seefeld, Germany) with the help of the guide obtained by the silicone wax and diagnosis (Fig. 9).

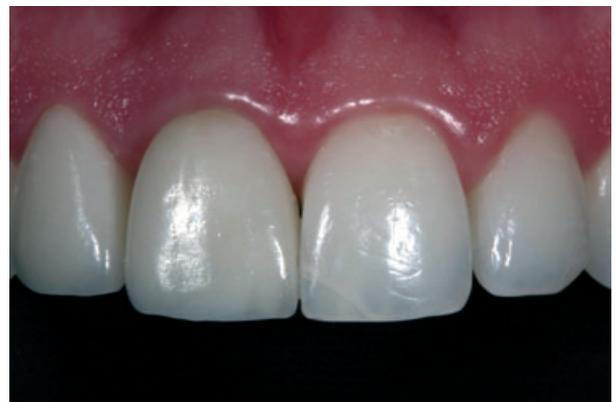
Fig. 12. After 1-year follow up, the restorations showed no signs of misfit or discoloration.

At 1-year follow up, the restorations remained perfect with no problems reported by the patient (Fig. 12).

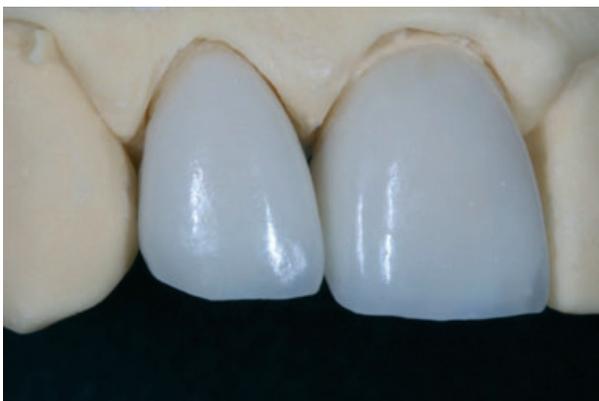
Fig. 10. Ceramic-based lithium disilicate crowns.

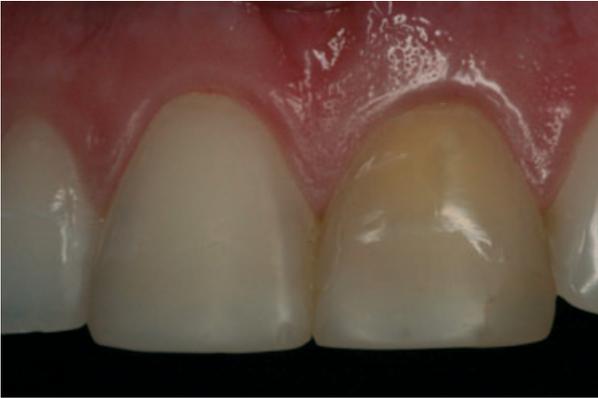
Clinical examination revealed tooth 21 was very dark. Furthermore, we observed that teeth 21 and 11 had extensive restorations of composite resin. In the anamnesis, the patient reported that at 15 years of age, he had suffered a fall while playing and had hit his front teeth. He reported that the two incisors were restored and that one had the root canal treated; there had been no other problems. Approximately 3 months ago, he suffered another trauma while playing soccer, and since then, the right central incisor had changed color (Fig. 13).

Fig. 13. Left central incisor changed its color after an incident of recurrent trauma.

Initially, it was proposed to extract the left central incisor, with immediate implant placement and immediate loading with a provisional crown. After implant osseointegration, placement of a ceramic crown on based zirconia abutment for tooth 21 and a ceramic veneer on tooth 11 were planned.

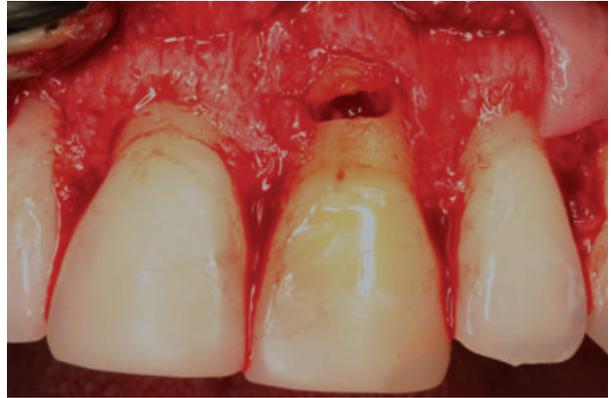
Fig. 15. Fractured root during the operation.

After extraction of the fractured tooth (Fig. 15), the implant was placed and primary stability was achieved (45 N per cm). The provisional crown was immediately fabricated with a bis-acrylic composite (Protemp 4).

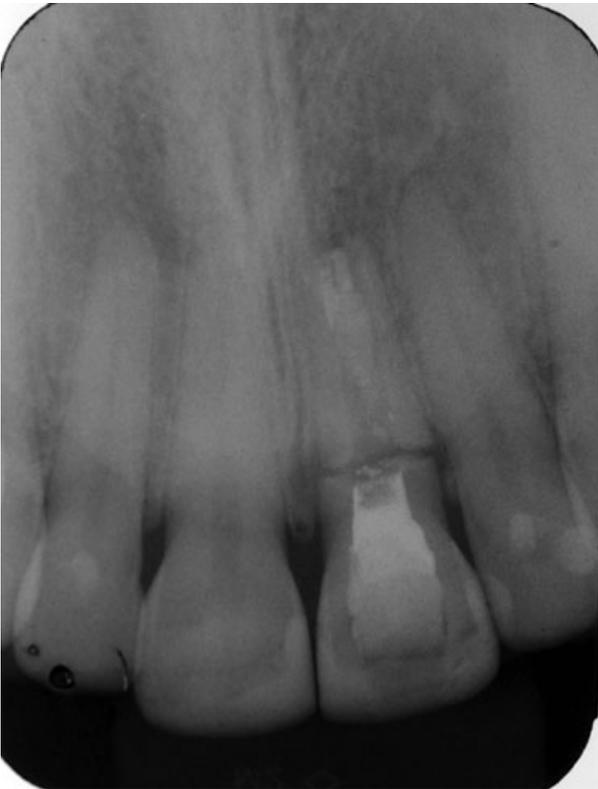
The diagnosis was the root fracture of 21 at the middle-third, as evidenced by radiography (Fig. 14). In element 11, there were no signs symptoms of trauma.

Fig. 14. X-ray of left central incisor, evidencing root fracture at the middle-third.

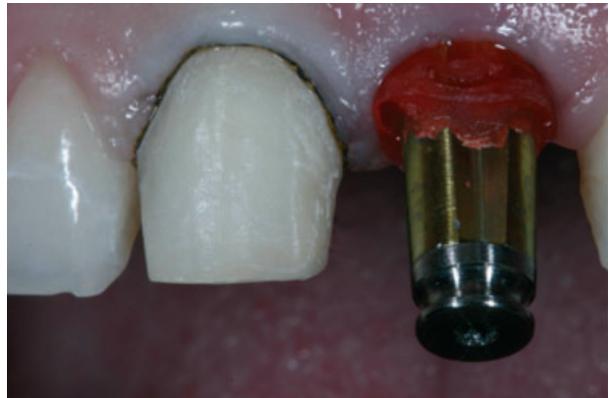
Fig. 16. Molding and transfer impression.

With complete tooth reduction, individualization of the square transfer technique was performed, and the molding was performed using two simultaneous retraction cords (# 00 and 0) and a polyether-based material (Impregum; 3M/ESPE, St. Paul, MN, USA) (Fig. 16). Then, after the color selection, the provisional crowns were made (Fig. 17).

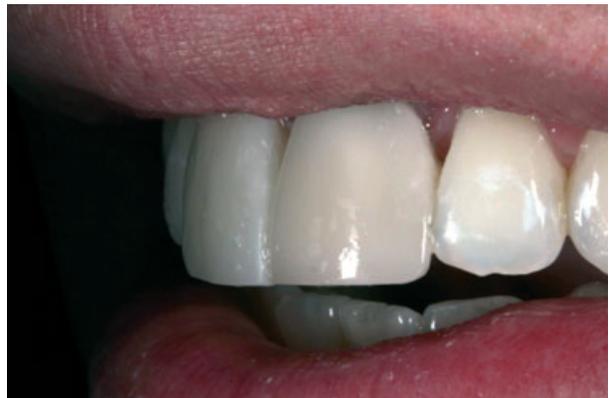
Fig. 17. Provisional restorations placed.

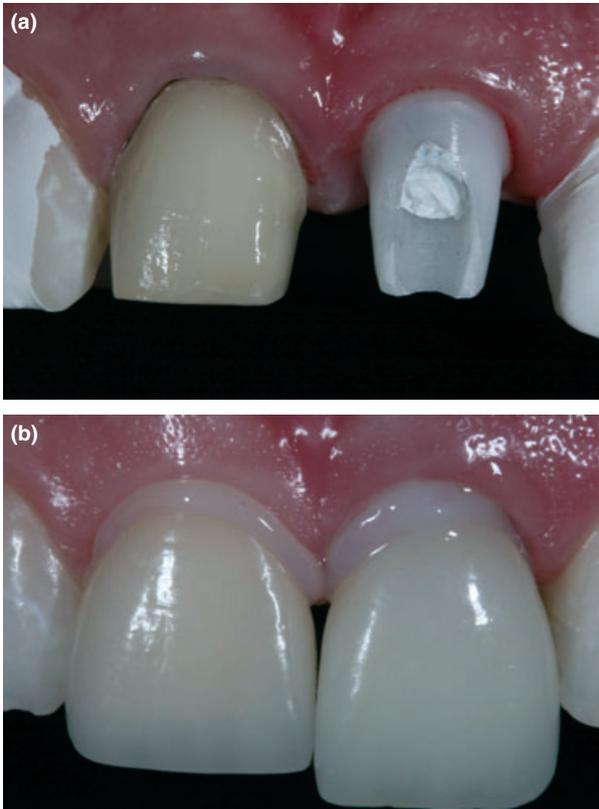
Fig. 18. (a) Proof of zirconia-based abutment, re-torque, and obliteration of orifice screw with teflon seals. (b) Cement color selection by the test kit.

With the restorations finished, the proof of the zirconia abutment was made (Fig. 18a), as were the crown on the implant (IPS e.max Press; Ivoclar Vivadent, Schaan, Liechtenstein) and the veneer (IPS e.max

Press). After the proof, the cement color was selected by the try-in kit (Variolink II Try-in) (Fig. 18b).

Before cementation, the crowns were etched by 10% hydrofluoric acid for 20 s and then the silane coupling agent (Prosil, FGM, Curitiba, Brazil) was applied, letting it dry for 1 min. A thin layer of adhesive system was applied and then polymerized. The abutment was placed with the first torque of 32 N per cm. The right central

The second torque (32 N per cm) was applied to the abutment, and afterward, the crown and veneer were cemented with resin cement (Variolink II).

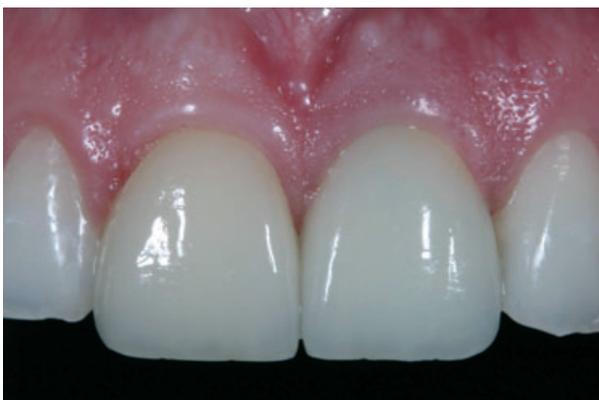
Fig. 19. Five days after the resin cementation.

Five days later, there was natural integration with the crowns and the gingival tissue (Fig. 19).
