DIGITAL TECHNOLOGY IN THE PROTECTION OF CULTURAL HERITAGE BAO FAN TEMPLE MURAL DIGITAL MAPPING SURVEY

BAO FAN TEMPLE MURAL DIGITIZATION SURVEY MAPPING PROJECT

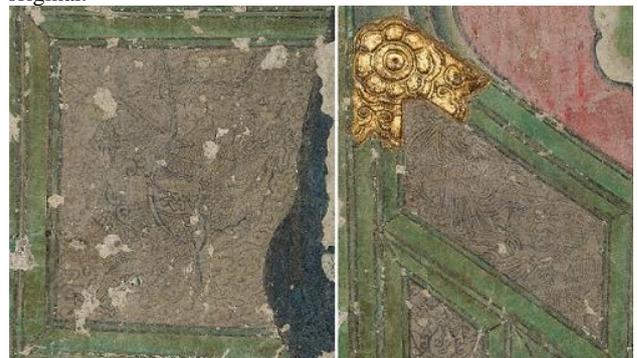
Figure 3 A10 mural image

Period one, created when the Bao Fan temple main building was constructed in Chinghua years (1465-1487), Ming dynasty. The mural is based on the Chinese couplet "*ran su zhu Luo Han, tu hua xi fang jing*" describing a bodhi wonderland. Nine pre-existing mural were the product of the Ming dynasty, although the nine paintings were reconstructed, retraced, and even regilded, the mural still shows the original skills of the Ming. The survey and mapping digitized by means of high definition image recording, multi-spectral, hyper-spectral and other tech detection to show the detail of the original mural of Ming dynasty. For example as image A10, retain fine Ming style including a detailed portrayal of the Dragon and Phoenix and the Passion Flower (*passiflora caerulea*) border. Image A03 the tiger in the center bottom of the mural is drawn using the technique of a silky method to provide the illusion of a realistic coat of fur, resulting in difficulty for the artists to recreate the same affect, the differential in color is because the tiger is the original.

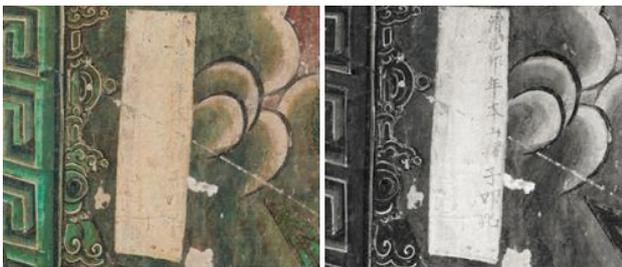
Figure 5 The text

The second period is in the Qing dynasty between 38th year of the Emperor Kangxi (1699) and the 24th year of the Emperor Qianlong (1759). More than 200 years after the creation of the mural, the mural was in disrepair and unclear, the temple monks hired a painter to reconstruct the painting on a larger scale. The mural we see today is the work of that artist. The text on the mural was covered, by multi-spectral detection the text can be clearly read: *qing yi mao nian ben shan shi zi kou hua* (during the *yi mao* year of Qing dynasty, the monks collected alms to fund the restoration). This text helps identify the date of the restoration.

The lunar calendar during the Qing dynasty had five special years referred to as *yimao year* these occur approximately every 60 years specifically during the 4th year of the Emperor Chongde (1639), the 38th year of the Emperor Kangxi (1699), the 24th year of the Emperor Qianlong (1759), the 24th year of the Emperor Jiaqing (1819), and the 5th year of the Emperor Guangxu (1879). The second period mural style differs from the third period's style quite drastically, indicating a big time difference between. Therefore, the second period mural restoration should be dated earlier than *yimao year* occurring during reigns of either Emperors Guangxu or Jiaqing (i.e., before 1819). During the 4th year of the Emperor Chongde (1639), the Qing army has not yet gained control of the Sichuan region. Therefore, it can be surmised that the restoration happened between the 38th year of the Emperor Kangxi (1699), the 24th year of the Emperor Qianlong (1759).

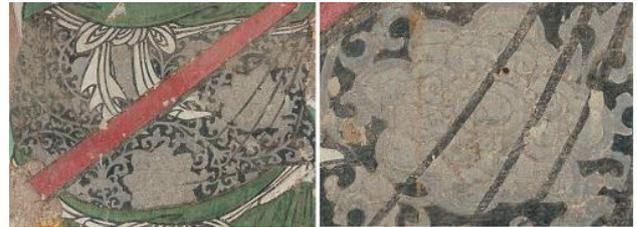
The second period mural painter did not change the composition of Ming murals, roughly based on the color of the first phase of recoloring and retracing. The existing main building mural contains many of traces of the restoration. Image A03 the original had a white base with black patterns after years of erosion the constructors painted the base black with white patterns. The second periods mural techniques became lacking compared to the first, part of the process is rougher. Excess use of paint made the mural embossed, laced with gold and quite rough. The restoration used embossed painting laced with gold rather than the original gilding or to describe many floral regions. In some plaster damaged areas the plaster was not

Figure 6 A03 mural image, the constructors painted the base black with white patterns

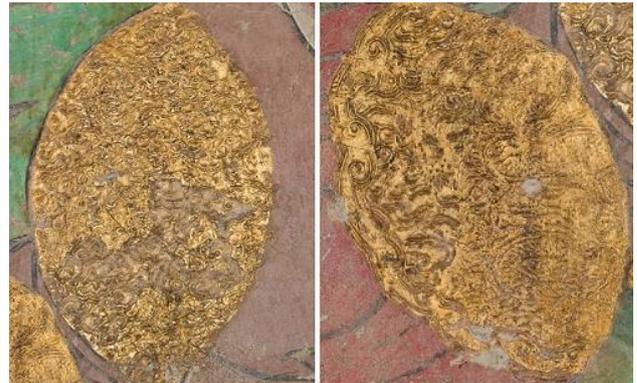
replaced before gilding causing it to become concave. As the paint aged, pieces flaked off; instead of replacing the pieces, the restoration painted over the original.

Figure 7 A04 mural image, the damaged plaster was not replaced before gilding causing it to become concave

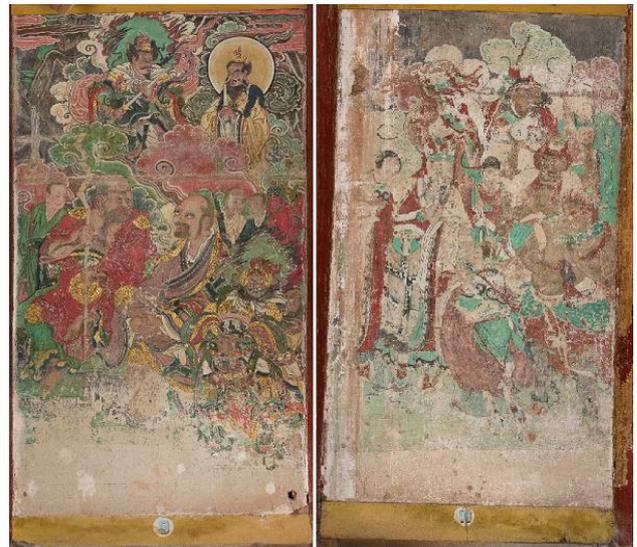
Figure 8 Image A12 (right) is part of the third period, the picture's composition and color compared to other murals (left) are quite different presenting the mural as late Qing.

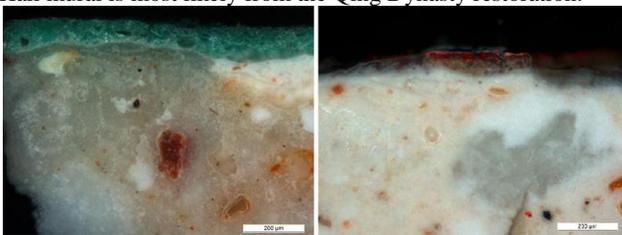
The Main Hall mural's composition is rich in color with mostly a green base. The colors include red, yellow, white, gold, etc. In addition to the use of conventional solids, there is a rage of color mixing, making the overall picture more realistic. At the site, samples of mural damage were collected using a resin-embedded section. The structure of the pigment layer of the murals are observed microscopically. The results showed that due to the difference in size of the pigment particles themselves, the amount of coloring required were different, so that the pigment layer thickness of different colors were not the same. Interestingly, there are slight differences gilding between the Main Hall mural and the Guan Yin Hall mural. In the Main Hall, the mural is decorated with a process including embossed paint gilding and flat paste two-layer technology. It can be seen from the microscopic cross-sectional structure of the paint used in the embossed layer; the gilding thickness is only about 0.01 mm. The Guan Yin hall mural uses less gold; the only part to use gold was the hair adornment and jewelry of the figures. Field observations and laboratory profile observations indicate the gilding technology is different: the thickness of the gilding is 0.05mm. This results in a more gold and less shiny gilding. Based on this, we can tell that the gilding of Guan Yin Hall mural is probably original Ming Dynasty and that of the Main Hall mural is most likely from the Qing Dynasty restoration.

Figure 9 the microscopic cross-sectional structure of the pigment green and red in Main Hall mural

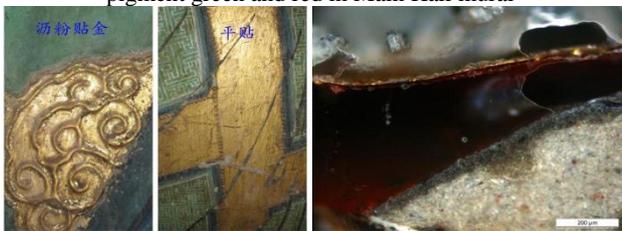
Figure 10 the microscopic cross-sectional structure of the gilding in Main Hall mural

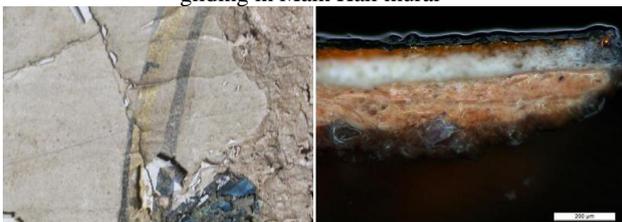
Figure 11 the microscopic cross-sectional structure of the gilding in Guan Yin Hall mural

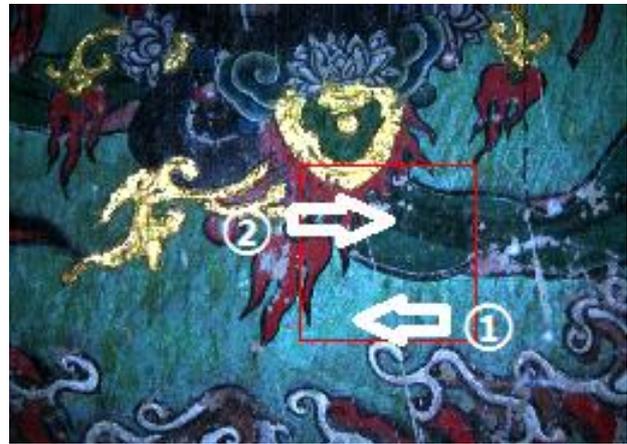
Mural paint analysis was mainly conducted in two ways: 1, hyper-spectral shooting: a non-destructive method to analyze the color; and 2, collection of small samples for use in laboratory analysis. During the elemental analysis in the laboratory, x-rays were used for phase-composition analysis. The analysis also used Raman Spectroscopy. The results of all these analyses were combined to completely determine the material and structure of the mural.

Figure 12 hyper-spectral shooting area of green

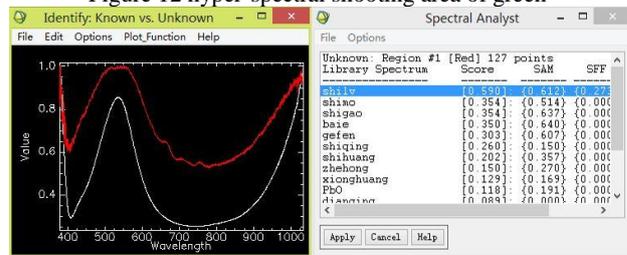
Figure 13 hyper-spectral shooting result of light green

After analyzing a number of ways, it was detected that the Main Hall and Guanyin Hall murals mainly used mineral pigments. The green is malachite for image and technique, differing in texture and thickness there are three types of green. The blue is azurite; microscopic observation and hyper-spectral results show that in the process of mixing colors either white or black is applied in order to produce different levels of color. The red is mainly cinnabar with a little bit of red lead and some iron red. The black is carbon black. The white is white lead. The yellow is most likely litharge. The white powder layer of the Main Hall mural is chalk and quartz. The Guanyin Hall mural uses plaster and baked plaster, the plaster layer contains chalk, quartz and montmorillonite.

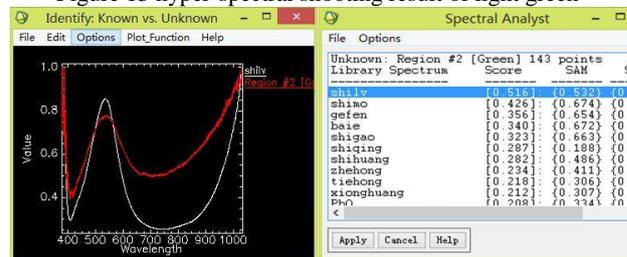
Figure 14 hyper-spectral shooting result of dark green

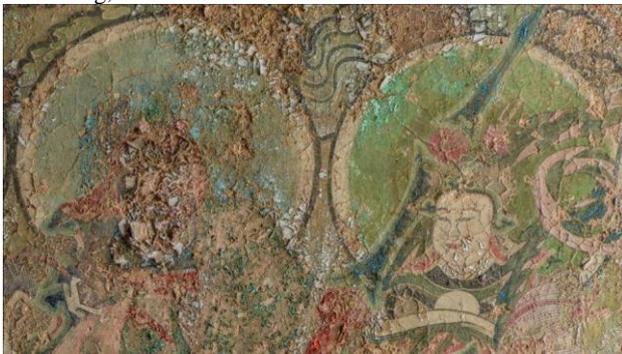
Figure 15 The degradation of mural

The digitization work we did is all for the needs of heritage protection and data collection. The collected data can be used for further monitoring and reconstruction. Using the digitization skills to recognize and provide statistics to help determine the level of degradation and the characteristics there of. Despite the focus on degradation of the murals themselves, much degradation are coming for the mural carrier. In the Main Hall mural long cracks generally appear at the same height. The root cause of these cracks is how the wall carries the mural and also the building structure related to the wall. We used a middle-distance scanner for a scan analysis of the overall wall carrying the mural. Figure 16 shows the Main Hall east wall shape changes for the four section mural. In the vertical direction as the standard plane color changing form red to blue represents a wall concavity and blue to red represents convexity changes. From the rightmost two sections, we can see that the upper part has an inward tilt of about 10 centimeter. The bottom corner of the rightmost section has a backward depression and not on the same plane with the other parts of the mural.

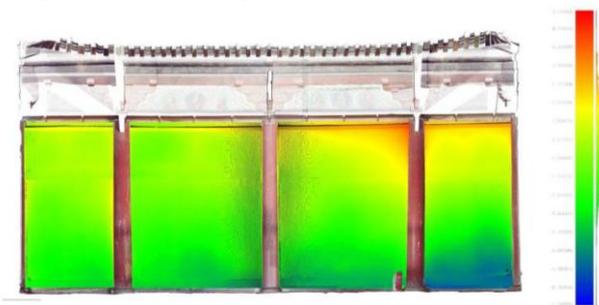
Figure 17 the Main Hall east wall shape changes for the four section mural

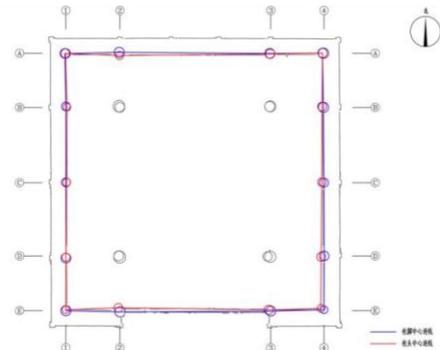
Figure 18 The image above shows a 3-D scan used to compare the offset of building stigma and column foot in the Main Hall.

Figure 21 shows a 3-D point cloud section cutting of the Main Hall front cave gold column and indicates a tilt in the structure. From precision 3D data measurement, the east column cap tilted 143 mm to the west. A reasonable amount of tipping might be 50 mm, but this column tipping is far in excess of this amount. This is due to uneven sinking of the column foundation. This is due to loading of the building framework causing deformation. In the Figure 22 image, according to the data we parsed, for the Main Hall the column foundation, there exists a height difference of 115 mm between the highest point in the south east and the lowest point in the southwest. This causes the whole structure to tilt and deforms the mural wall.

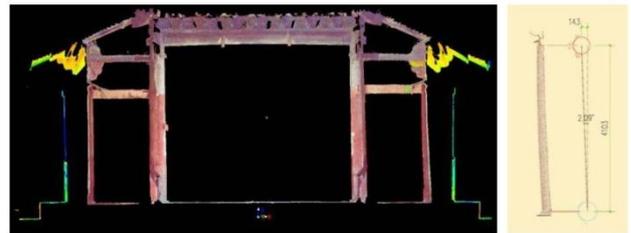
Figure 19 3-D point cloud section of the Main Hall

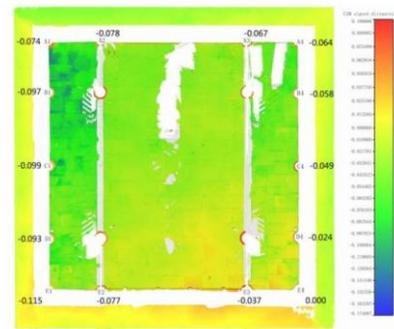
Figure 20 the Main Hall foundation and ground shape changes

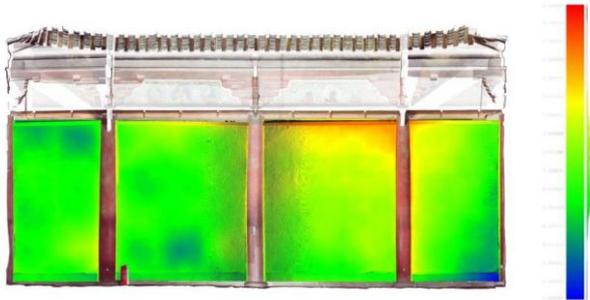
Some wall damage is not only caused by the column tipping but is also related the wall structure itself. Figure 19 shows the Main Hall west wall four section mural overall shape. This shows that part of the wall projecting inward and the shape changing evenly. This is possibly related to the overall structure and deformation. Another part of the wall, below the overall plane, maybe related with the sandwiched bamboo wall structure. A detailed look at the image above clearly represents the first mural towards south west side. Through field observation it is difficult to discover the shape change of the upper area of the mural, but the scanner easily discovered the change in shape.

Figure 1923 the Main Hall west wall shape changes for the four section mural

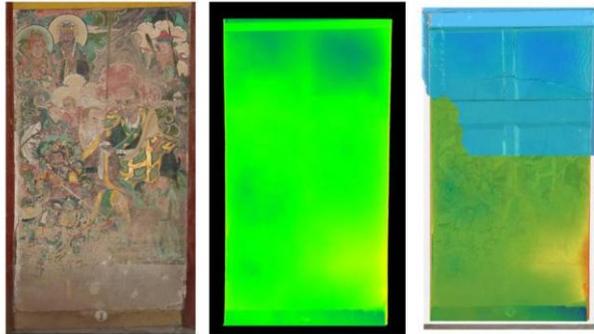
Figure 2024 A scan of the back of the mural wall indicates the structure of the bamboo inside is deforming

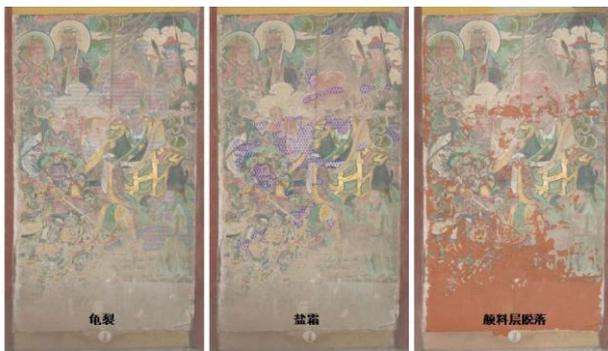
Figure 2125 degradation map of mural *yi fu fo hui*

Silhouette optical imaging is a kind of digitized tool: by emitting light from the side we can observe more subtle effects such as cracking, peeling, pigment shedding, salt formation etc. This mural depicts *yi fu fo hui* (a meeting of the gods). Its total area is 7.58 m². Cracking occupies 0.74 m² this is 9.76% of the total; salt formation occupies 0.39 m² (5.15%); pigment peeling occupies 1.83 m² (24.14%).

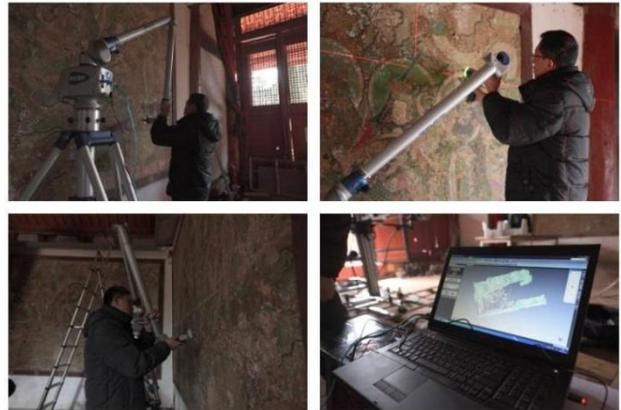
We used a 3D laser scanning survey and a middle-distance scanner with a dot density is 1.5-3 millimeter and a measurement error less than two millimeter; these are sufficient to determine the surface degradation of the murals itself.

Figure 22 use arm of a laser scanner to develop a good 3D model of the mural surface

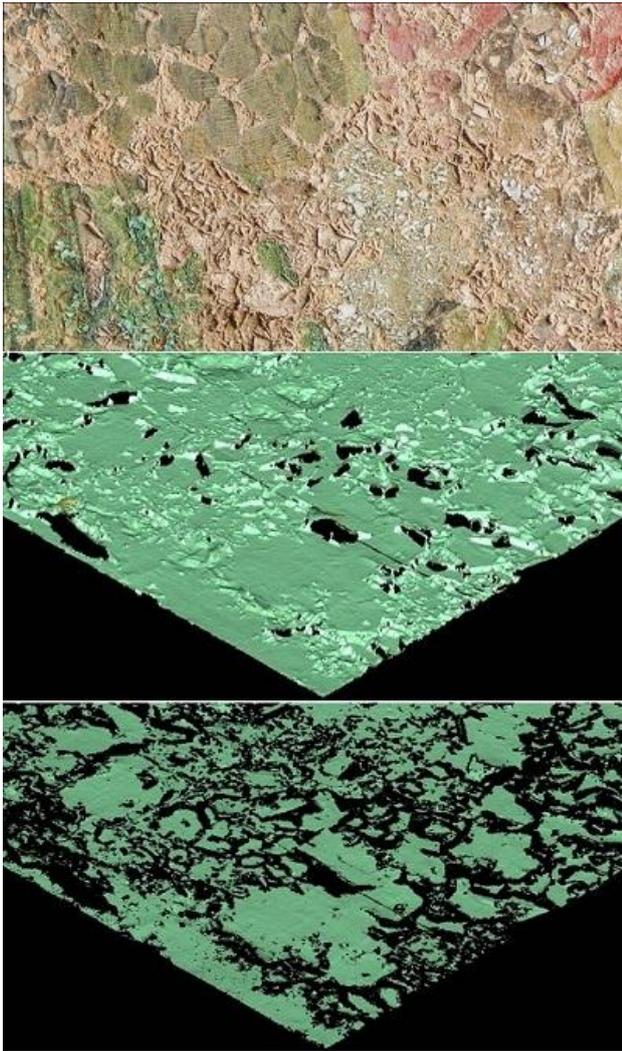
For example, for pigment peeling analysis, we took advantage of the long arm of a laser scanner to develop a good 3D model of the degradation. Figure 23 is an enlargement of the pigment peeling for the Guanyin Hall mural. Much of the color layer used alum water which is affected by environmental humidity which causes the layer to curl. The middle image is an enlargement actual pigment curling. The bottom image is a computer simulation of the surface without the pigment curling and from which we can observe many empty areas and the actual distribution of peeling. After the computer has conducted an accurate calculation of the empty area (without the pigment peeling), we can determine the peeling occupied 0.1309 m² or 19.62% of the total area.

Figure 2326 use 3D laser scanning for pigment peeling analysis

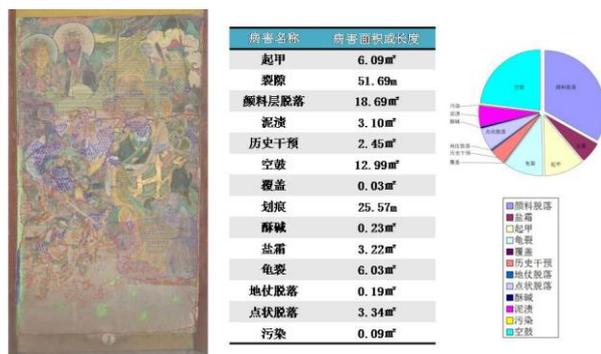
After all of this work, we now have a very detailed survey of the Bao Fan mural degradation. The Main Hall has ten sections of murals with fourteen forms of degradation and deformation. Including one-time damage such as animal damage, pigment separation, vandalism, human contact damage, nicks, water-logging, etc. Continuing degradation including changes in alkalinity, fissuring, hollowing, cracking, peeling, salt crystal formation, mud logging, etc. constitute a big threat to the murals. The most urgent threats is the structural degradation including

wall shape changes, large transverse crack formation as well as insect damage. The degradation and deformation statistics are shown in the table above.

Figure 2427 detailed survey of the Bao Fan mural degradation

We can see that continuing degradation related to the environmental humidity, and which is difficult to control, affects 16.8% of the Main Hall mural. In conclusion the next step, based on the result of the past survey mapping, is to develop a plan to prevent the mural from being destroyed any further and begin the reconstruction of the mural.
