# Surface Characteristics of Zirconia-Based Posterior Restorations: Clinical and Scanning Electron Microscopic Analysis

**Aim:** The aim of this prospective clinical trial was to evaluate the performance of zirconia-based all-ceramic posterior fixed partial dentures (FPDs) after 4 years of clinical use.

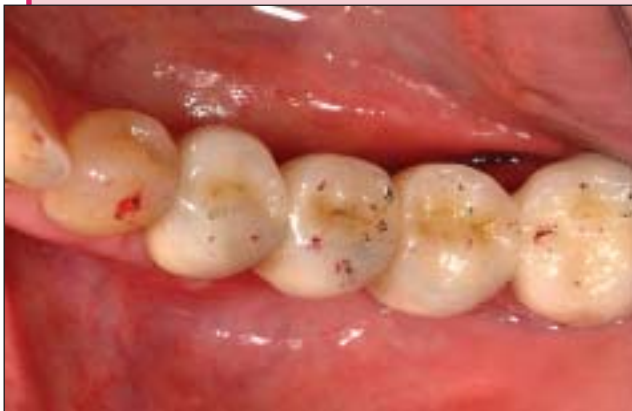
**Figure 3:** Occlusal contacts at baseline examination for a zirconia-based all-ceramic posterior fixed partial denture.

Each restorative unit of each FPD was examined and rated individually for surface wear. Upon clinical examination, 30 (59%) of the 51 surfaces showed a visibly rough contour that was also detectable with a dental probe. By SEM analysis, 33 (65%) of the replicas revealed a rough-textured surface (**Table 1**). SEM showed a wear pattern with crystalline structure (**Figs. 1 and 2**). The surface of the teeth opposite each restoration was metal (19 [37%]), enamel (17 [33%]), amalgam (12 [24%]) or ceramic (3 [6%]). Relative to the baseline examination, occlusal contact points were altered, with respect to either site or surface area, for 28 (55%) of the 51 restoration units (**Figs. 3 and 4**).

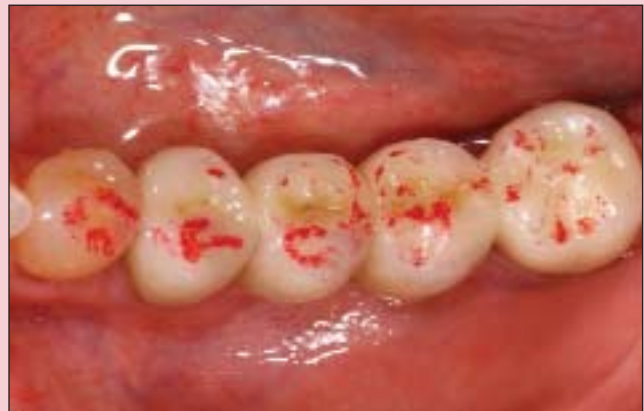
**Figure 4:** Occlusal contacts for the same restoration as shown in Fig. 3, 48 months after placement.
