Effects of Adding Nanosilica on Performance of Ethylsilicat (TEOS) as Consolidation and Protection Materials for Highly Porous Artistic Stone

Abstract: Historical sandstone surfaces and architectural heritage may undergo unwanted changes due to the exposure to many mechanical, physical and chemical deterioration factors. This paper evaluates the effectiveness of inorganic compatible treatments; Based on nanoparticles of silica (SiO₂) dispersed in silicon based product, commonly used as a water-repellent/ consolidation for the decayed construction materials. The nanocomposites obtained by dispersing the silica nanoparticles in polymeric matrices SILRES® BS OH 100 (solventless mixtures of ethyl silicates (TEOS) tetraethoxysilane) were used to improve the physiochemical and mechanical properties of the stone material. The nanocomposites and pure SILRES® BS OH 100 were applied by brush on experimental sandstone blocks. Scanning electron microscopy coupled with energy dispersive X-ray microanalysis (SEM-EDX), polarized transmitted light microscopy (PLM), X-ray diffraction (XRD), capillary water absorption measurements, colorimetric measurements and compressive strength tests were used

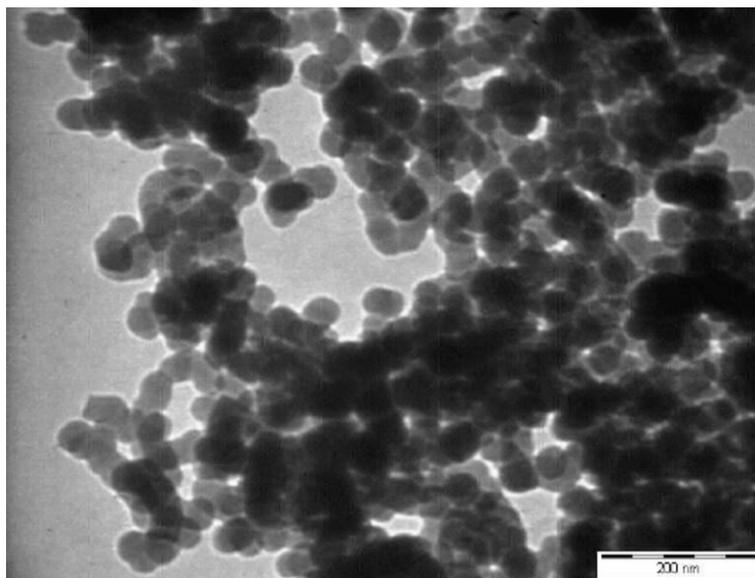
Fig. 2 TEM micrograph of the silica nanoparticles (< 50 nm).

An aqueous colloidal solution of silica nanoparticles were purchased from Sigma Aldrich (particle mean diameter < 50 nm, see Fig. 2).

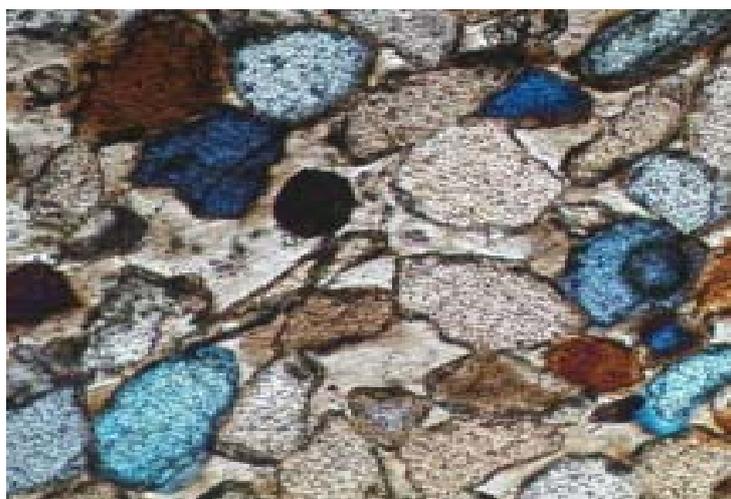
Polarizing microscope observation of sandstone. Fig. 3 showed that it consists mainly of white grains of quartz crystals in addition to high ratio of iron oxides and clay minerals. P.M. Microscopic photo showed degradation in the mineralogical components of sandstone, especially quartz and iron oxides. SEM microscopic photos of the sandstone sample in Figs. 4a and 4b showed high porosity of sandstone and roundness of Quartz crystals due to degradation by physical weathering and salt crystallization. The total

Fig. 3 Thin section of sandstone- Al-Nadora temple, (X30. crossed nicols).

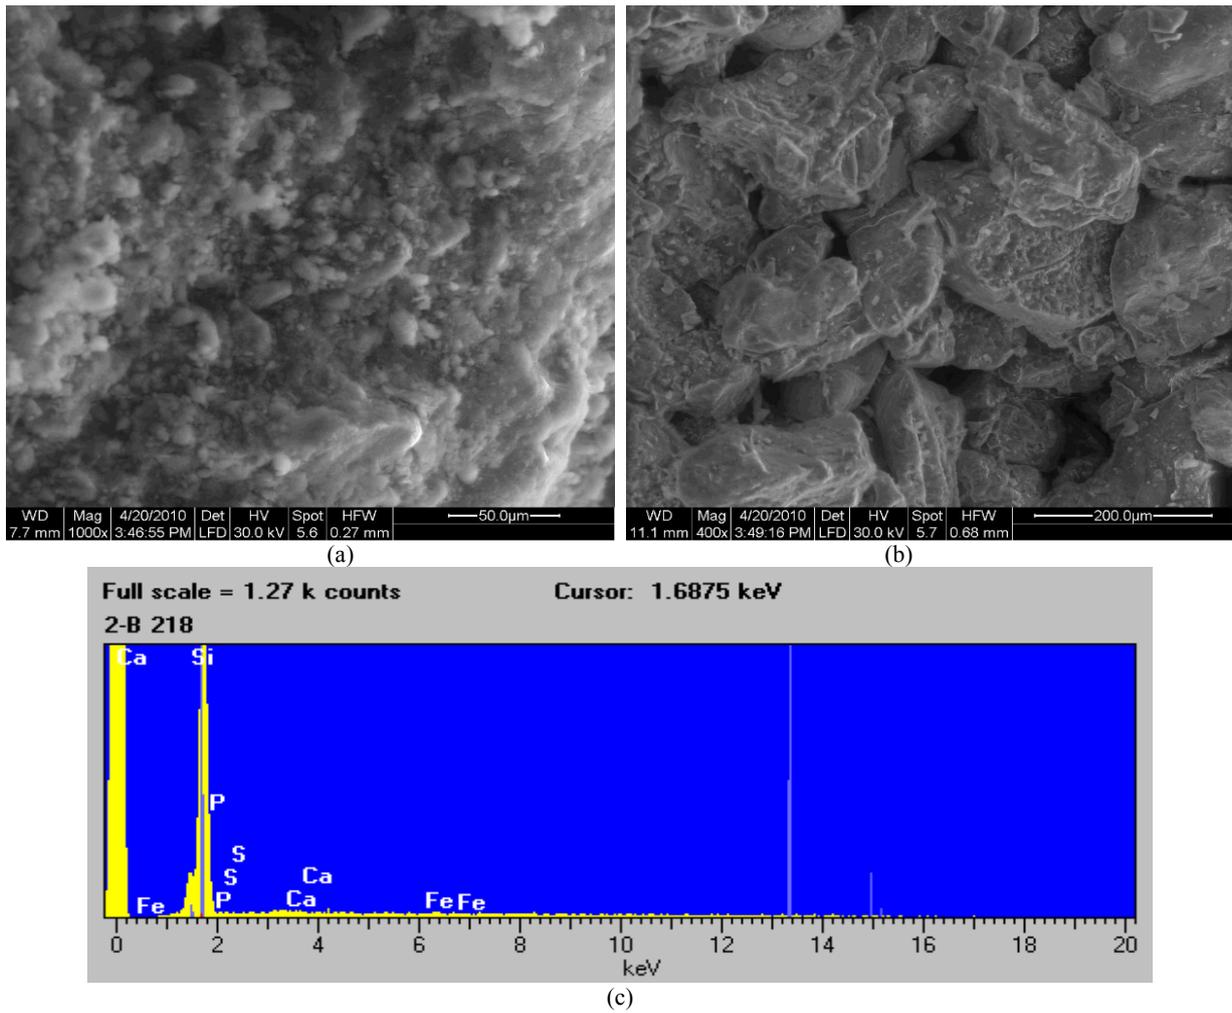
EDX analysis of the sandstone samples in Fig. 4c showed that silicon (Si), calcium (Ca) and potassium (K) are the dominant elements; Iron (Fe) and sulfur (S) were observed.

Fig. 4 (a) and (b) SEM images of historic sandstone and (c) EDX spot analysis from image (a).

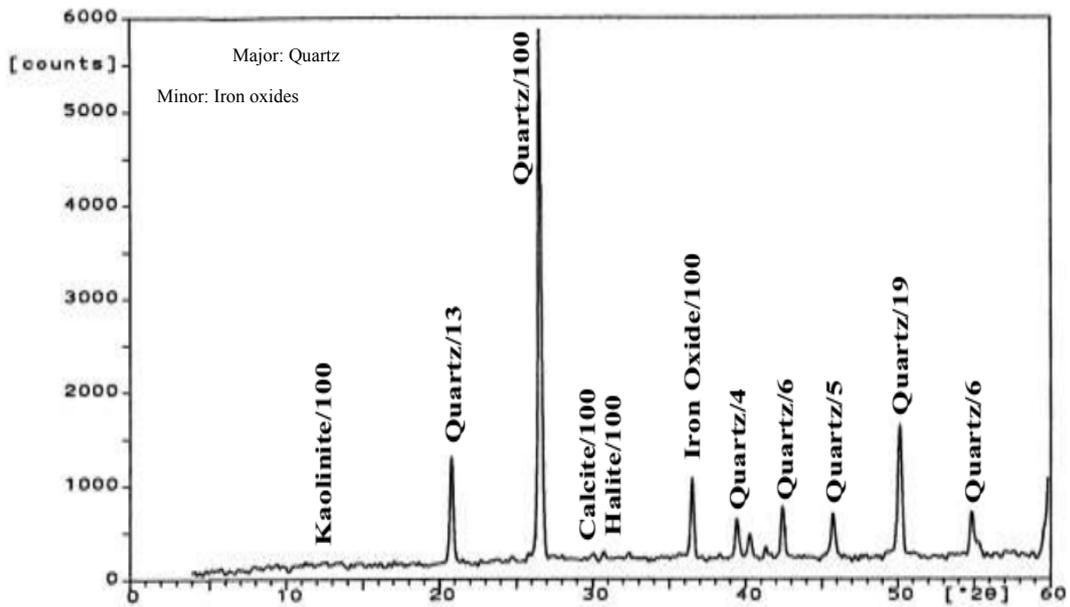
Fig. 5 showed that it consists essentially of quartz [SiO_2] as a major mineralogical constituent, with trace amounts of the following minerals: Iron Oxides, Calcite, Halite and Kaolinite.

Fig. 5 XRD pattern of historic sandstone sample.

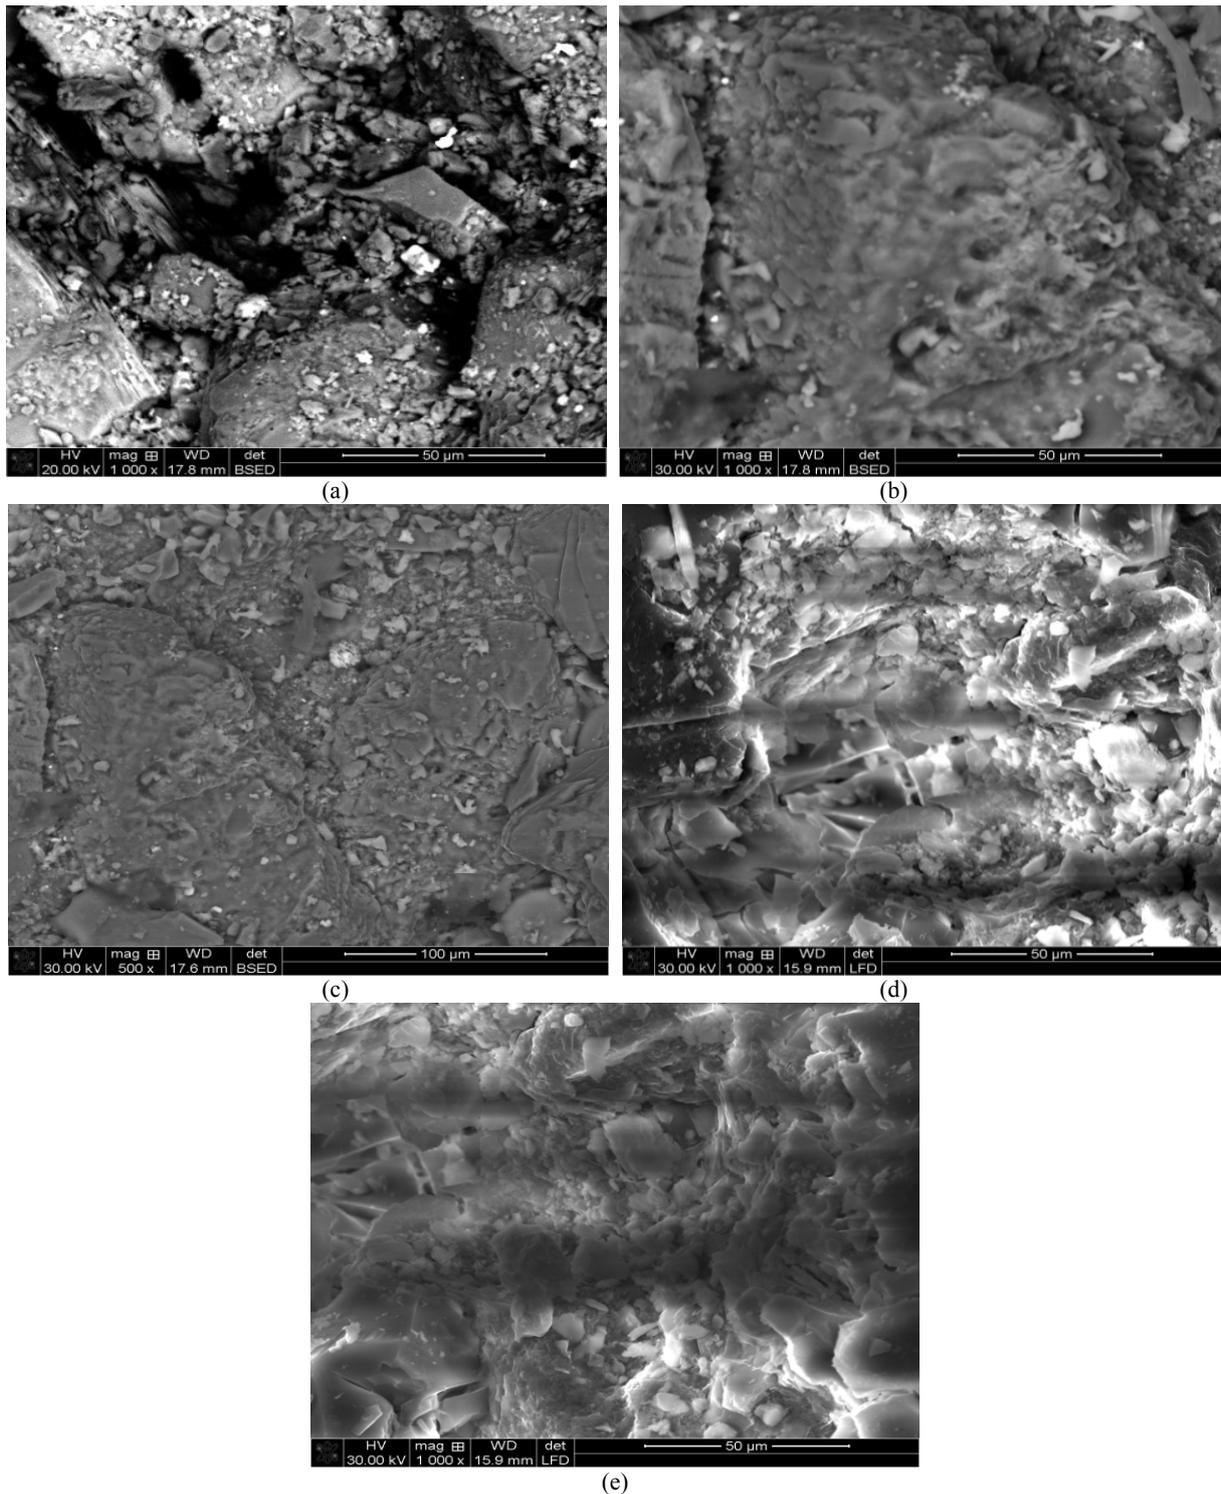
Fig. 6 Show the SEM micrographs of (a) untreated sample, (b) the sample treated with Pure SILRES® BS OH 100, (c) sample treated with SiO₂/polymer nanocomposites, (d) the samples treated with SILRES® BS OH 100 after thermal aging and (e) sample treated with SiO₂/polymer nanocomposites after thermal aging.

binding materials. SEM micrographs of samples treated with SILRES® BS OH 100 (TEOS) in Fig. 6b showed that the treatment material succeeded in

covering the sandstone grains and obscuring the boundaries between them. The network structure of consolidant can be seen dispersed between the grains

and through the pores, but in some depth areas, the consolidant material has failed to fill the fine cracks.

On the contrary, the samples treated with SiO₂/polymer nanocomposites in Fig. 6c showed a homogeneous coating of the particles more than the coating with SILRES® BS OH 100 without nanoparticles. Adding of nano silica to the consolidant material improved their interaction with the stone grains, in addition to increase their ability to fill the big pores between the grains.

After artificial thermal aging, some changes were observed in samples treated with both products. These changes were shown in the form of drought and shrinking of the polymer in some areas. Thermal aging also affected the film uniform and homogeneity which was illustrated further in samples treated with Pure TEOS. On the other hand, in the samples treated with TEOS containing SiO₂ nanoparticles, no significant changes were observed in the consolidants film. This proved the stability of microstructure of the product under the effect of the artificial thermal aging compared to those coated with TEOS without the nanoparticles in Figs. 6d and 6e. This may be due to the fact that the unique physical and chemical properties, size and the higher surface area of the nanoparticles.

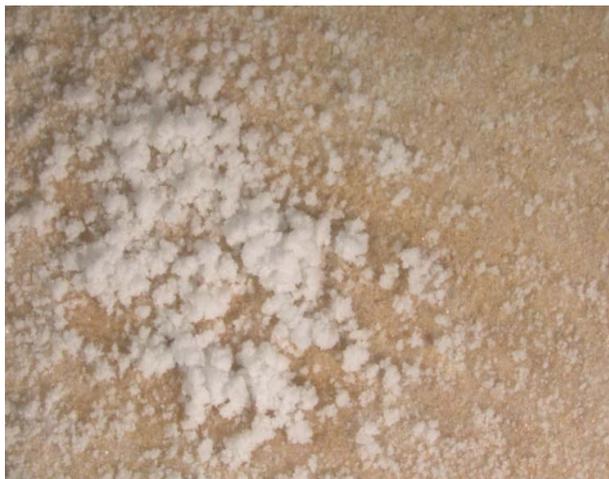
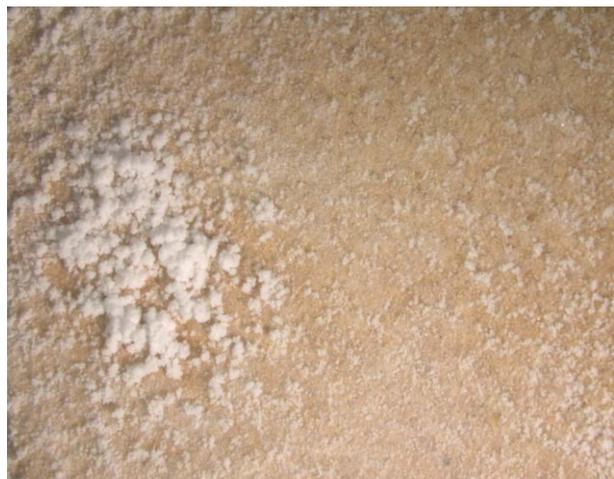
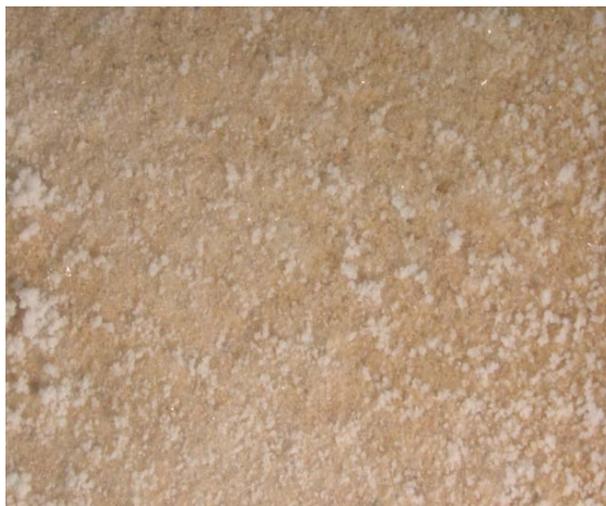
In fact, the nanomaterials in these additives can be up to 100,000 times smaller than even the smallest sand particles. This allows their molecules to literally pass sand particles and ultimately become part of the sand with which they react and protect porous building materials against salt efflorescence. The results showed that, the treated samples had a greater resistance to damage than the untreated samples. This was evaluated through the weighing of material lost. Following the salt weathering tests, the surfaces of the samples were visually observed. While the untreated samples had a powdery rough texture, the samples treated with SiO_2 /polymer nanocomposite had a smoother surface with less deterioration visible, compared to those coated with TEOS without the nanoparticles, see Figs. 7a-7c.

Fig. 7 Stereo microscopy images, Show the effect of the salt weathering on (a) untreated samples, (b) samples treated pure SILRES® BS OH 100 and (c) samples treated with SiO₂/polymer nanocomposite.
