ANALYSIS OF MULTI-LAYER SAFETY IN COUNTRIES AFFECTED BY RECENT TSUNAMIS: EMERGENCE OF A GLOBAL TSUNAMI CULTURE

M. Esteban¹, V. Tsimopoulou², T. Mikami³, N.Y. Yun⁴, A. Suppasri⁵, and T. Shibayama⁶

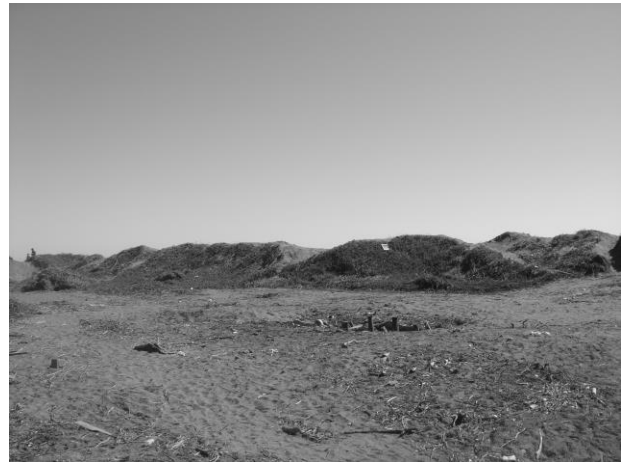
Fig. 1 Partially degraded sand dunes at Llolleo

Generally speaking, it could be said that tsunami counter-measures were not adequately developed in Chile. Prevention measures were virtually non-existent, showing how little effort was made to develop layer 1 measures. Where present, they appeared not to have been there to prevent the damage due to any natural disasters, but more as an accidental feature of the terrain. For example, in the village of Llolleo sand dunes protected parts of the coastline (see Fig. 1).

These sand dunes were effective in blocking the tsunami, at least on the side of the village where the sand dune was continuous. The southern half of the village, however, only had a broken sand dune to the west side of it, and was completely open to the sea on its southern half. This part of the village was consequently almost completely wiped out (see Fig. 2)

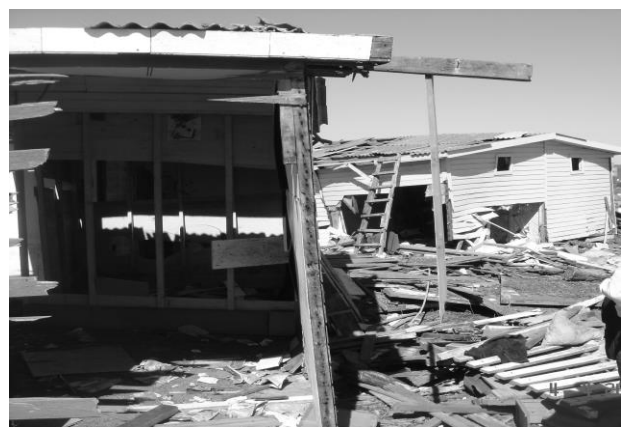
Fig. 2 Destroyed houses behind the sand dunes

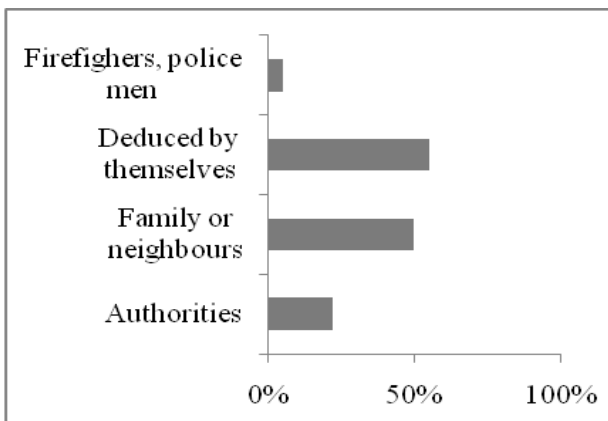
Fig. 3 Source of information that prompted local residents to evacuate

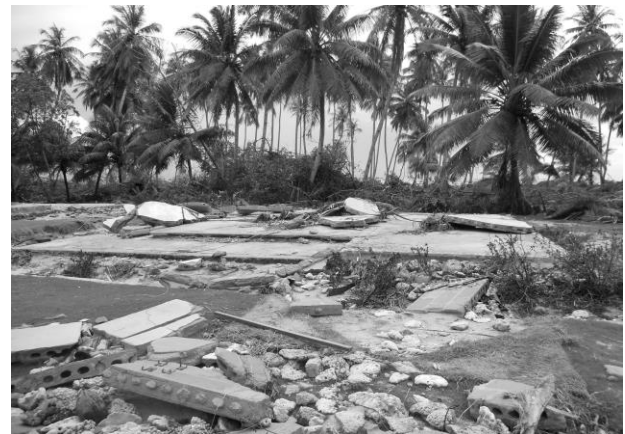
Fig. 4 All wooden houses were destroyed in Gobic

At 21:42 local time on October 25, 2010, a large earthquake of magnitude M_w 7.7 occurred off the coast of Mentawai Islands in Indonesia, generating a tsunami that struck the coastal area of these islands. Houses located near to the sea (generally wooden constructions) were washed away with damage gradually decreasing as the wave progressed inland. The areas generally possessed little in terms of modern infrastructure, and thus most of the recorded damage was to housing (See Fig. 4)

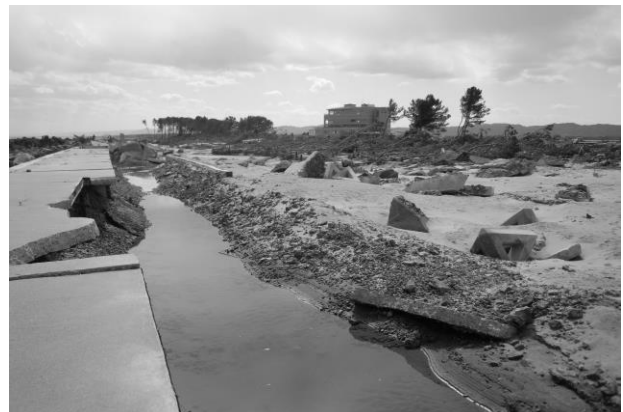
Fig. 5 Extensive failure of coastal dykes

This was actually the first time in history that a tsunami had encountered a well-developed modern tsunami counter-system method (Mori et al., 2012). Before the *2011 Great Eastern Japan Earthquake and Tsunami*, a large variety of tsunami countermeasures, representative of all three layers of multi-layer safety, could be found along the coast of Tohoku. This clearly indicates that a tsunami culture existed in Japan prior to the event. However, the type of tsunami countermeasures employed were not uniform along the entire affected coast. Generally speaking, layer 1 measures included offshore breakwaters and tsunami walls along the northern part of the coastline (known as the rias area) and coastal levees and sandy frontages on the southern region (known as the Sendai coastal plain). Most of these structures and the area behind them suffered extensive damage, as can be seen in Fig. 5.

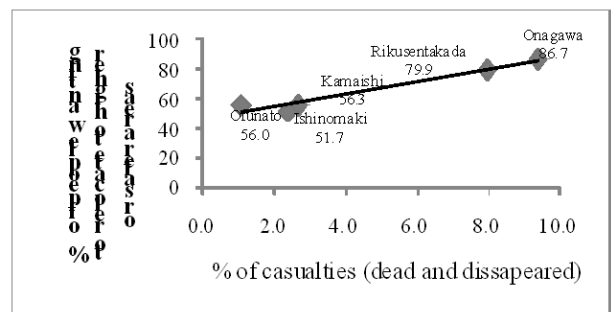
Fig. 6 Relationship between number of inhabitants who would like to depart from each population centre and the proportion of casualties

It is important to note that it is possible that the population that will live in tsunami prone areas in the future will decrease in the Tohoku region, mainly due to the effect that the tsunami has had on the local population. Fig. 6 illustrates the relationship between the number of inhabitants who would like to move to safer areas as a proportion of the population that perished in various localities in the Rias coastline (Oyama, 2012). Fig. 7 shows also the relationship between those who would like to leave compared to the proportion of the population that lived in areas that were inundated, for each city. If this is compounded with an expected demographic decline due to population aging, then it is clear that far less people will probably live around these areas (Japanese National Institute of Population and Social Security Research, 2012).

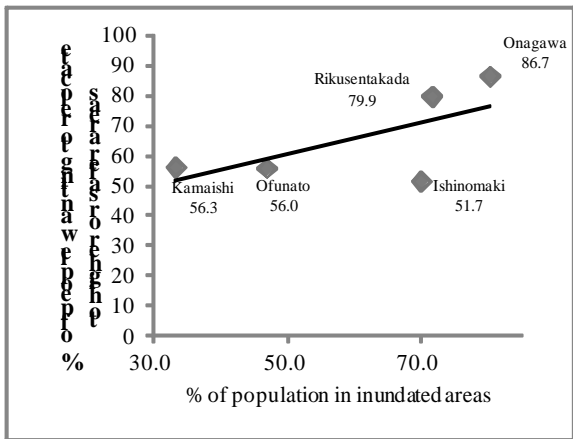
Fig.7 Relationship between number of inhabitants who would like to depart and the proportion of the population in each of the inundated areas
