# Overcoming and Preventing Dental Implant Complications: Abutment Fracture Case Report

**Key Words:** Abutment fracture; Implant complication; Mechanical complication; Prosthetic complication

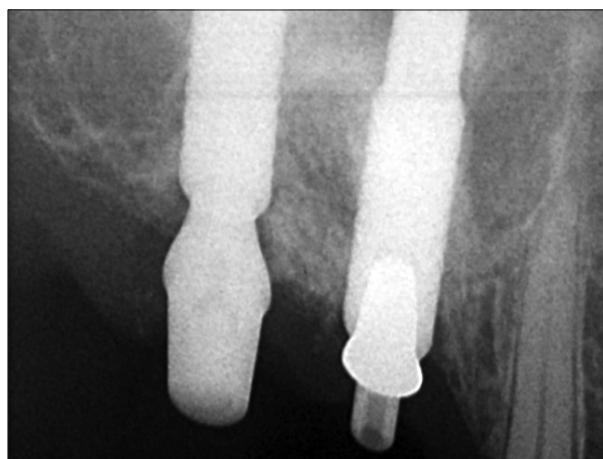
Mobility of prosthesis was detected, and the abutment screw in the screw retaining area was removed using torque wrench to remove the prosthesis accordingly. But there was a defect in the structure of the upper prosthesis as shown in Fig. 1, a radiograph of the root apex, and Figs. 2 and 3,

Fig. 1. Radiograph of root apex after removing prosthesis.

This case was likely to be associated with abutment fracture because prosthesis received loads including lateral pressure for a long time after loss of cement from the cement-retained-type prosthesis. In particular, if antagonistic teeth are in the implant group, complications can arise unless chewing pressure especially lateral pressure is controlled properly. In addition, the posterior screw-retained-type abutment will have excessive loading if dissolution and failure of cement in the posterior abutment are not managed properly with regular inspection. In addition, error in prosthetic process and defect of abutment may be influencing factors. Considering the location of fracture in Fig. 2, there may be a need to consider the problem in the joint area between the custom cast abutment with screw retention (UCLA) abutment and the upper structure when casting.

The separated lower structure of the UCLA abutment was removed including the posterior cement-retained-type abutment, and prosthesis was manufactured again by collecting impression implant from fastener level. The posterior abutment was changed to the hex type, and conformity of the prosthesis was checked thoroughly to connect 'passive fit' prosthesis that does not deliver excessive loading to the abutment.

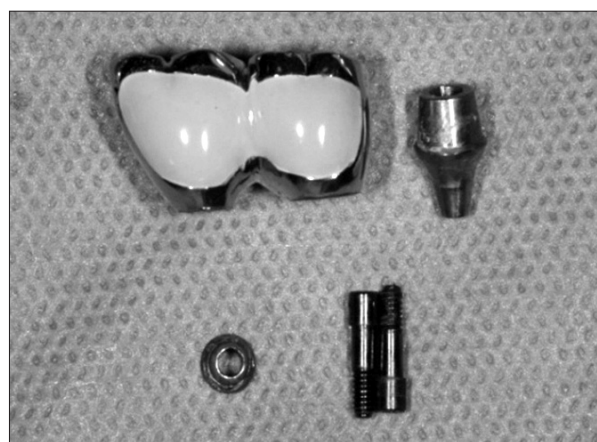
Fig. 2. Removed prosthesis and fractured abutment.

pictures of the removed prosthesis and fractured abutment. Antagonistic teeth used an implant-retained-type prosthesis.

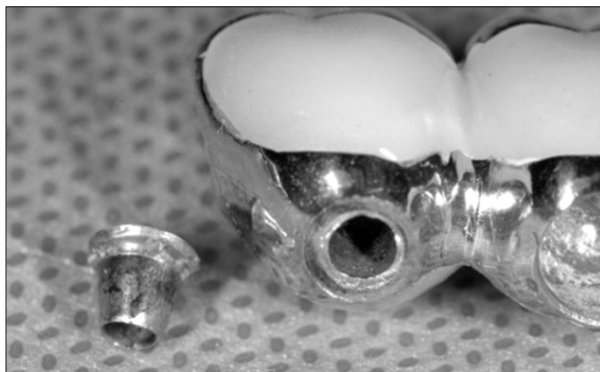
Fig. 3. Fractured abutment and lower part of prosthesis.

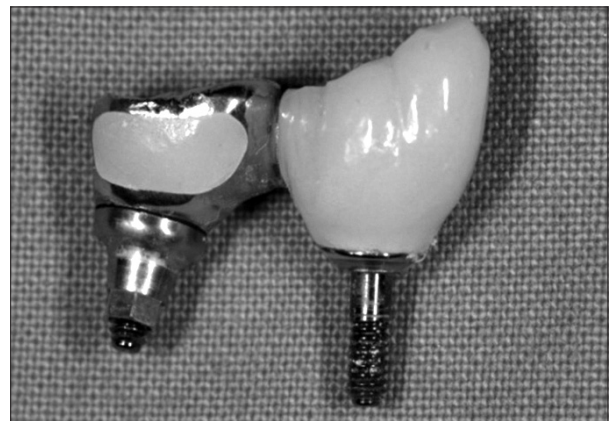
Fig. 4. Removed prosthesis and abutment.

One or more of the 2 abutments were expected to have attachment failure or loosening of screw including loss of cement, thus the screw was removed by creating a hole at the top of the prosthesis. After removing it, fractured abutment was identified in the prosthesis and the lower part of the remaining abutment as shown in Figs. 4, 5, and 6.

To remove the abutment remaining in the implant, the 'removal kit' delivered from each implant manufacturer was used, and prosthesis was manufactured again by collecting impression at the fastener level. In this case, 2 implants placed in different directions were of the cement-retained type, and at the time of manufacture, stress may be concentrated when applying to the front abutment, or there may be excessive lateral pressure around the #46 tooth. Even when using custom abutment or angled abutment, goodness of fit or retention force of the upper structure may decrease compared to that of a correctly placed implant, and misfit within the prosthesis may be undetected due to cement. If a misfit is generated when manufacturing prosthesis, such may be a major cause of fracture, and great care is needed if antagonistic teeth are natural teeth of implant fixed-type prosthesis. When manufacturing prosthesis again, the height and angle of the #46 MB cusp tip were lowered, and goodness of fit of prosthesis was evaluated to

restore with cement-retained-type prosthesis that delivers 'passive fit.'

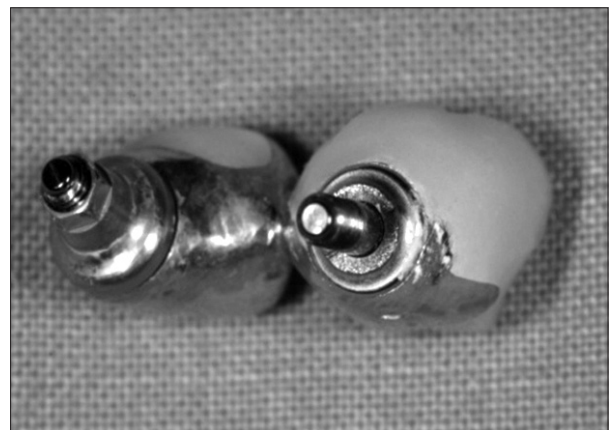
Fig. 5. Removed prosthesis and lower part of abutment.

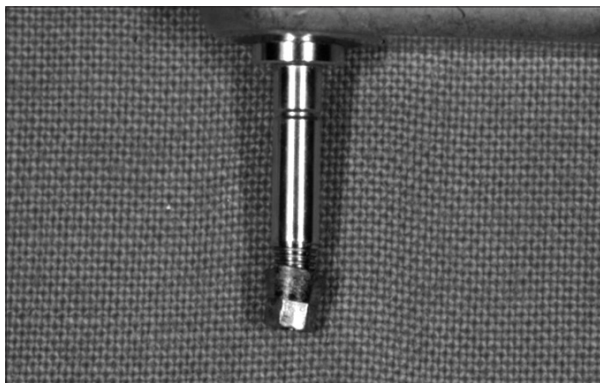
Fig. 6. Removal of fractured abutment using an exclusive tool.

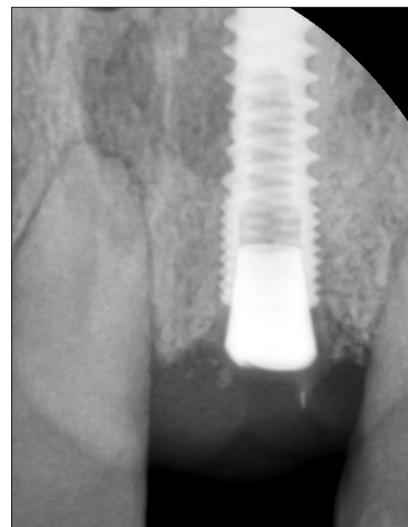
When manufacturing prosthesis, first, for the aesthetic restoration of prosthesis, cement was placed at the top of abutment using zirconia abutment provided by the manufacturer. However, fracture occurred at the abutment in the lower part of the prosthesis. As shown in Figs. 7 and 8, the location of the fracture is 1/3 from the center of abutment. In this case, implantation was done by placing ceramic on the non-hex-type zirconia abutment; therefore, internal flaw caused by the repeated placement of ceramic and heat treatment

Fig. 7. Radiograph of root apex of fractured ceramic abutment.

was likely to spread due to repeated loading caused by excessive occlusion force or disadvantageous delivery of loading in the anterior area. However, there was no specific problem in the regular occlusion test and adjustment. In addition, there may have been a flaw in the abutment, or loading is concentrated on a certain location due to the uneven contact surface between the exterior of the abutment and inside of the implant fastener. For restoration, impression was collected again from the implant fastener level, and cement-retained-type prosthesis was manufactured using normal titanium abutment.

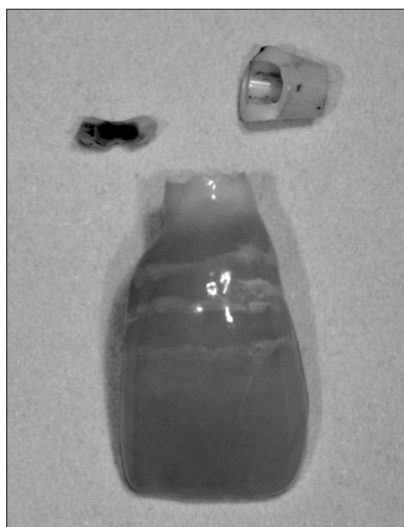
**Fig. 8.** Upper structure of ceramic abutment and lower part of fractured abutment.
