Spore Migration in the Indoor Environment

AIHCE 2007

Roundtable 202

Boelter Associates, Inc.

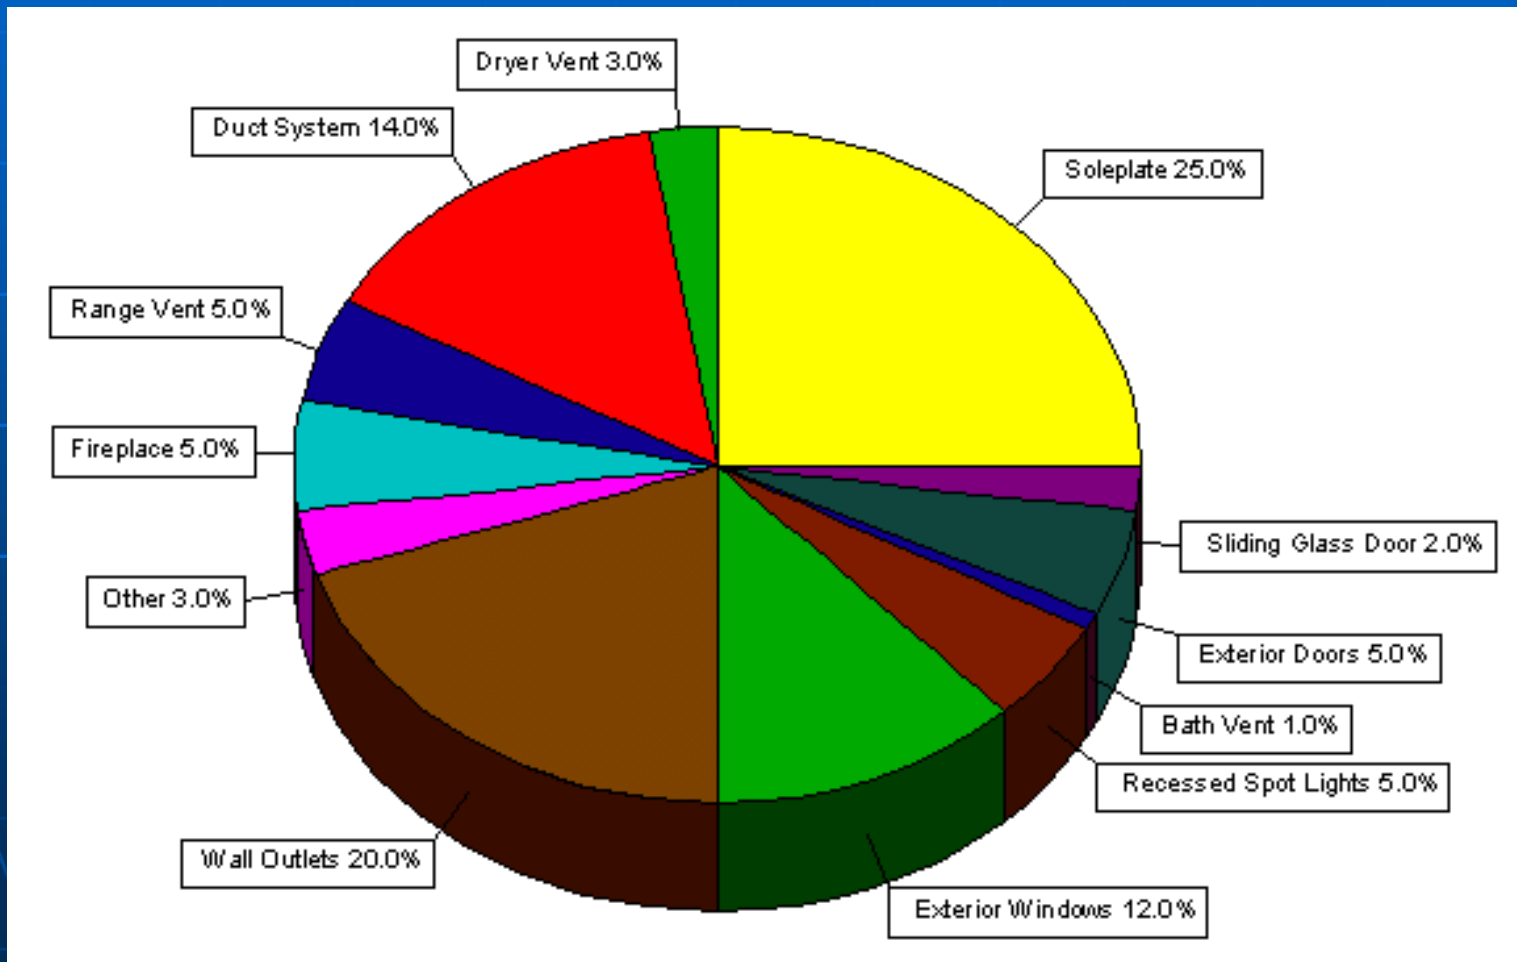
Air Infiltration Pathways

Chart from LSU study

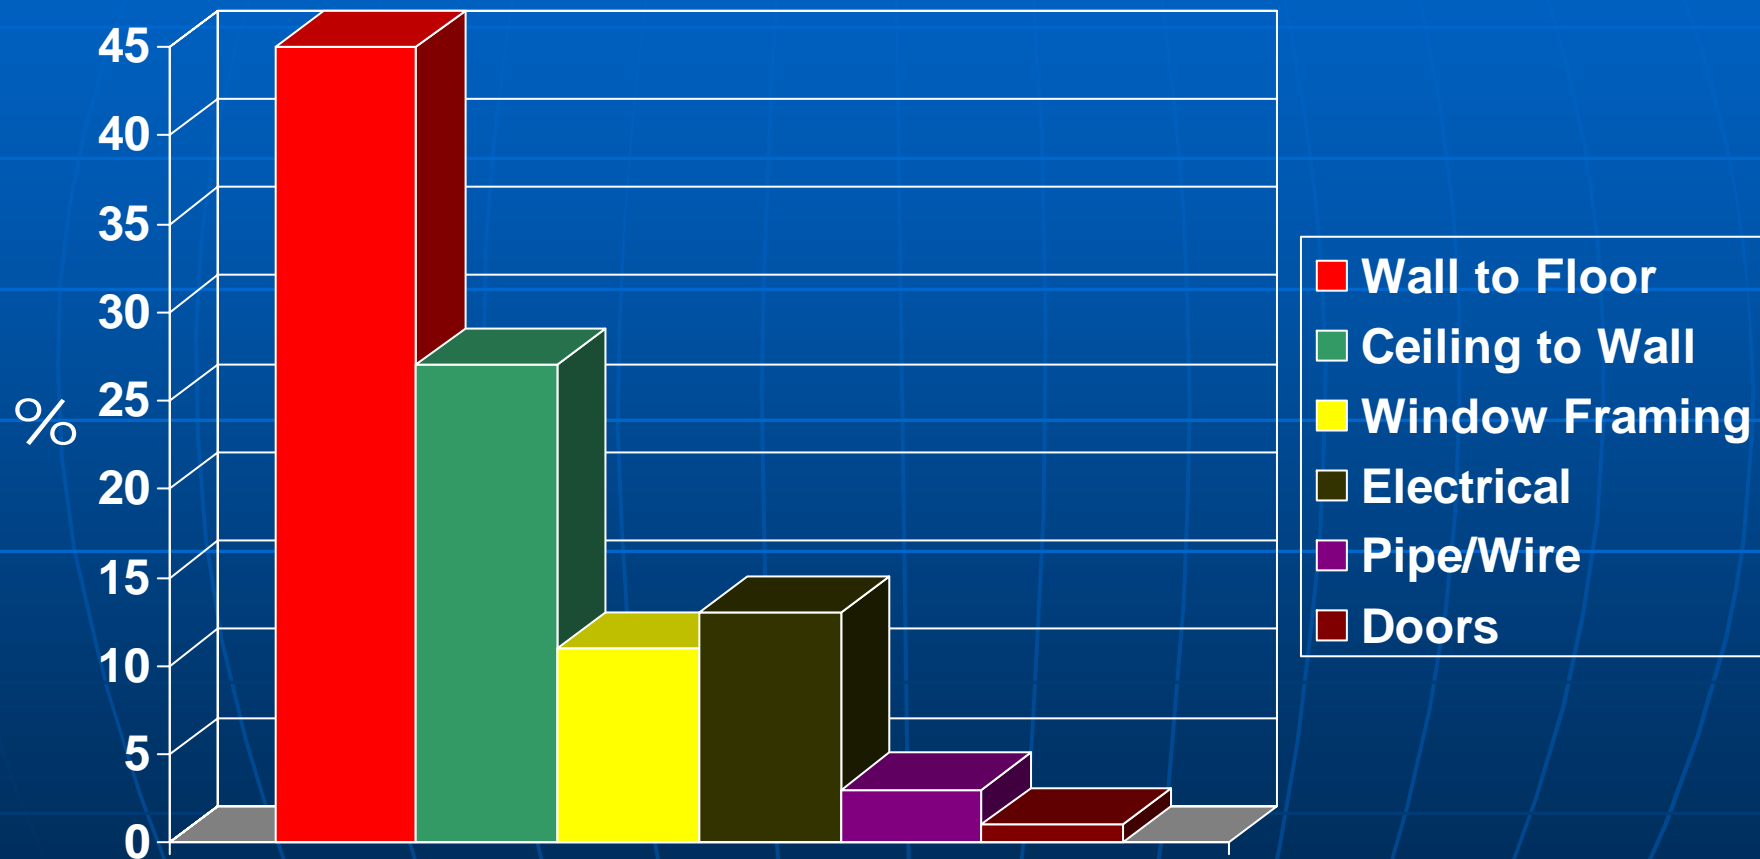
Air Infiltration Pathways In Unsealed Framed Wall Cavities

ASHRAE research project RP 438, Colliver, D.G.; 1994

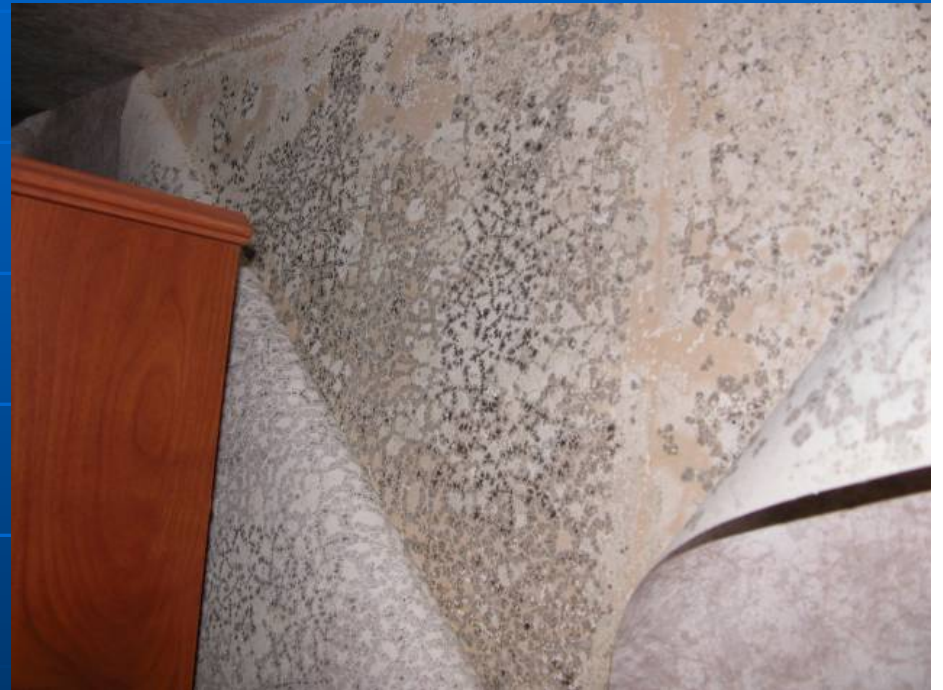
Vibration & Disturbance

- Disturbance of a few square feet of vinyl wall covering over moldy drywall increased Asp/Pen in air concentration by 1,000X

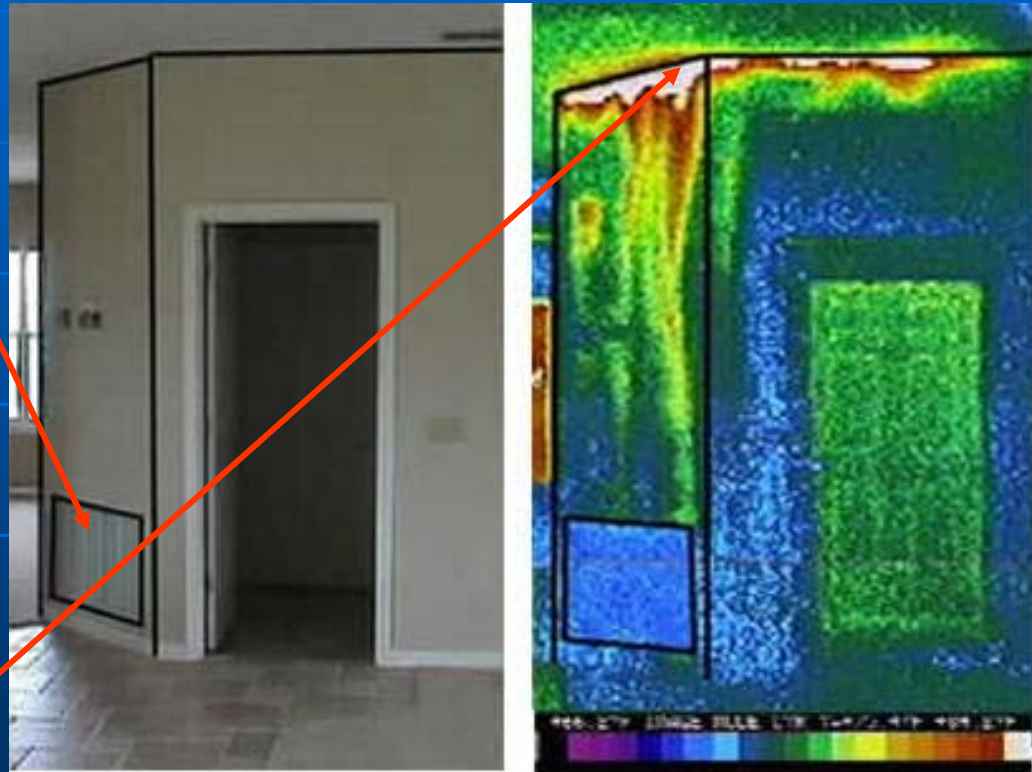
Driving Force

- Reduced air pressure = driving force
- Air infiltration from attic = pathway in wall framing

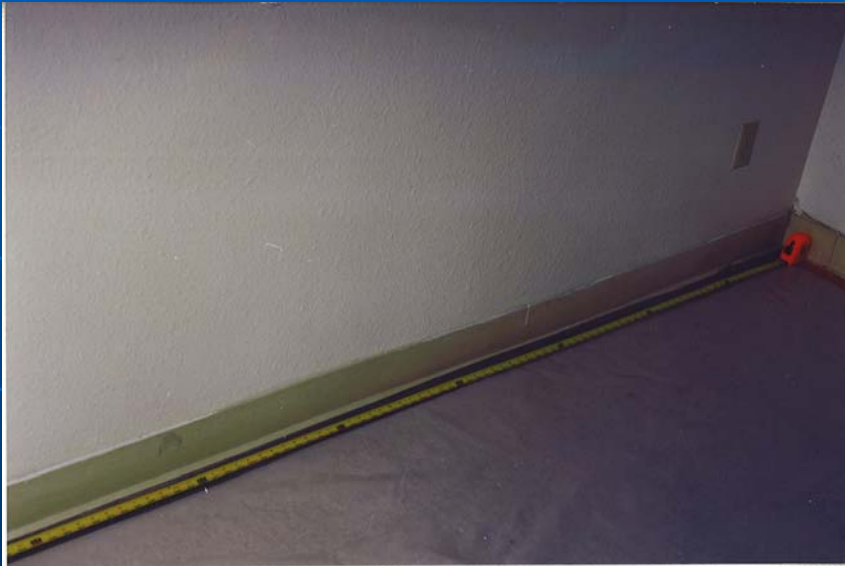
Case 3 Leaking Apartment

Typical exterior wall – no visible mold (atypical air test)

- Defects in building envelope allowed wind driven rain to infiltrate wall cavities of some apartments.
- Hidden mold growth developed in those wall cavities.
- Air infiltration carried spores from the wall cavities into the living space of those apartments.
- Profile of airborne mold taxa significantly different in affected apartments.

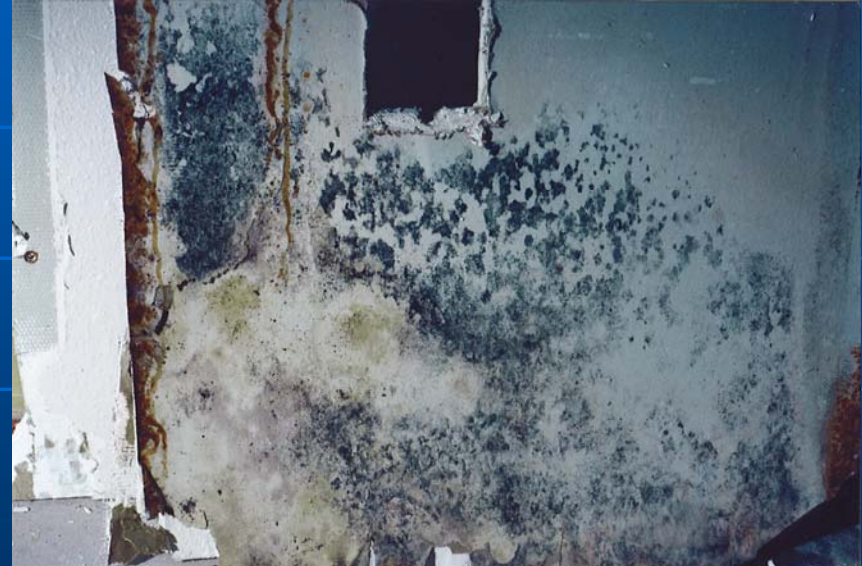
Interior cavity with hidden visible mold
