Improving the reliability of industrial multi-MW wind turbines

Jun Zhou[1], Sanaz Roshanmanesh[1], Farzad Hayati[2], Valter Jantara Junior[1], Taoran Wang[1], Siavash Hajiabady[1], Xiao Ying Li[1], Hector Basoalto[1], Hanshan Dong[1] and Mayorkinos Papaelias[1]

[1]School of Metallurgy and Materials, The University of Birmingham, UK
[2]School of Engineering, The University of Birmingham, UK

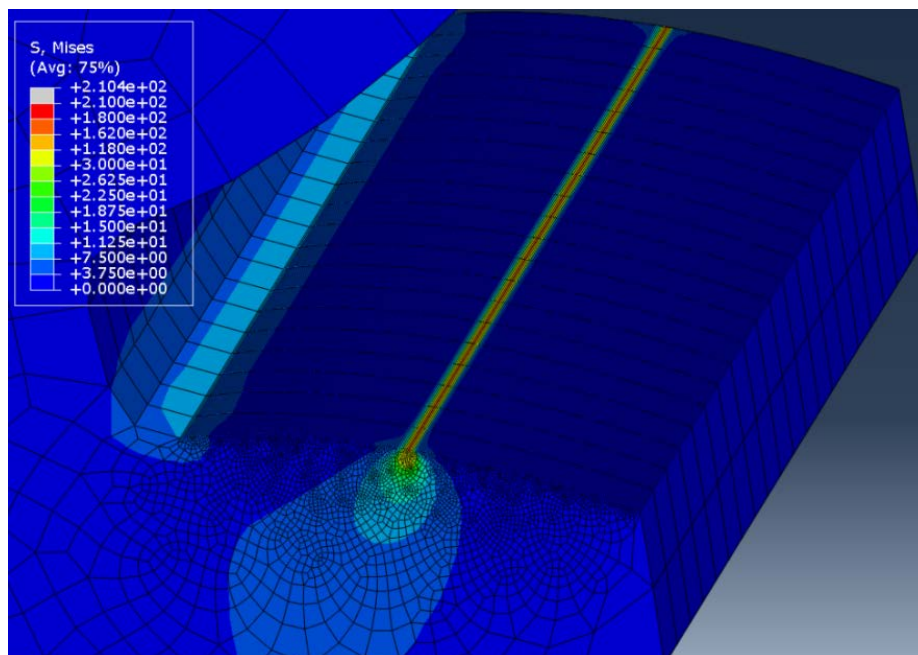
The highest stresses are concentrated in the contact area between two rolling elements, e.g. two gears. The contact and bending stresses between two gear teeth in contact can be seen in figure 2. For this gear pair and input torque, the bending stress is much lower than the contact stress, as observed in the contour plot.

Figure 2: Von Mises contour plot for gear pair, lateral view. The mating gear was removed for better visualisation.

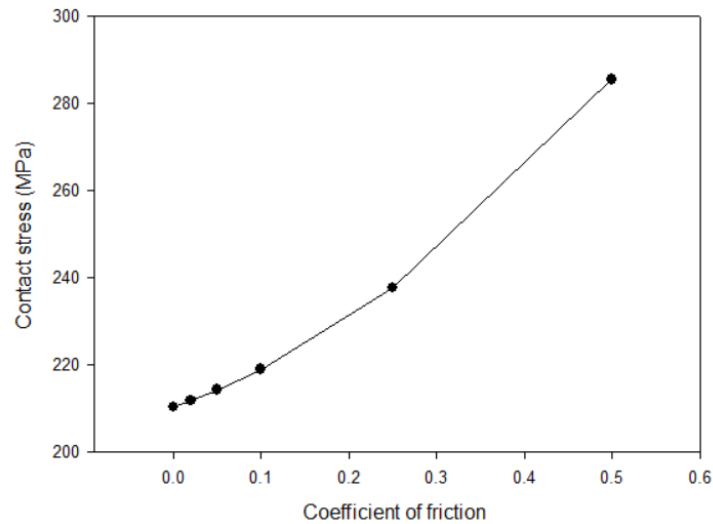
The contact stress levels will be influenced by a number of variables but primarily it will be a function of the coefficient of friction and contact area. From calculations carried out it is possible to see that higher coefficient of friction value results in much higher contact stresses (figure 3). Similarly, the effect of angular misalignment on contact stress amplitude has also been evaluated.

Figure 3: Plot showing the effect of the coefficient of friction on contact stress.

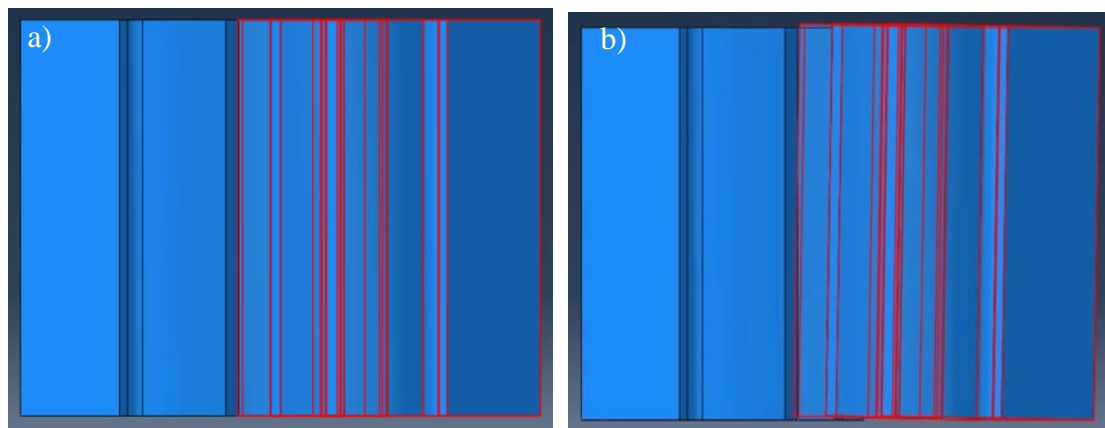
In order to test the effect of angular misalignment, one of the simulated gears was rotated along its y-axis, between 0° (figure 4a) and 1° (Figure 4b). The results of the effect of misalignment on contact stress level can be seen in the plot of figure 5.

Figure 4: a) Gear pair in perfect alignment (left); b) Gear pair in angular misalignment (1°) (right).

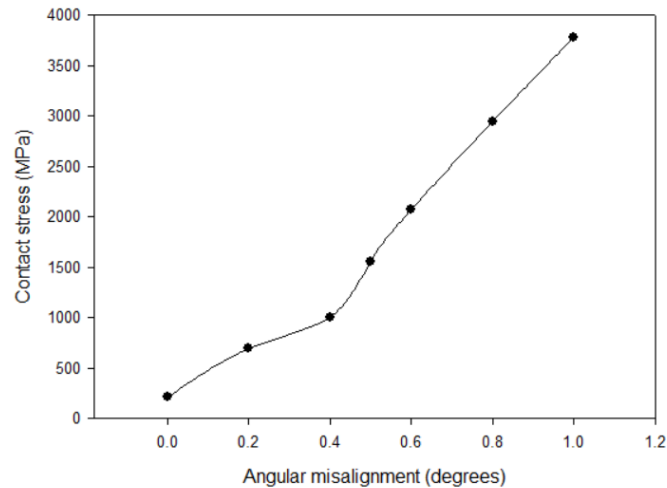
Figure 5: Plot showing the effect of angular misalignment on contact stress.

Angular misalignment has a significant effect on the amplitude of the contact stress. Even a small amount of misalignment, such as 0.20° can produce contact stresses as high as 692.7 MPa, which is almost 3.3 times the contact stress level obtained from two gears in perfect alignment. At 1° of angular misalignment, the contact stress can be almost 18 times higher than the initial contact stress. Such high contact stresses could lead to severe plastic deformation, causing initiation and subsequently rapid propagation of damage.

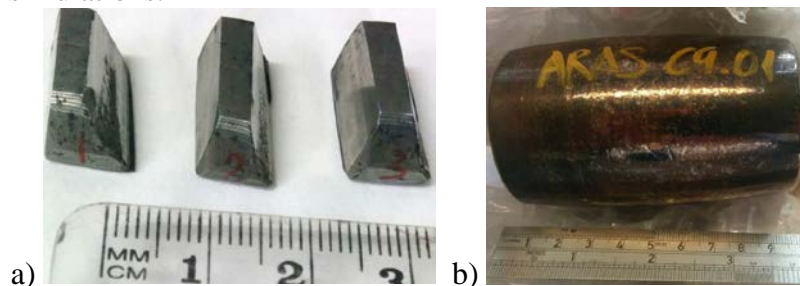
Tests on reference materials from failed bearings and gears provided by wind turbine operators participating in the OPTIMUS FP7 project consortium have revealed that the cleanliness of steel plays an important role in the initiation and subsequent propagation of fatigue cracking in rolling elements. The presence of inclusions, such as manganese sulphides (MnS), has a detrimental effect on the fatigue lifetime of gearbox components. This is due to the fact that fatigue cracks due to contact and bending stresses can initiate from MnS inclusions and then propagate along them. The initiation of the cracks can also be related to the MnS inclusion distance from the surface. Therefore, depending on the cleanliness of the steels employed damage can propagate faster or slower following a path outlined by inclusions present in the microstructure. This failure mechanism has been observed in samples obtained from defective gearboxes (Figure 6) and verified using finite element analysis (FEA) simulations.

Figure 6: Damaged a) gear teeth and b) roller removed from gearbox.

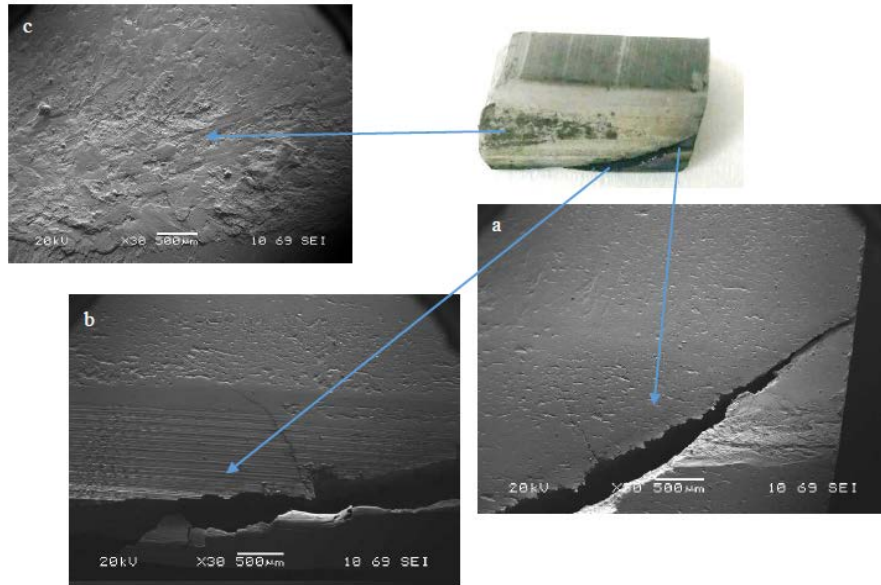
Figure 7 shows crack propagation in one of the damaged gear teeth evaluated using optical and Scanning Electron Microscopy (SEM). The SEM micrographs in Figure 8 show that the crack propagates along inclusions which have been established to be MnS.

Figure 7: SEM evaluation of cracked tooth sample.

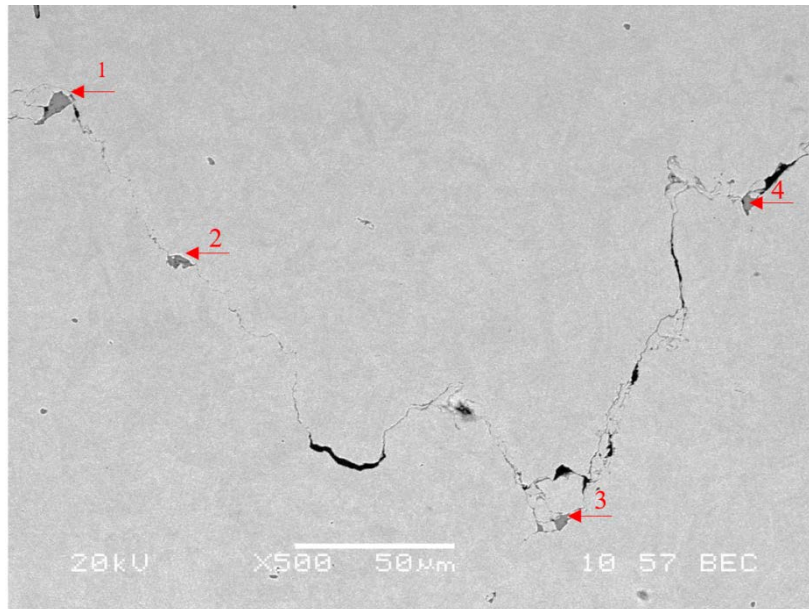
Figure 8: SEM images showing crack propagation along MnS inclusions (direction of crack propagation is from inclusion #4 towards #1).

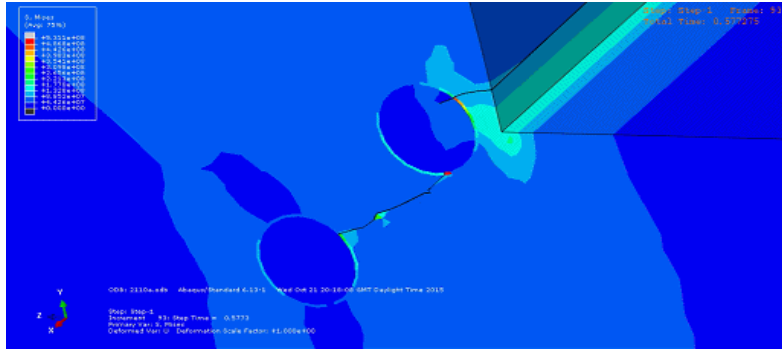
FEA simulations carried out using Abaqus have also clearly shown that the cracks can initiate at MnS sites in the gear tooth material and subsequently propagate along a path which is outlined by the presence of such inclusions. This is shown in the FEA results of figure 9.

Figure 9: FE model showing crack propagation initiating and propagating on a gear tooth along MnS inclusions.

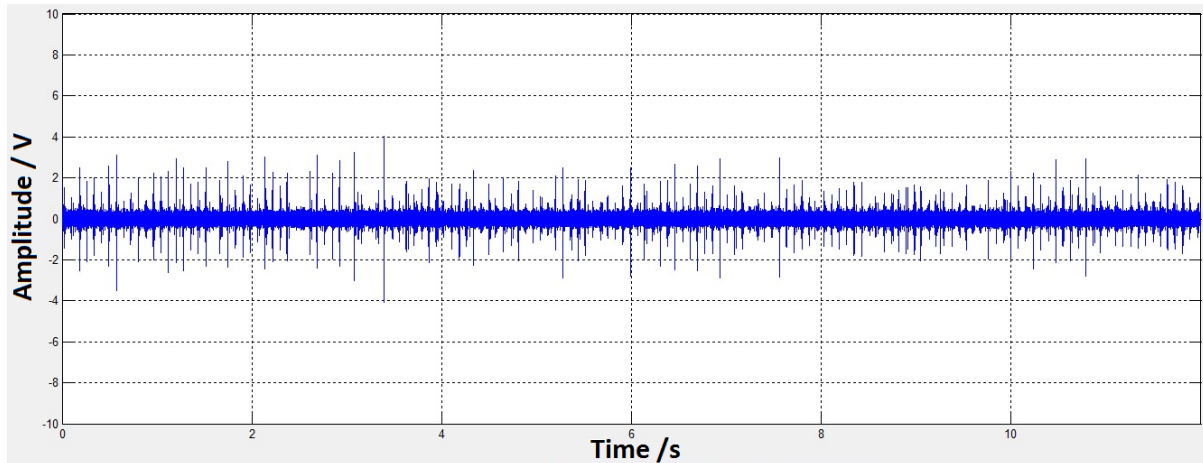
Figure 11 shows a raw AE signal acquired from the planetary stage sensor position. From the spiky nature of the signal it is evident that a defect is present. Further in-depth data analysis revealed clear evidence of significant damage present in the planetary stage (planetary bearing) which was also verified by TERNA maintenance personnel. Figure 12 shows the power spectrum of the demodulated signal, indicating the presence of a planetary bearing tone with sidebands and related harmonics.

Figure 11: Raw AE signal acquired from the planetary stage sensor showing multiple regular peaks. This is an indication of a possible defect.

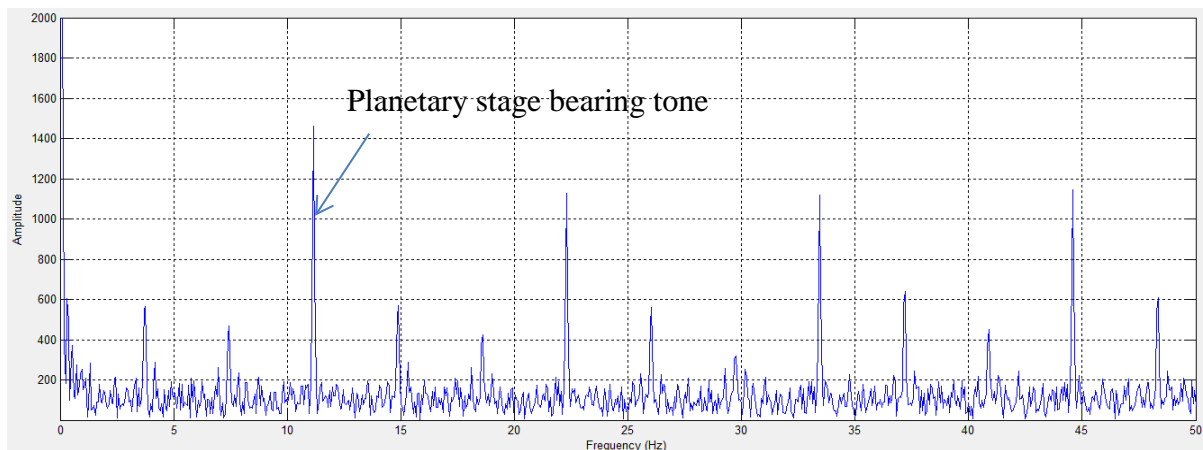
Figure 12: Low frequency power spectrum of the demodulated AE signal showing a planetary stage bearing defect with sidebands.
