DAMAGE TO CONCRETE BUILDINGS WITH PRECAST FLOORS DURING THE 2016 KAIKOURA EARTHQUAKE

Richard S. Henry¹, Dmytro Dizhur², Kenneth J. Elwood³,
John Hare⁴ and Dave Brunson⁵

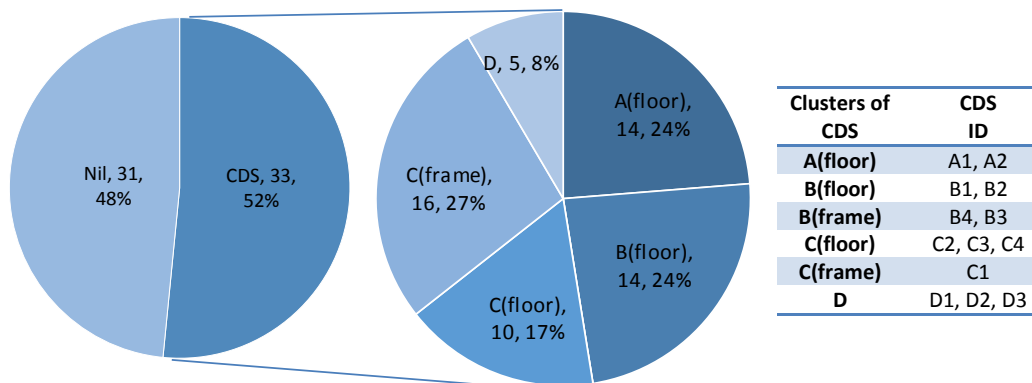
As shown in Figure 1, 52% (33) of inspected buildings showed evidence of at least one CDS, with 28 reported with CDS A or B (all classified as floor CDS), 26 reported with CDS C (10 classified as floor CDS and 16 as frame CDS), and 5 buildings with reported CDS D (secondary elements). The primary focus of the TDE inspection process was on identifying CDS A or B which may impact building occupancy. Of the CDS A or B cases, 8 buildings showed distributed damage across the floor diaphragm and/or over three or more stories, with the remaining 25 buildings exhibiting more localised or isolated damage.

Figure 1: CDS identified in TDE buildings.

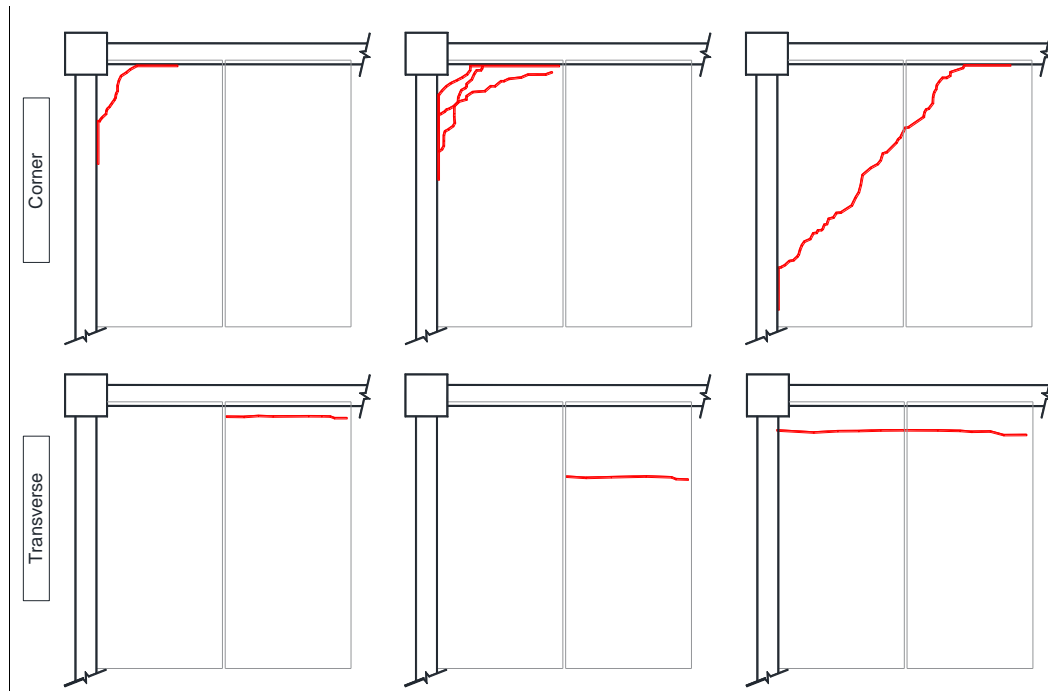
The most commonly observed damage pattern of the floor diaphragms was cracking of floor precast units in the corners of the floor diaphragm. As shown in Figure 7, corner cracking typically takes one of three forms: 1) localised with only one or two, typically fine, cracks near corner column (examples in Figure 8); 2) a complex intersection of many, typically wider, cracks, generally limited to the first unit (examples in Figure 9); or 3) a single diagonal crack set back from the corner, crossing more than one unit, and intersecting the frames roughly halfway along the bay lengths. The first two corner damage patterns result from deformation incompatibility between the beam and the floor unit leading to twisting of the first unit running parallel to the external frame, and can be exacerbated by beam elongation. Hollow core units are weak in torsion and crack at low deformation demands [7, 8]. In 2004, an amendment to NZS 3101:1995 [13] introduced a requirement to include a link slab between the exterior frame and the first precast unit to accommodate the deformation of the beam relative to the floor unit. Due to the small number of post 2004 buildings included in the TDE, the performance of

link slabs was not able to be assessed in detail. The orientation of the third damage pattern noted above suggests this cracking may be accentuated by bidirectional movement of the building and the resulting bending of the floor diaphragm in the corner, in addition to beam elongation demands.

Figure 7: Plan views of typical crack patterns observed in hollowcore floor units (from below or from above).

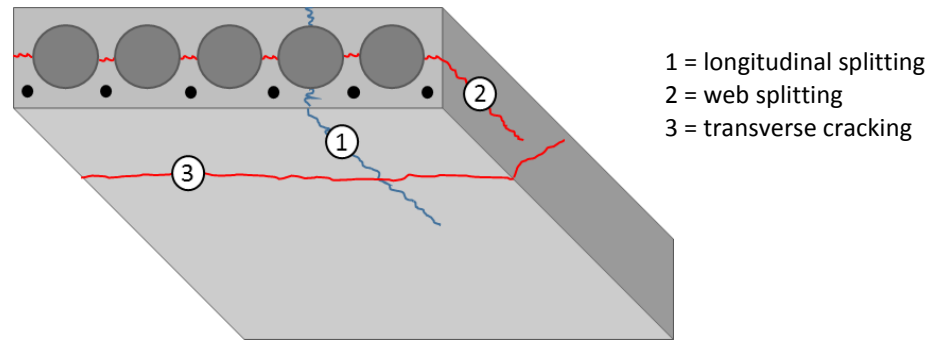
When assessing the critical damage states, it was important to identify whether the cracks in the floor topping concrete had propagated between the joints of precast units or through the unit itself. Different types of cracks found in hollowcore units are shown in Figure 11. Hollowcore units manufactured in New Zealand do not contain transverse reinforcement and bottom flange prestressing strand is not well developed at the ends of the unit and may also be affected by strand draw-in or slip. As a result, transverse cracks near the support can significantly impact the shear capacity near the ends of the hollowcore floor units [7]. Transverse cracking in hollow core units was observed in 14 of the 64 TDE buildings. In three of these buildings the transverse cracks were identified to have propagated diagonally through the web of the hollowcore (CDS A1), but in the remaining 11 buildings the orientation of the cracking through the hollowcore unit had not been confirmed. Transverse cracking close to the supports of hollowcore units was also observed during the 2010/2011 Canterbury earthquake sequence [9], but was more prevalent

Figure 11: Types of cracks found in hollowcore units.

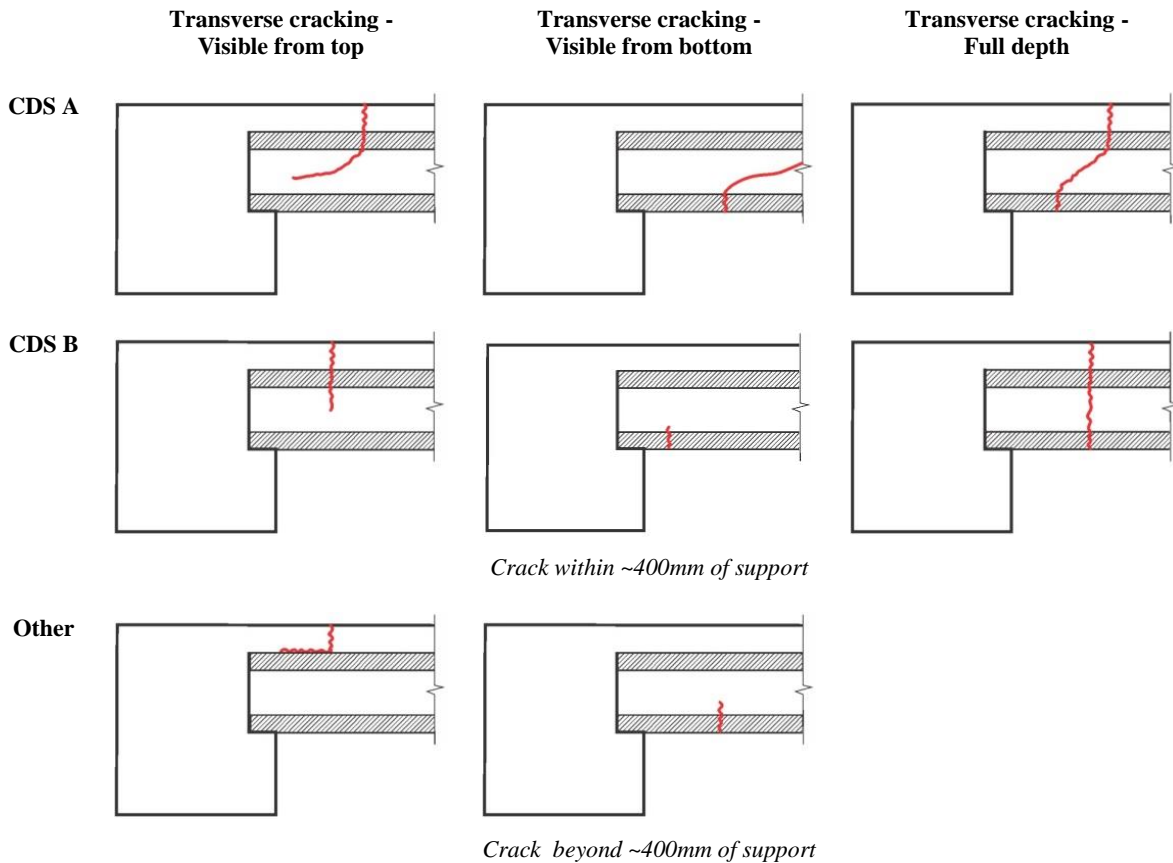
The most common hollowcore floor unit damage patterns observed in Wellington buildings can be described as a combination of crack sections shown in Figure 12 and plan views shown previously in Figure 7. The top row would be classified as CDS A as the gravity load support has been compromised with a diagonal crack in the web. Engineers were encouraged to use a borescope camera, such as that shown in Figure 13, to inspect cracking in web of units. If webs were not inspected, the TDE guidance document [4] instructed the engineer to assume the presence of a diagonal crack. In the case of spaced hollowcore, the sides of hollowcore units were visible and diagonal cracking could be seen in the webs, as shown in Figure 14. Past research has demonstrated that units with transverse cracking top or bottom, combined with diagonal cracking in webs, can be close to sudden brittle failure [14, 15].

Figure 12: Cross sections of observed crack patterns in hollowcore floor units.

The second and third rows in Figure 12 show damage patterns which are generally of lower risk, compared with CDS A; however, cracking at underside near the support is also of concern. Such damage, along with possible retraction of the prestress strand from the end of the unit, can reduce the bond between bottom flange prestress strand and concrete leading lower shear strength at the end of the hollowcore unit. Inspection of the end of the hollow core unit for any signs of strand retraction was typically not possible due to casting of beam concrete and topping slab over hollowcore unit end, hence without extensive removal of concrete it was not possible to determine if the strands had retracted.

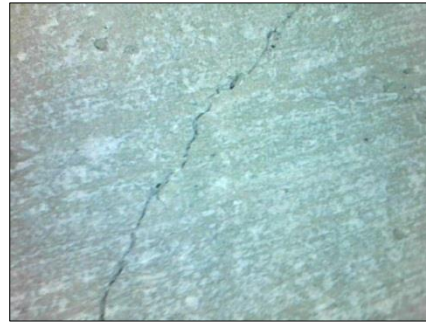
(b) Image inside cell of hollowcore

Figure 13: Borescope camera example.
