FACADE DAMAGE ASSESSMENT OF MULTI-STOREY BUILDINGS IN THE 2011 CHRISTCHURCH EARTHQUAKE

Andrew Baird¹, Alessandro Palermo² and Stefano Pampanin³

SUMMARY

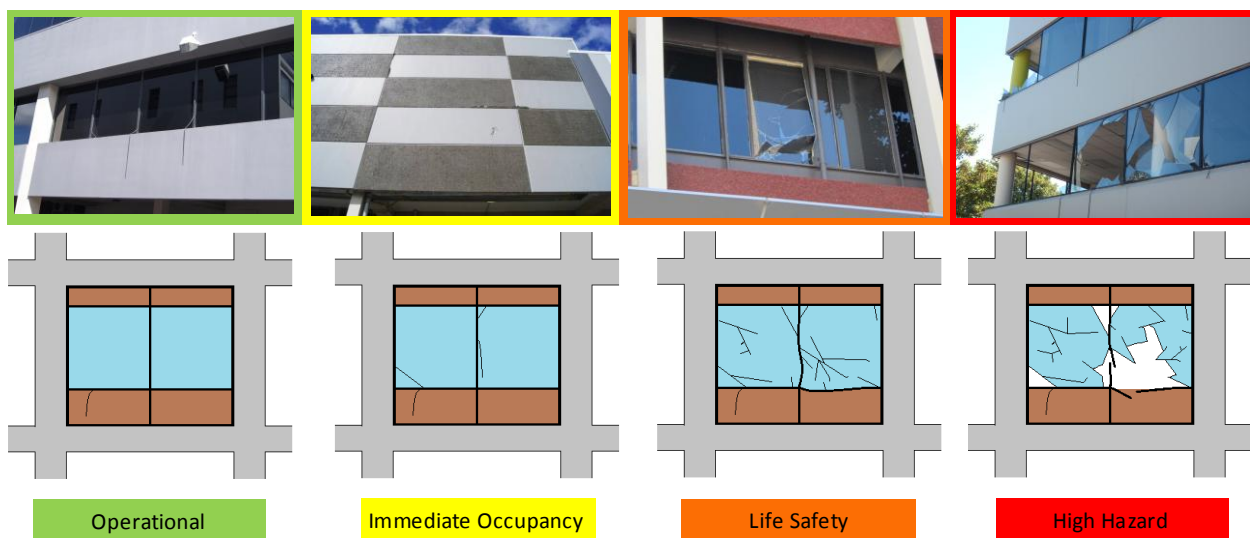
Figure 16: Facade performance levels.

order to avoid the confusion, the hazard reduced performance level is herein re-named the 'High Hazard' performance level to accurately include any cases where there was a high risk of serious injury or fatality from facade damage. Figure 16 presents photographs and a graphic illustration of the different facade performance levels sustained during the Christchurch earthquake.

Damage to the facade is present but building access and life safety systems remain available and operable. Minor window breakage could occur. Presuming that the building is structurally safe, occupants could safely remain in the building, although normal use may be impaired and some clean-up required. The risk of life-threatening injury due to facade damage is very low.

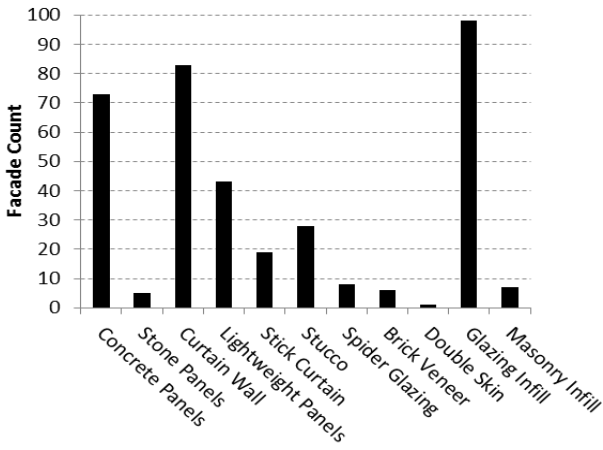
Figure 18: Facade typology composition.

The facade systems are grouped according to the groups previously identified. The cladding typologies surveyed are listed below and the frequency that they were identified is shown in Figure 18.

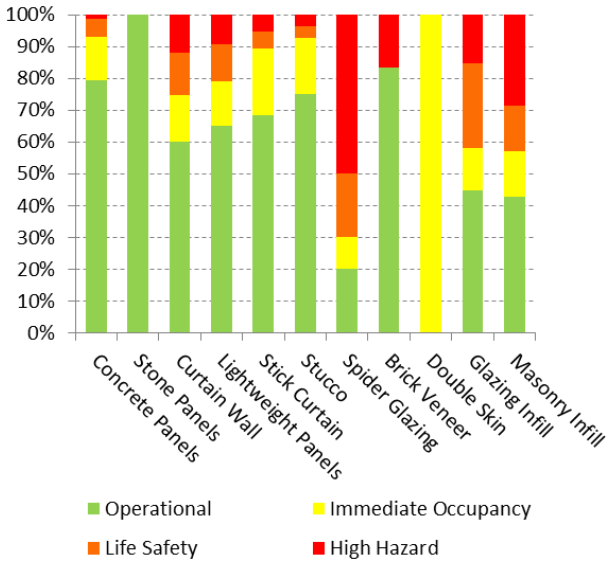
Figure 19: Facade performance by facade typologies.

Firstly, the composition of performance levels for each facade system is presented in Figure 19. The performance level of each facade system was determined according to the criteria discussed in the section titled 'Facade Performance Levels'. Overall, 64% of facade systems surveyed were deemed operational, 14% deemed Immediate Occupancy, 12% deemed Life Safety and 10% deemed High Hazard. This means that the performance of 37 facade systems was outside an acceptable level for even a very rare earthquake event as it posed a significant risk to life safety.

It could be concluded that heavy claddings performed better than most facade systems; with 94% of heavy claddings deemed either operational or immediate occupancy. However, it is possible a more thorough assessment of the connections from inside the buildings may lower this percentage. More importantly the possible consequence of heavy claddings falling is severe which means further attention towards their treatment is necessary.

The composition of performance levels for light-medium weight claddings varied greatly. Overall, 82% of lightweight claddings were deemed either operational or immediate occupancy, exhibiting either no damage or very minor damage such as ejected window seals or cracked glass.

A large number of high hazard cases were also observed. This was usually due to a significant portion of the glazing falling from the system. The glass damage was recorded for all lightweight cladding that contained glass. Nearly half of all glazed lightweight claddings had glazing damage and 39% presented a falling hazard. Only 60% of infill systems were deemed either operational or immediate occupancy. 17% were deemed high hazard, the highest of the facade groups.

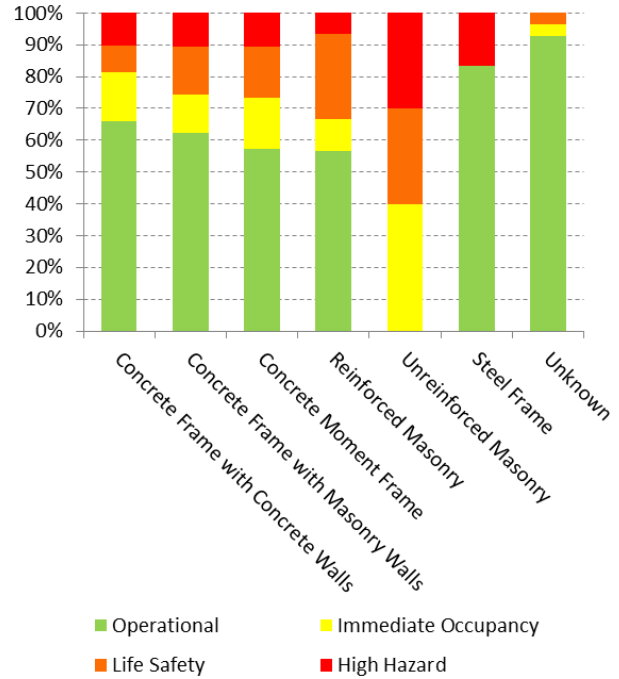
Figure 20: Facade performance by construction type.

Shown in Figure 20 is the facade performance grouped by building's predominant structural typology. The typologies are listed from left to right in terms of the frequency that they were identified. As expected, facade systems attached to unreinforced masonry performed by far the worst, likely a consequence of the poor structural performance. The

remaining structural typologies showed fairly consistent facade performance. It would not be expected that structural typology would have a large influence on facade performance. However, one possible point of difference is between the facade performance of 'concrete frame with concrete walls' and 'concrete moment frame'. It can be seen that more damage was observed in concrete moment frames; this may possibly be due to concrete moment frames being more flexible structures than concrete frames with dominant shear walls.

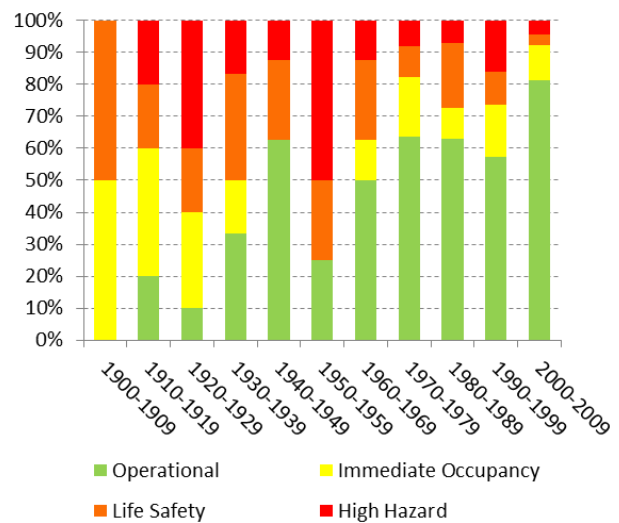
Figure 21: Facade performance by building age.

There is an evident trend that the newer the building, the better the facade performance. Buildings built in the 1950s exhibited the highest number of 'high hazard' cases. It is encouraging to see that facade systems built from 2000 onwards were clearly the best performing.

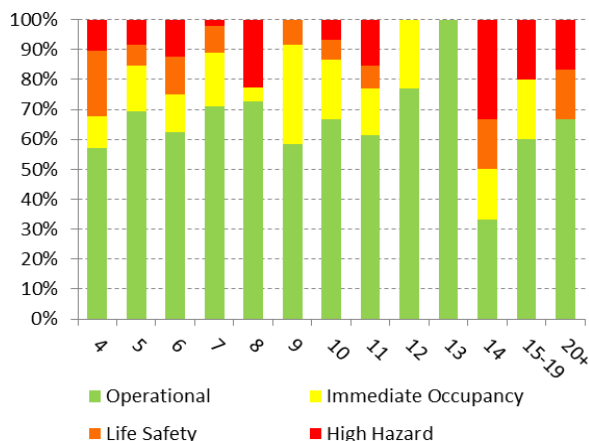
Figure 22: Facade performance by number of building storeys.

Finally, shown in Figure 22 is the facade performance grouped by the buildings height (number of storeys). A building's natural period is correlated to its height, so it is possible trends relating facade damage to the earthquake spectra could be observed, however it does not appear there is any such trend. The low amount of data present for taller buildings is likely the reason for the apparent higher level of damage in buildings 14 storeys and taller.
