THE DECEMBER 28, 1989 NEWCASTLE, AUSTRALIA EARTHQUAKE D.R. Brunston*

ABSTRACT

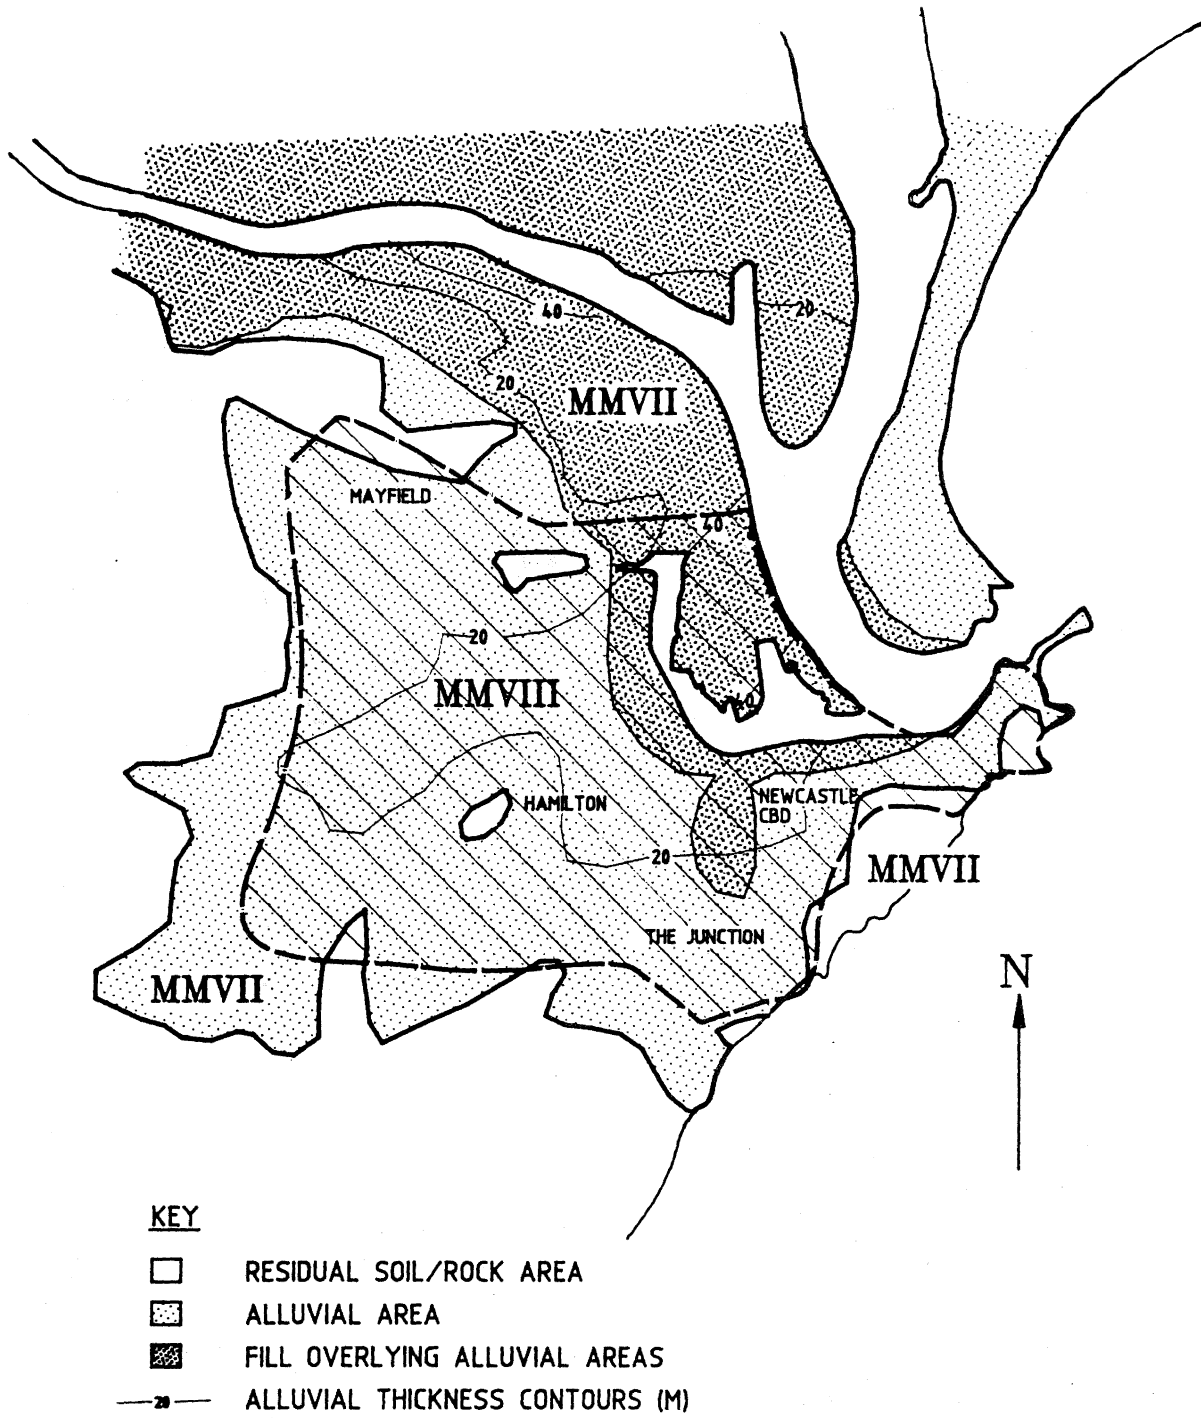
The predominant geological feature that influenced the extent of damage to buildings in this earthquake was the variation in depth of the alluvial material overlying the bedrock. There is a strong correlation between the areas where MM VIII intensities were recorded and the zones of deep alluvium and fill as illustrated in figure 3. The central city and inner suburbs are located over fluviially deposited sandy layers of varying densities with occasional peaty deposits. These layers have total thicknesses in the range 10-20m in the inner suburban areas of Hamilton and The Junction where the worst building damage was recorded.

FIGURE 3 RELATIONSHIP BETWEEN AREA OF GREATEST DAMAGE AND ALLUVIAL REGION (MODIFIED FROM [3]).

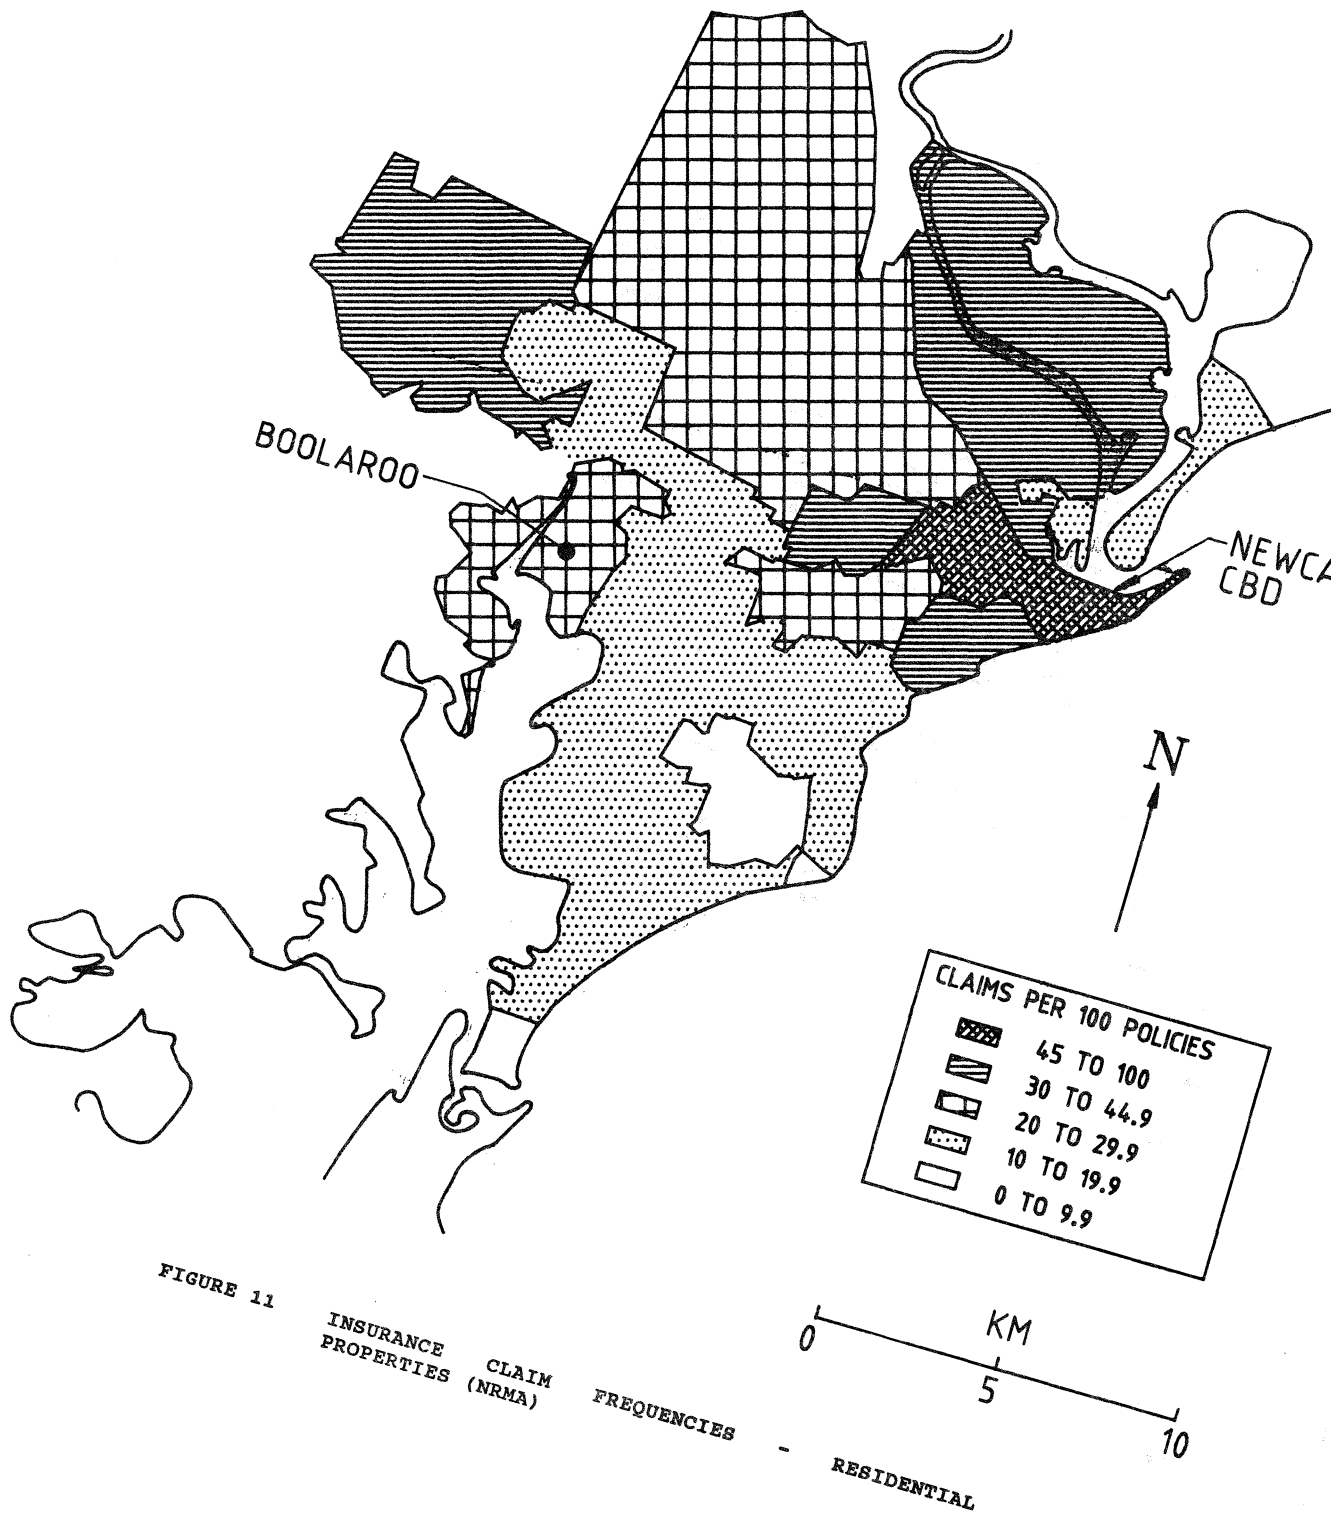
However a large number of detached and terrace houses sustained earthquake damage. While older houses in the inner suburbs generally received the greatest damage, many newer houses in these areas above deep alluvial layers were also hard hit. The geographical distribution of damage to residential premises in the greater Newcastle area is illustrated in figure 11. This figure is based on data compiled from the analysis of domestic earthquake insurance claims by the National Roads and Motorist's Association (NRMA), which is the largest insurer of domestic property in New South Wales.
