The WWII German Heavy Artillery Battery AV 67 of Cleus Foz (Finistère-FR)

Giancarlo T. Tomezzoli

How to cite this paper: Tomezzoli, G. T. (2017). The WWII German Heavy Artillery Battery AV 67 of CleusFoz (Finistère-FR). *Archaeological Discovery*, 5, 61-78. <https://doi.org/10.4236/ad.2017.52004>

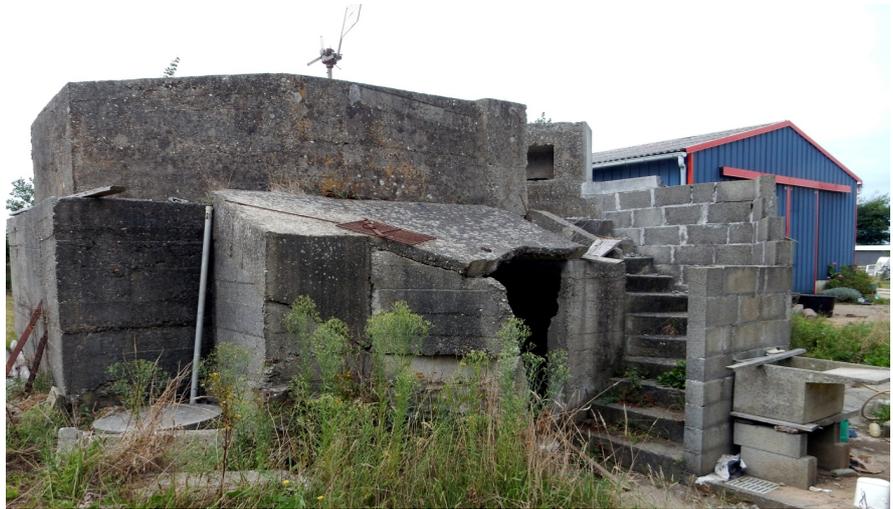
Figure 8. *Flak Vf(7)*-(1) concrete, cubic section with superimposed hexagonal gun emplacement, (2) entrance with protective walls, on the left small shed leaning on the bunker, (3) octagonal gun support with mosaic and mast of a small Aeolian generator, on the foreground ammunitions niches, (4) mosaic probably of origin, (5) bunker inside cluttered by materials, (6) staircase to the hexagonal emplacement, (7) front side: annexed concrete room and access stair, on the top the small Aeolian generator, on the right the agricultural shed (23), (8) access ramp to a buried bunker near the *Flak Vf(7)*, (9) *R669* with hexagonal emplacement, (10) *Vf(8)* near to the gun emplacement (8).
